# February 2004 flood damage in the Rangitikei and Manawatu Districts and associated remedial works

Tony Davies  
GHD Ltd, New Zealand

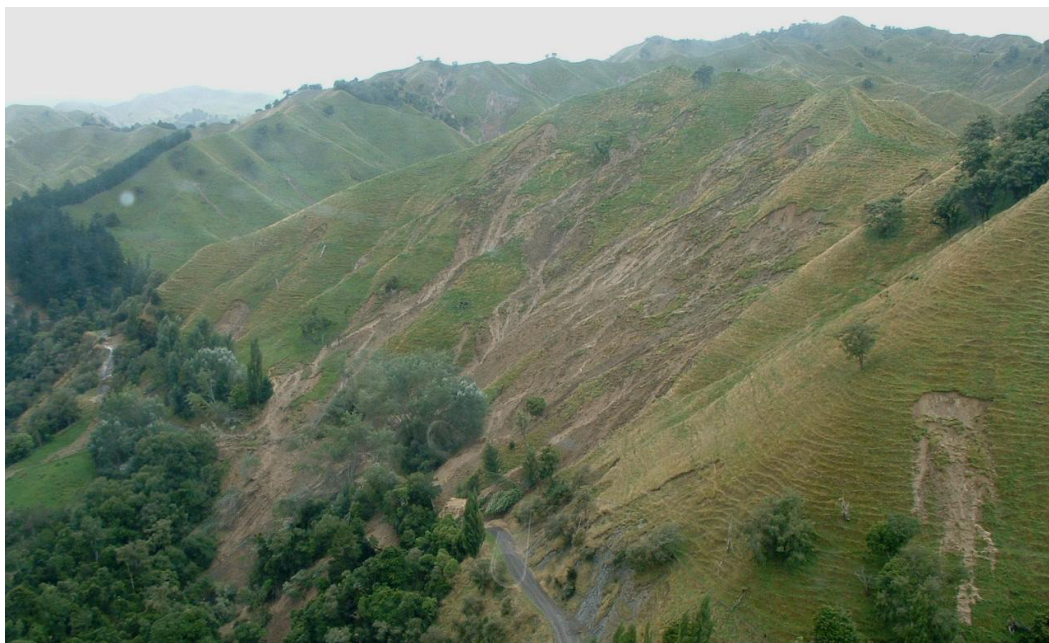
Figure 1: Aerial view of landslips Turakina Valley Road

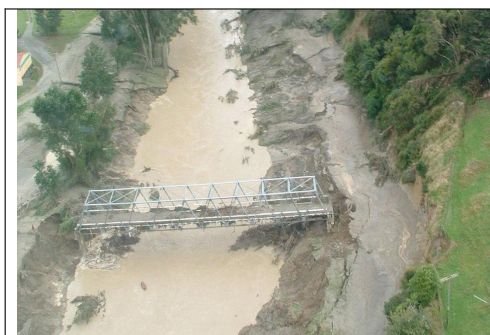
Figure 3. Aerial photo of McLays Bridge.

Both embankments and the approach roads were damaged when the Turakina River breached its banks, note debris on bridge deck. The bridge deck and pile foundations were assessed and found to be sound, the deck was extended and new embankments constructed.

The approach road along Turakina Valley Road was reinstated with a slope re-contouring and the road pavement reconstructed.

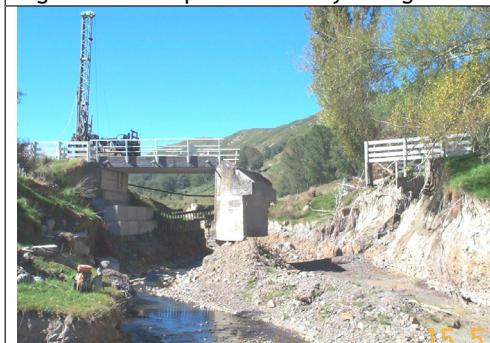
Figure 4. Dalzeils bridge.

The left embankment was washed away during the flood and the piles exposed. Masses of trees and other debris, mainly from riverbank collapses, had contributed to the failure.

The embankment was reconstructed using gabions.

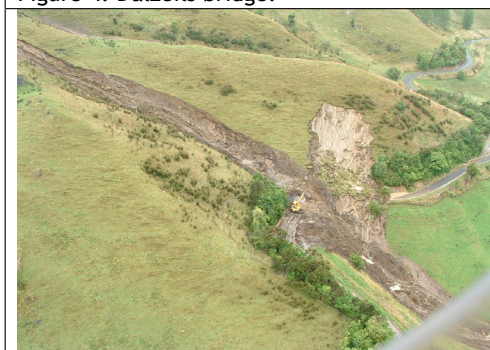
Figure 5. Aerial Photo of Pukeokahu Road.

It appears that once initiated the volume of the slide increased dramatically as the flowing debris advanced down the slope, scouring a deep channel. Most of the debris flowed into and down an existing watercourse, scouring a deeper gully.

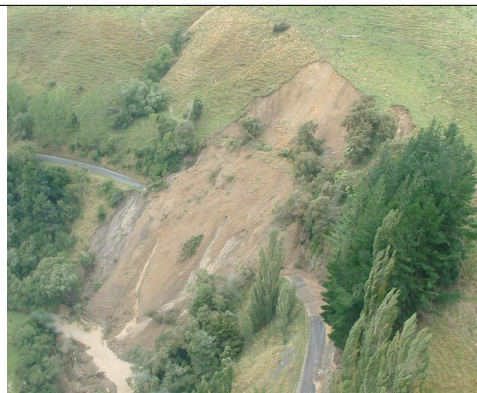
Figure 6. Aerial photo of Turakina Valley Road.

This landslide involved approximately 100,000m<sup>3</sup> of mainly surficial soils exposing the underlying Papa rock.

It took 2 weeks to clear the debris and reopen this section of road. The underlying pavement only suffered minor damage.

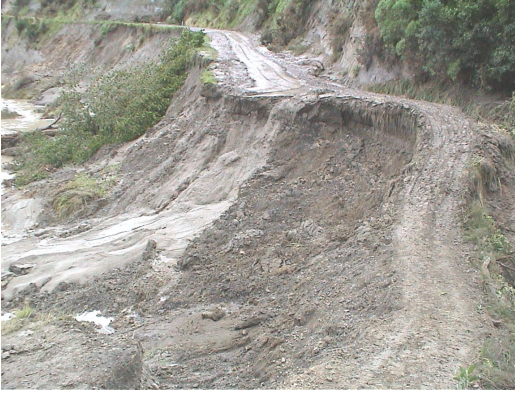
Figure 7. Failure prior to re-contouring

For most slips within the Rangitikei and Manawatu Districts Slope re-contouring (retreat) of the slopes is the safest and most cost effective way of repairing the failed zone as well as providing a medium to long-term solution.

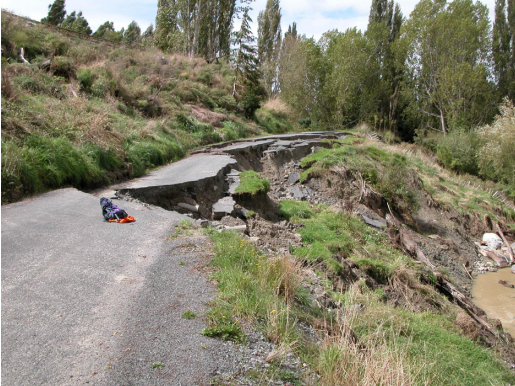
Figure 10. Otaihape Slip after failure.

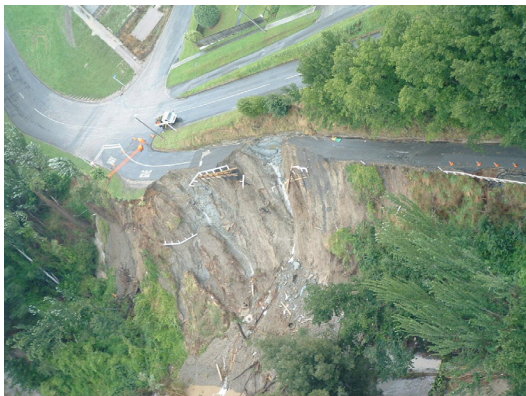
Figure 12. Papakai Road failure

The larger failures required tied back timber pole walls. This slip along Papakai Road required a retreat, deep drainage and a tied back timber pole wall.
