Residential development in a landslide area in Sydney

Indra Jworchan, Emged Rizkalla, Tony O'Brien
Geotechnique Pty Ltd, Lemko Place, Penrith, NSW 2750, Australia

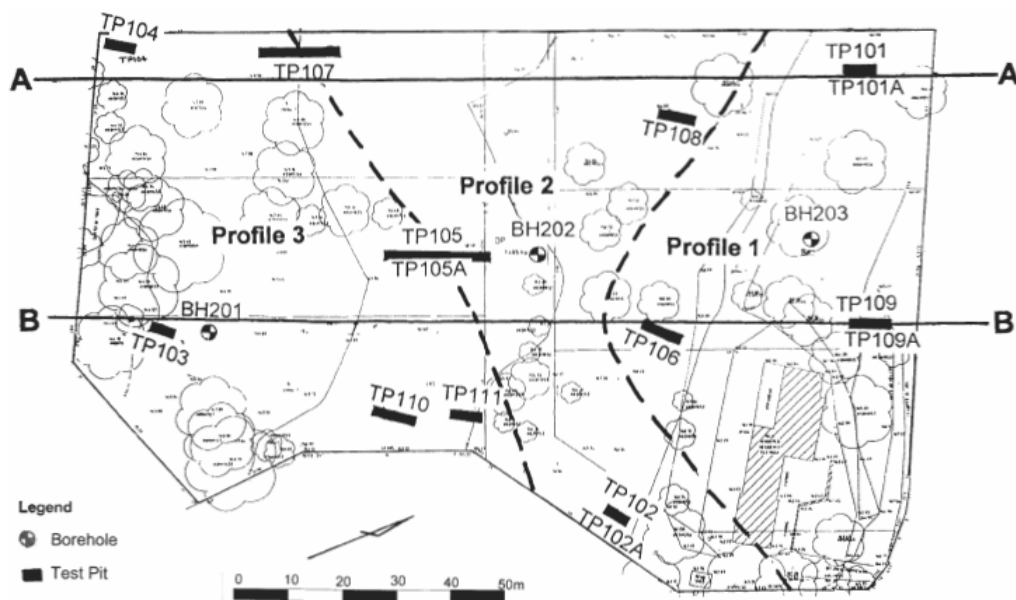
Figure 1: Plan showing locations of boreholes and test pits and three types of subsurface profiles

The site is underlain by Middle Triassic Age Bringelly Shale and Ashfield Shale (Herbert, 1980). The three distinct sub-surface profiles across the site are arbitrarily defined as Profile 1, Profile 2 and Profile 3 (Geotechnique Pty Ltd, 2006). The approximate boundaries between profiles areas are indicated in Figure 1 with the subsurface profiles along Sections AA and BB shown in Figures 2 and 3.

Groundwater levels in three standpipes (see Figure 1) and rainfall in North Parramatta (nearest meteorological station located at distance of about 8.0km from the site) as obtained from the Bureau of Meteorology web site (2006) are presented below in Table 2.

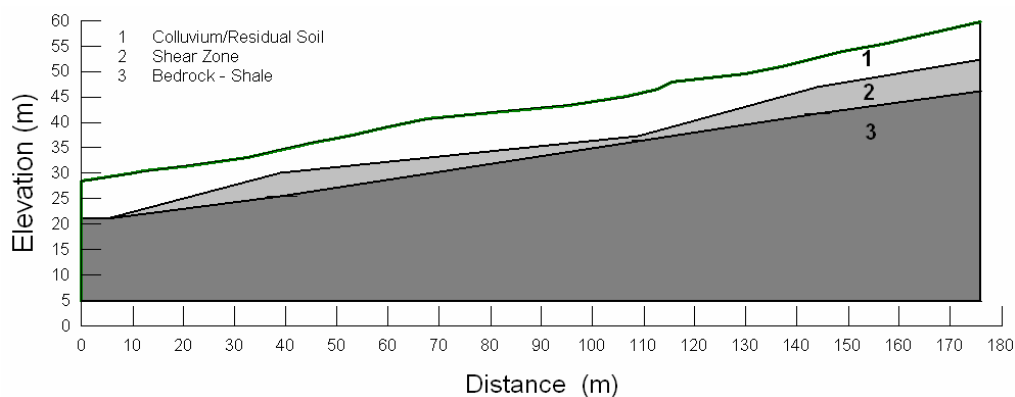
Figure 2: Cross Section AA (Distance measured from the Southern Boundary)

Bedrock shale is extremely or distinctly weathered up to depth of 7.0m and then becomes slightly weathered or fresh. Sliding planes were observed in Profile 1 and 2 but not in Profile 3. Sliding planes comprised polished or slickenside surfaces, within soft and high plasticity clay, generally about 100mm thick. Slip surfaces dipped approximately at 15 - 20 degrees towards the south.
