# Landslide risk assessment for residential dwellings on known landslides

Golder Associates Pty Ltd, Melbourne, VIC, Australia

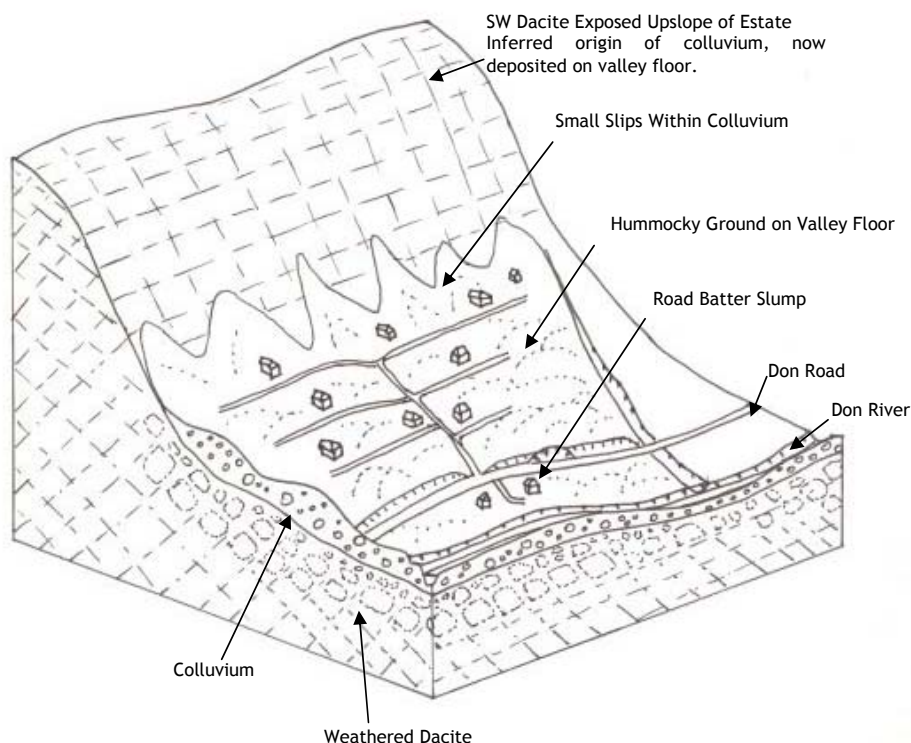
Figure 1: Conceptual Sketch of Ben Cairn Landslide

As shown in Figure 1, the Estate is on the foot of a mountain, bounded by a river on its downslope side. Slope angles within the Estate are typically about  $10^\circ$ , steepening up to about  $32^\circ$  higher up the mountain.

Based on these observations, it was assumed that the major landslide occurred at least 10,000 years ago, probably more. This was a time when rainfall within eastern Australia was inferred to be higher than it is today. It was assumed that the landslide probably occurred in response to saturation of weathered rhyodacite comprised of cobbles and boulders within a silty and clay matrix. It moved rapidly from the slopes of Ben Cairn into the valley below, causing mixing of debris and deposition of the hummocky, colluvial deposit observed in the valley floor. The extent of the landslide is defined by this colluvium. However, the area on the slopes of Ben Cairn from which the colluvium derived is less well defined. The rock outcrops on the slopes above the Estate, suggest that the weathered mantle that typically overlies the rhyodacite has been removed and that it could be the source of the colluvium in the valley floor. The area defined by the rock outcrops is much less than that defined by the colluvium on the valley floor. It is possible that debris from a smaller area fanned out as it moved down the slope and was deposited on the valley floor.

The colluvium is a poorly consolidated, weak deposit. The smaller scarps, on steeper parts of the colluvial deposits, appear to be recent events, possibly having occurred in response to land clearing, logging activities and periods of high or prolonged rainfall.

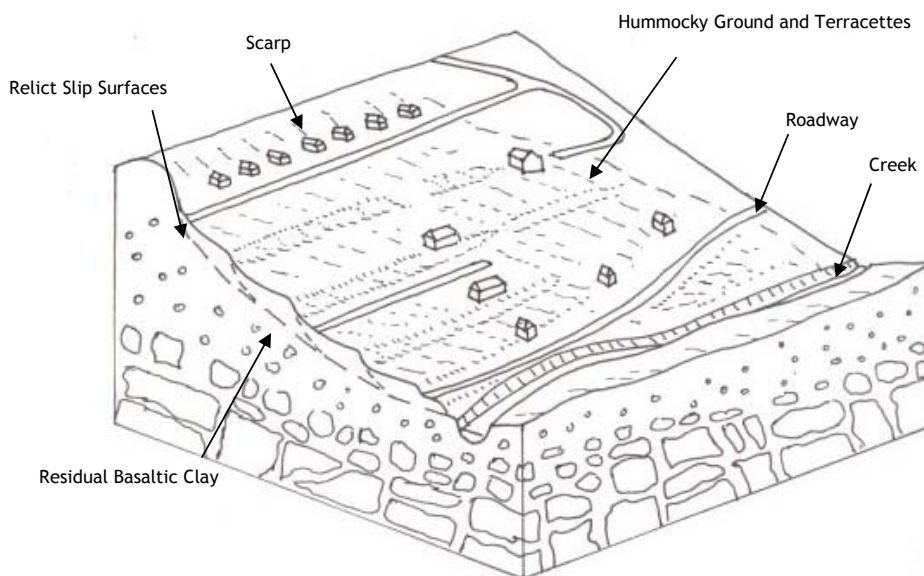
Figure 2: Conceptual Sketch of Silvan South Landslide

Based on the geomorphological evidence it was assumed that the Silvan South landslide probably occurred within the past 1000 years. The clearly defined scarps and terraces within the landslide suggest retrogressive landsliding within the cohesive weathered Tertiary Basalt. Movement is likely to have been slow, incremental and triggered by heavy or prolonged rainfall. A conceptual sketch of the landslide is shown in Figure 2, below.
