Ongoing movement of the West Taihape Landslip, New Zealand

Kate Williams

Tonkin and Taylor Limited, PO Box 5271, Auckland, New Zealand

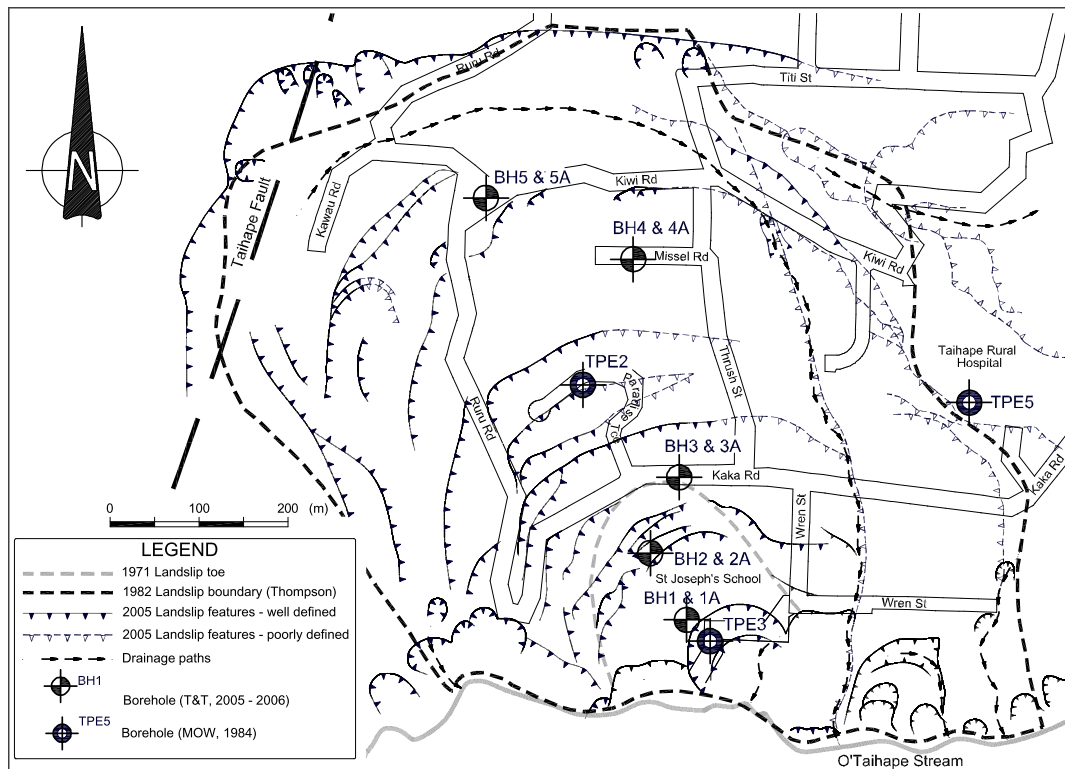
Field investigations were carried out under T&T supervision and were initially scoped to specifically address the 2005 active toe slope movements (Tonkin & Taylor Ltd, 2005), which were subject to insurance claims at that time. In 2006 further investigations were undertaken across the wider Taihape Landslip (Tonkin & Taylor Ltd, 2007) to extend the monitoring area in collaboration with the GeoNet Research Project conducted by GNS Science (Massey et al., 2007). Site investigation works consisted of five fully cored machine boreholes drilled to a maximum depth of 63 m along with five wash drilled boreholes for multilevel piezometer installation drilled to a maximum depth of 38 m. Slope Indicator 70 mm APS plastic inclinometer casings were installed to the base of the fully cored drillholes BH1 - BH5. Locations of the borehole and piezometer (BH1A - BH5A) positions are shown in Figure 2.

As a part of the field investigation, geomorphological mapping was undertaken in detail over the toe slope area of the landslide (1971 failure area) and more generally over the wider area (Figure 2).

Figure 2: Location plan of field investigations and preliminary mapping

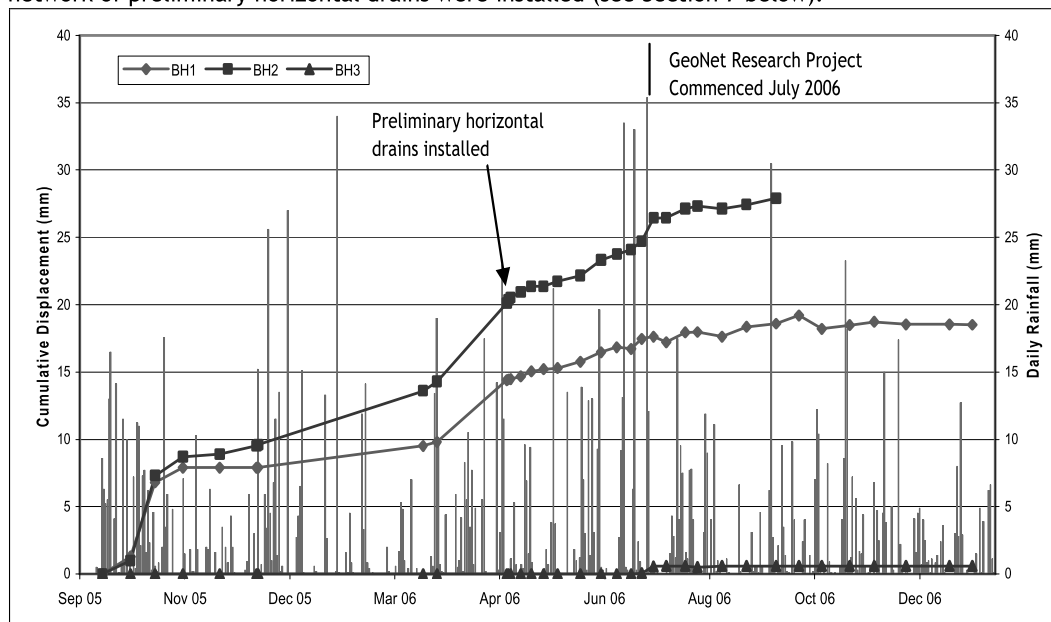
Monitoring of the inclinometers has been generally undertaken on a two weekly basis (Figure 3). Discrete movement (up to 8 mm) within BH1 and BH2 inclinometers was detected across the failure surfaces within the first month of installation. These movements occurred following periods of high intensity and/ or prolonged rainfall (up to 89 mm of rain recorded in a two week interval) and periods of elevated groundwater levels. In response to these movements, up to 0.5 mm/day, a network of preliminary horizontal drains were installed (see Section 7 below).

Figure 3: Cumulative displacement of the West Taihape Landslip and daily rainfall

- BH1 recorded movement at 22.3 m below ground with up to 19 mm of cumulative displacement in a direction of approximately 160° . This movement has been ongoing since installation.
- BH2 recorded movement at 25.75 m below ground with up to 28 mm of cumulative displacement in a direction of approximately 142° . This movement has been ongoing since installation. Inclinometer monitoring of this installation ceased in early October 2006 due to the amount of shearing the tube had undergone.
- BH3 first observed movement was during the monitoring round in late July 2006. Minor movement (up to 0.6 mm) was recorded around 24 m below ground with a direction of approximately 161° and has remained static since.
- BH4 and BH5 inclinometers have indicated no detectable movement.

Subsurface movements have continued to be recorded (up to 0.04 mm/day) within the inclinometers (Figure 3) indicating continued creeping of the slope at similar rates to those before the drainage was installed. However, following prolonged rainfall events, post drainage installation, the recorded rates of movement (small surge events) have slowed to 0.2 mm/day in BH2 only and are not evident in BH1 (versus 0.5 mm/day in BH1 and BH2 prior to the drains).

It is concluded from the inclinometer movements that the drains have had a positive effect providing dewatering in the toe area and may have slowed the rate of movement for a small surge event. The drainage has not however removed the peak water levels occurring during significant prolonged rainfall events contributing to these movement events nor affected long term creep rates to date. Further understanding of groundwater movement in the landslide area and drainage options for the wider West Taihape Landslip are currently being developed to increase the influence zone of drainage. These may involve further subsurface drainage and options to reduce seepage zones and improve stormwater control from open drains and the local council services networks.

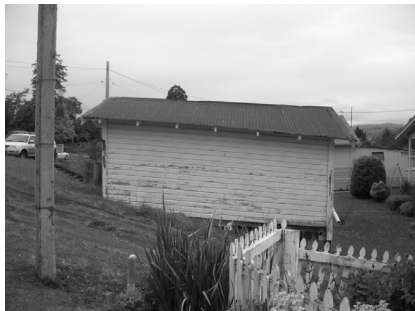
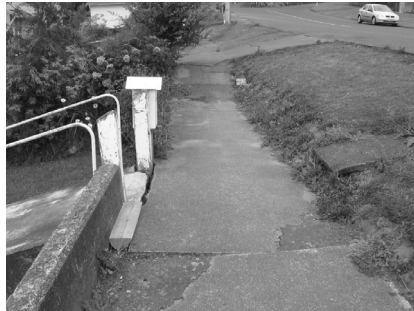
With the recent increased movements recorded new risks are now apparent with damage to structures and services about the edges of the reactivated slopes. Ground surface mapping and observations of damage clearly support this as many EQC insurance claims have been received within the last 12 months, with newly reported damage to dwellings and land on private property. This damage in some cases is the result of cumulative movements over a period of time, some with up to 40 years of movement (Figure 4).

Figure 4: Photographs of ongoing damage to land and structures
