An update of Deep Soil Mixing in New Zealand

Graeme Quickfall, NZCE (Civil), REA, MBA
 Andy O' Sullivan, BE, CEng, MIEI, MIPENZ, Eurling
 Isaac Kett, ME (Civil)

Hiway Stabilizers Environmental Limited - Auckland, New Zealand

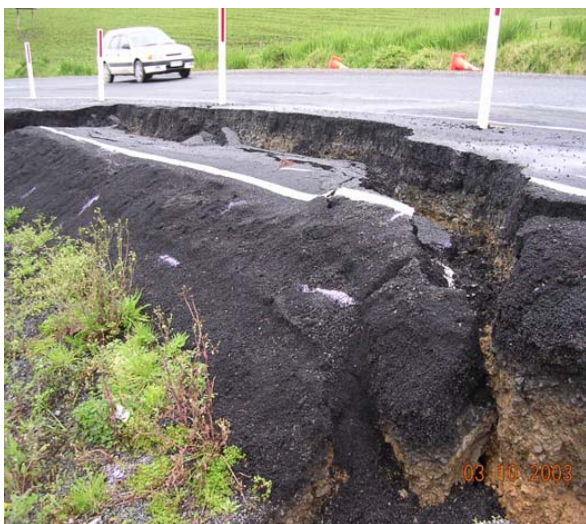
New Zealand's geology generally comprises a range of young and geotechnically challenging soils. In particular Northland and the Gisborne region on the North Island's east coast are prone to instability of road structures. As a result, New Zealand roads have long suffered from over and under slip settlements, many associated with increase pore water pressure build-up and/or weak soil properties. A photograph of a typical road under slip is shown in Figure 1.

Figure 1 (left): A typical New Zealand road under slip.
 Figure 2 (right): The Colmix C1300 rig

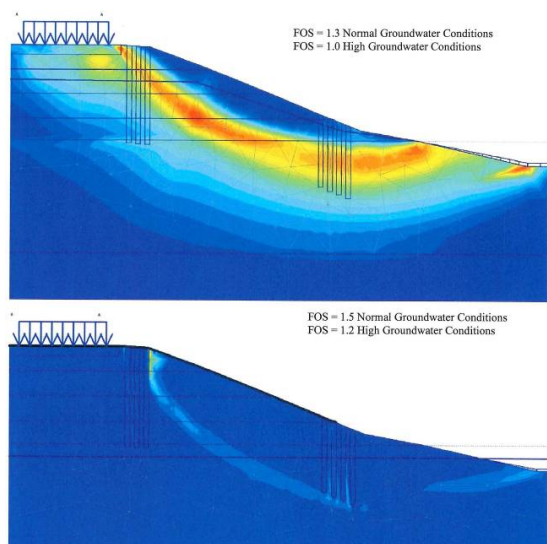
A new 15 km long section of Northern Motorway, known as Alpur Section A, was opened in late 1999. In December 2005 a 70m long section just outside of the shoulder on an 8m high embankment slipped to cause a 0.6m high head scarp. The head scarp occurred just outside the crash barrier, but threatened the road shoulder and pavement. Traffic protection measures were installed, and the slip was monitored. As of July 2006, the scarp had increased to 1m in height.

of construction. The slip was determined to be primarily rotational as the embankment upon which this new section of State Highway One was constructed was only seven years old, and bearing capacity failure of the underlying materials appeared unlikely. The underlying material consisted of natural alluvial clays which have been proven as suitable for a cement based "wet" DSM process in the past.

Figure 4: Modelling of the slip at Okura before and after installation of columns.

A DSM solution was adopted that involved the drilling of 83 columns drilled to a depth of 8.5 m. The columns were divided into 7 rows of which 4 were constructed at the base of the slope, and 3 were constructed adjacent to the pavement shoulder. Safety factors of 1.5 and 1.2 were adopted for the normal and extreme groundwater conditions, as displayed in Figure 4. The remedial works, as illustrated in Figure 5, were completed in 2.5 weeks.

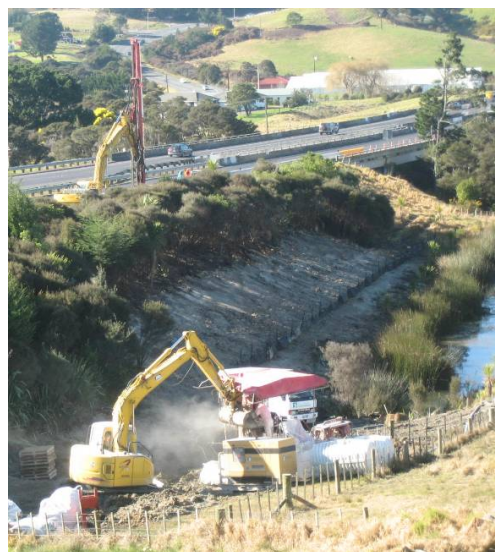
Figure 5: Installation of DSM columns at Okura.

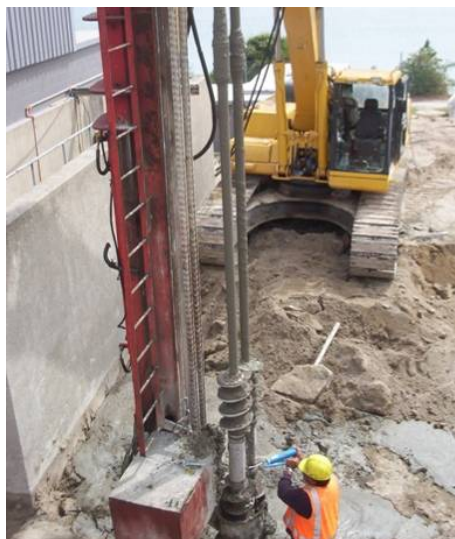
Soils underlying a proposed extension to Tauranga's Waste Water Treatment Plant were determined to be susceptible to liquefaction in a seismic event. The factor of safety against liquefaction was determined to be between 0.3 and 0.7 at varying depths below existing ground level.

Figure 6: Tauranga WWTP site.

The 500mm wide DSM wall was constructed to provide a 70mm overlap - this created 8.5m cells upon which the liquefaction mitigation design was based. 171 columns were constructed in total. The perimeter wall encompassed 62 m² with 7 cells created by internal walls. Construction took place in March 2006 and required a great deal of attention to be placed on the location of each column due to the required overlaps and the presence of substantial services due to being located in the WWTP. Columns were drilled to 11.5m maximum depth, creating significant construction challenges. The site and cells created by overlapping columns are illustrated in Figures 6 and 7.

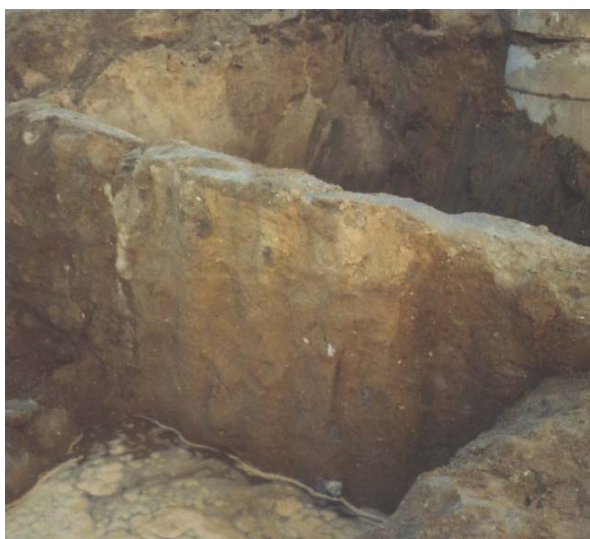
Figure 7: Overlapping columns creating cells.

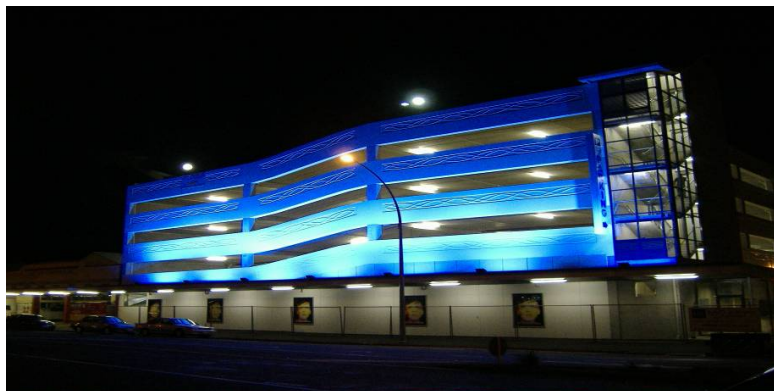
A multi-story reinforced concrete carpark building had been proposed for Knox Street, Hamilton. The building foundation was designed utilising strip footings and no piles. However, the presence of a 3m deep layer of incompetent low strength silty sand material from ground level down would not support the proposed foundation design.

Figure 8: Knox Street Carpark, Hamilton - Inaugural use of DSM in building foundations.

The building was designed to be founded on raft footings, and it was these footings that the DSM columns were designed to support. The number of columns required under each raft varied from 8 to 200, depending on the load that each raft was required to restrain. The foundation design required each of the 539 columns to obtain a UCS of 2.5 MPa and be capable of supporting a bearing capacity varying between 0.75 and 2.0 MPa. The columns extended to depths of between 2.5 to 3.5 metres, and the contract was completed in 14 days.
