Site classification and early floor movements in a new subdivision

Aaron O'Malley

Don Cameron

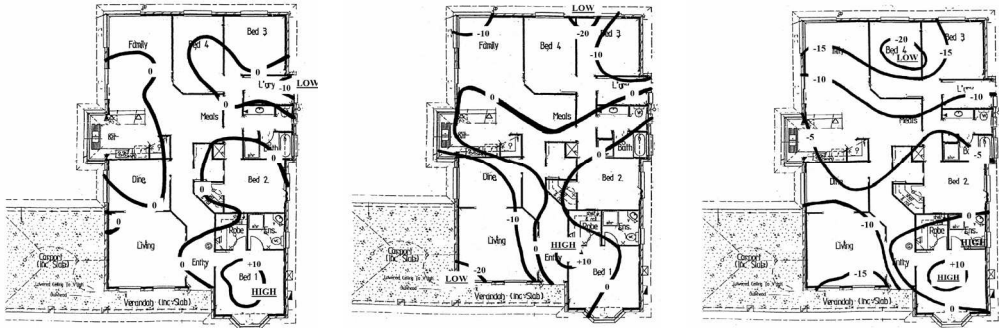
Figure 1: 8DWH house floor movements

The house at 8DWH was built in 1999 on an allotment with an expected characteristic site surface movement, y_s , of 104 mm. There was no cracking evident in the building on the first visit in September 2002. Over the four years of inspections, the house has experienced a nearly constant 10 mm heave below the front southern bedroom. More generally, patterns of movement began to become distinct by April 2005, with settlements appearing along the North side and about the South-West corner of the house. At the same time, minor cracking (≤ 1 mm) was noted next to a window in the bathroom and adjacent to the cornices between the lounge and dining areas. The patterns of settlement had extended by December 2006 at the back of the house and had receded a little at the front. A centre heave deformation was evident in the NS direction, with a differential movement of approximately 30 mm. Nonetheless the slab has performed well compared to other slabs within the subdivision, especially given the relatively lower flexural strength of the footing.

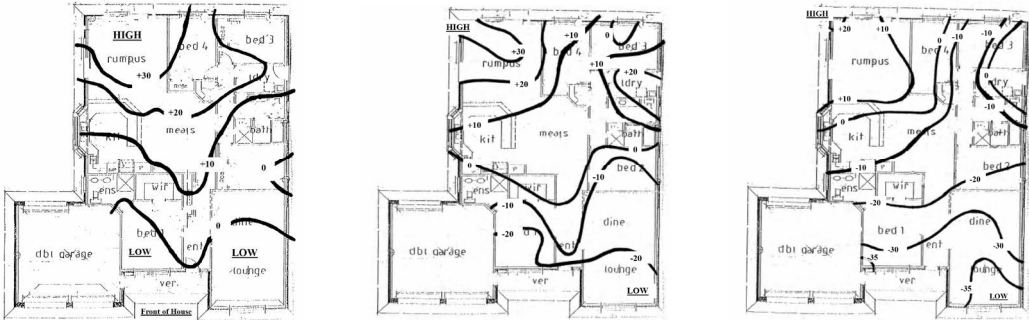
Figure 2: 3LWH house floor movements

The house on site 3LWH was one of the first built in the subdivision in 1999 on an allotment with an estimated site characteristic surface movement of 100 mm. An inspection of the house on the first visit in October 2002 did not reveal any cracking; however by December 2006, minor cracking of 1.5 to 2 mm wide was noted in the cornice above the en-suite. From the first level survey, it appeared that the Northern half of the slab was undergoing heave, which had reached 40 mm near the NW corner by June 2003. The front of the house barely moved until approximately 20 mm of settlement was recorded in April 2005. By December 2006, the edge heave at the NW corner had reduced to about 20 mm and the front of the house had settled further (35 mm or so). Settlement was observed over 70% of the slab area. Fortunately there was no distinct edge or centre heave pattern. The maximum differential movement was 55 mm, and although greater than expected, its impact was lessened by tilt. There are signs however of the onset of centre heave.

Only the slab at site 3LWH was believed to have been affected by nearby vegetation. Over the monitoring period, an ornamental pear tree had almost doubled in height to 3.5 m and the tree is now relatively close to the house (proximity ratio ~ 1.0). In contrast the site at 8DWH had few significant trees or plantings; on the last visit lawn areas were thin and patchy. Two Silver Birch trees at the front of the property had not grown significantly over the monitoring period. The homeowner had not regularly watered garden areas, which is reflected in the poor growth. As already noted the slab seemed to be relatively less stiff for edge heave movements, yet this slab has performed relatively well to date.

For example, for the slab at 3LWH in December 2006, the maximum value of Δ observed was 55 mm, occurring almost diagonally (SE to NW corners) across the floor. The maximum difference in level below the south wall (arguably suffering the worst distortion) was greater than 35 mm. This value of movement was reduced to about 20 mm when tilt was removed, a value which is well within the design limit of 30 mm

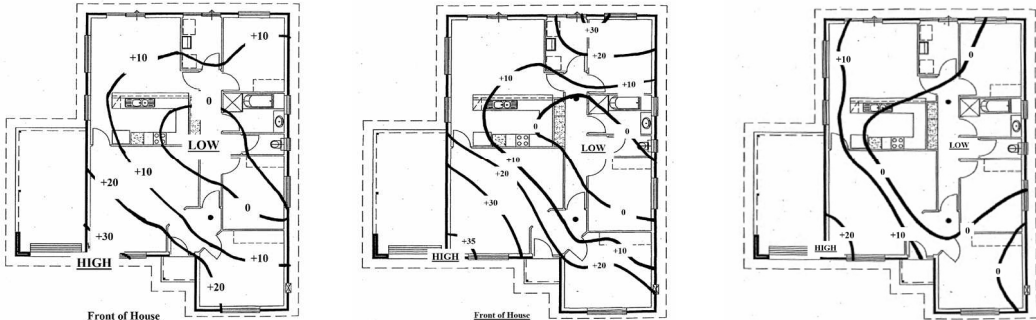
Figure 3: 8SWH house floor movements

The house at 8SWH was built in 2001 on an allotment with an estimated site characteristic surface movement of 83 mm. Floor slab levelling surveys were conducted in August 2002, March 2003, October 2003 and April 2005 at the site. The slab was unable to be surveyed during 2006. A skewed edge heave pattern, reaching from corner to opposite corner of the house, was clearly evident from the first floor survey. The highest differential movement in edge heave was 35 mm in March 2003, which lessened as settlement increased at the NE and SE corners. An inspection of the house on the first visit revealed minor cracking, 1 to 1.5 mm wide above two inner walls; these cracks had widened slightly to 2 to 2.5 mm by April 2005. The reason for crack widening is not apparent from the contour plots.

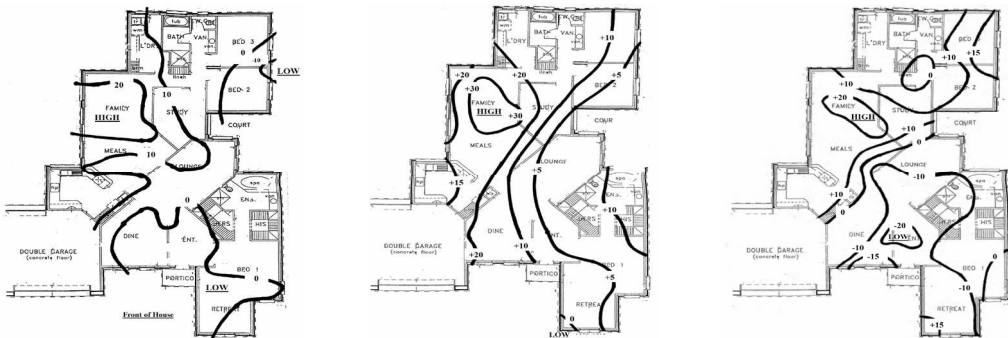
Figure 4: 16LWH house floor movements

The house on site 16LWH was built in 1999/2000 on an allotment with an expected site characteristic surface movement of 101 mm. An initial inspection of the house revealed no cracking, however in April 2005 and December 2006, minor cracking of approximately 1 mm wide was noted in the tiled wall of the en-suite.

From the first inspection in October 2002, it was observed that the slab had heaved below the family room to a maximum value of 20 mm. The family room is at the West side of the house; a paved and rooved patio was located adjacent to this room. The upward movement continued in June 2003 and April 2005, extending further across the house, before receding by December 2006. In April 2005, an asymmetrical edge heave was evident from the SE to the lower NW corner of the house. Drying in December 2006 caused shrinkage settlement at both ends of this same section. Reduced movements were recorded around the slab, except towards the NE corner adjacent to two bedrooms, which rose approximately 10 mm. The maximum observed differential movement for this house was about 40 mm in 2006. The slab is now showing signs of progression to centre heave.
