Remediation of flood damage on the Toowoomba Range Railway, Queensland, Australia

G. Rogos¹ MIEAust FGS Senior Geotechnical Engineer, D. C. Starr¹ FIEAust Principal Geotechnical Engineer, P. Booth¹ Senior Engineering Geologist, J. Sugawara¹ MIEAust Senior Geotechnical Engineer, N. Gurung² Senior Engineer

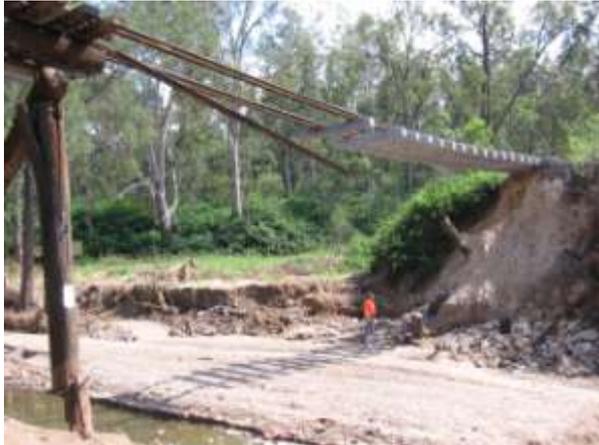
Figure 2. View upstream of destroyed Kings Bridge.

A six week program of investigation, pile design and construction was implemented for replacement of the damaged bridge as described below (Figure 7).

The site investigation at Kings Bridge identified the presence of between 10 m and 13 m thickness of alluvium including boulders, overlying extremely weathered sandstone. The sandstone was typically underlain by mudstone at 20 m depth. Although a driven pile solution was initially considered as an economic solution, bored cast *in situ* piles were selected as the foundation option for Kings Bridge, as the equipment required was readily available and this technique would provide the necessary lateral resistance and reduce potential difficulties associated with penetrating coarse alluvium.

The ultimate axial pile capacity of a single vertical bored pile was calculated using the computer program AllPile (CivilTech, 2009). The pile design accounted for proposed Serviceability Limit State pile loads of between 2000 kN and 2700 kN. Several pile diameters were analysed - a 1200 mm diameter pile with 4 m penetration into the sandstone bedrock was adopted to reduce the socket length and limit loading on the mudstone underlying the sandstone.

The bridge reconstruction was completed in two stages to facilitate rapid restoration. The first stage involved construction of a 5 m thick temporary fill embankment using rockfill, cement stabilised sand and incorporating four 3.5 m diameter CMPs. This temporary structure formed a working platform for the piling activities and the piles were constructed over a one week period during continuous day and night shifts. A total of eight, 1200 mm diameter piles with a typical length of 21 m were constructed. The pile boring and construction was supervised by a geotechnical engineer from Golder and this provided a valuable opportunity to confirm ground conditions and validate the design.

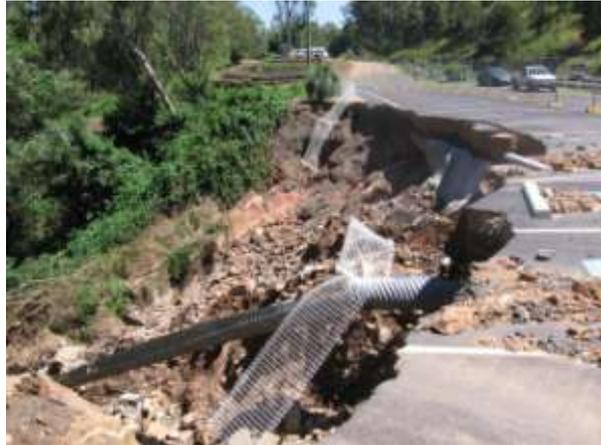
Figure 3. Slope failure of carpark at Spring Bluff station.

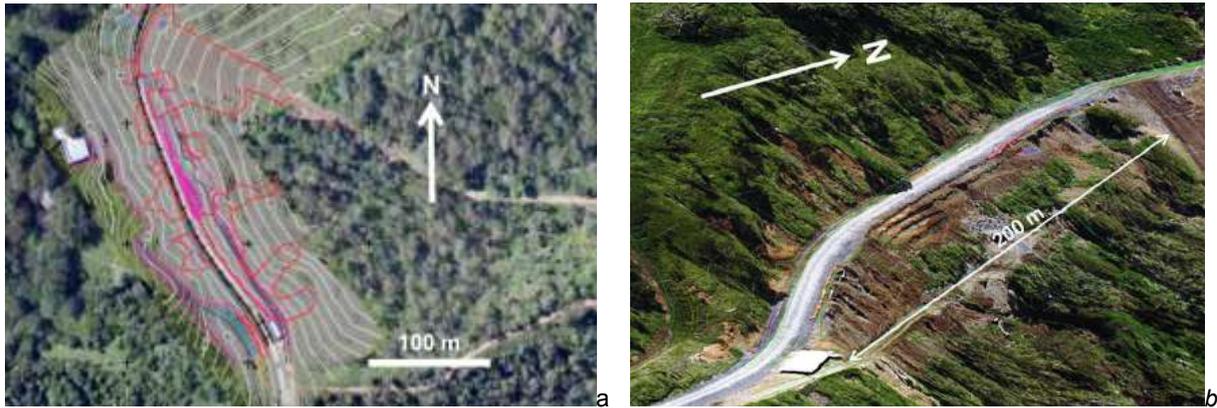
Figures 4a and 4b. Ortho-rectified photographic mosaic from high and low altitude aerial photography, showing topographic contours and outlines of landslide locations (a), and oblique view of a rendered digital terrain model (b) at Rangeview Station.

The railway line at Rangeview Station was originally constructed on a cut slope which has been progressively built out by placement of side-tipped fill, comprising predominantly ash waste. Damage of varying degrees was sustained across a 200 m width of the downslope area and comprised undercutting of the railway line and washouts of the slope and adjacent vehicle track below. Slopes of up to 40° were observed for both the fill material and adjacent natural ground. A gas pipeline located at the northern end of the site sustained damage after backfill material was eroded by flood waters (Figures 4a and 4b).

In order to remediate the slope and associated vehicle track in a timely fashion several options were considered including: pre-cast, reinforced concrete L-section retaining wall panels; gabion baskets; and concrete mass blocks. All of these options were technically feasible, however in considering the local availability of products, topographic constraints and constructability, the L-section panel option (L x W x H = 2.4 x 1.75 x 3m) was chosen for retaining the toe of reconstructed slopes. Conventional wall stability analyses were undertaken as part of the design and considered sliding, overturning, bearing capacity and loss of overall stability. The design geometry was based on topographic information collected during the aerial photogrammetric survey.

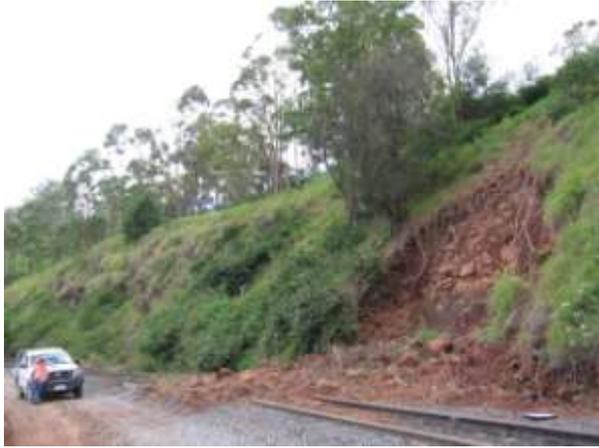
Figure 5. Typical upslope cutting failure.

The majority of failed slopes, including cuts in natural soil and rock above the railway and fill embankments below the railway, were remediated by excavating and removing failed material, reprofiling (including benching) and replacing with a combination of compacted fill and rockfill (Figure 6). At numerous locations Corrugated Metal Pipes (CMPs) were utilised to restore or establish drainage under the railway. These methods proved to be a practical and relatively rapid method for remediating slopes and restoring stability to the railway line and associated vehicle service tracks.

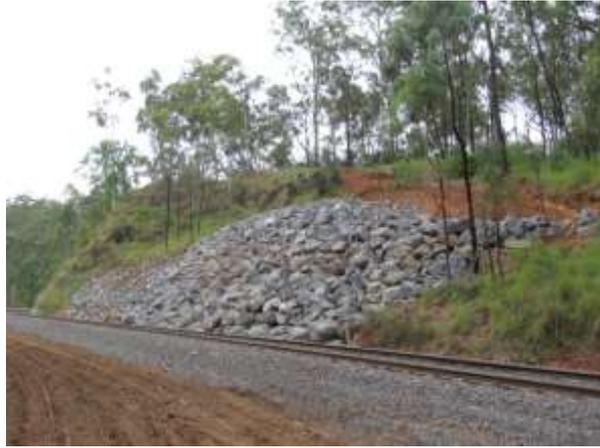
Figure 6. Failed colluvial slope remediated using typical rockfill construction.
