# Remediation of a Major Urban Rock Slope - Howard Smith Wharves, Brisbane

C.B. Thorley<sup>1</sup>, B.E. MIE(Aus), RPEQ and T. Weingarth<sup>2</sup>, B.E.

Howard Smith Wharves on the Brisbane River near the Central Business District (CBD) are currently being redeveloped as open space parkland. Overlooking the parklands is a 25m high, 500m long, vertical cliff face formed progressively by quarrying over the last 150 years. The cliff face consists of two dominant rock types, the Brisbane Tuff and phyllites of the Neranleigh Fernvale Beds. Between the two rock types and exposed in the face is probably the best example of a Triassic age unconformity in the Brisbane region. Prior to parkland construction, the first stage of redevelopment consisted of the design and construction work necessary to stabilise the cliff face. For architectural and space reasons, the adoption of rock fall fences or rock fall zones was not possible, hence the stabilisation works had to ensure the cliffs were remediated to a standard where the risk to park users was as low as possible. Potential future uses of the park also included recreational rock climbing on the cliffs, requiring minimal artificial chang

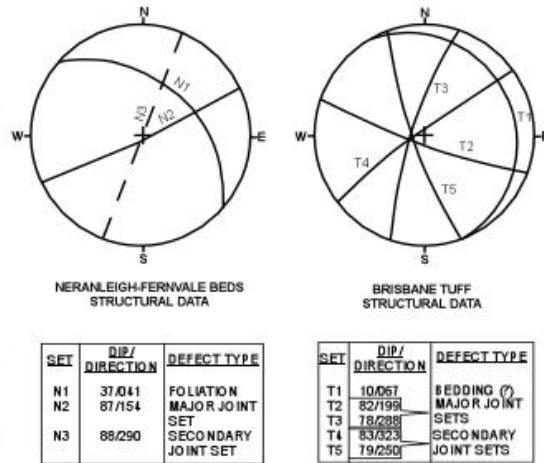
Figure 2 - Structural Mapping Data

Brisbane Tuff is exposed east of the unconformity. It comprises a fine to coarse-grained porphyritic rhyolite tuff with generally well defined layering or bedding at  $5^{\circ}$  to  $15^{\circ}$ . The rock mass is generally slightly weathered. Weathered zones occur extending to the base at one location where the weathering is identified with the presence of a fumarole vent. The rock in these weathered zones varies between pale brown and off-white and rock substance strength is estimated to be low to high (City Design, 2008). Structural joint and bedding data for the Brisbane Tuff is shown on the equal area, lower hemisphere projection at Figure 2. One bedding set, two major joint sets and two secondary joint sets were identified.

Rocks of the Neranleigh-Fernvale Beds exposed west of the unconformity comprise phyllite, which is a slightly metamorphosed (hardened and slightly recrystallised), fine grained marine sediment. This rock has been subjected to folding and faulting which resulted in a pervasive, closely spaced foliation overprinting the original bedding and the partial solution and redeposition of quartz as veins mainly parallel to foliation. The phyllite exposed in the cliff face is slightly to distinctly weathered with the rock substance strength estimated to be medium to high (City Design, 2008). Three distinct defect sets were identified. The mean orientations of these three sets are plotted on an equal angle, lower hemisphere projection included on Figure 2.

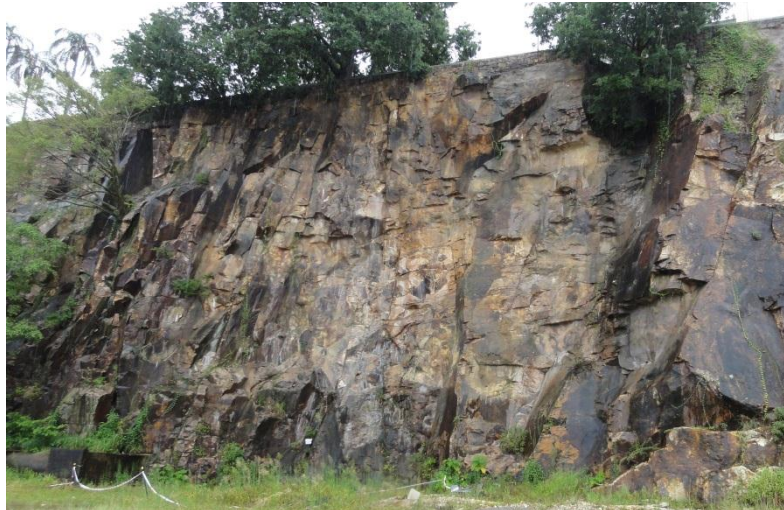
Failure modes identified at the site were mainly small to medium sized ( $1\text{m}^3$  to  $3\text{m}^3$ ) block and wedge failures in the Tuff section, and smaller ( $0.5\text{m}^3$  to  $2\text{m}^3$ ) block, planar and wedge failures in the Neranleigh section. Significantly larger failures were also possible in the Tuff depending on jointing, with a  $40\text{m}^3$  wedge failure evident at the crest at one location (Figure 3), and blocks up to  $20\text{m}^3$  to  $30\text{m}^3$  identifiable above the unconformity. Original stabilisation measures proposed for the site, prior to detailed development proposals, involved rock fall ditches and rock fall fences combined with rockbolting, scaling and buttressing (City Design, 2010). This approach, particularly the rock fall ditches and mounds, is typically the lowest cost option compared to more extensive structural solutions. An early risk assessment for the cliffs, based on estimated failure frequencies and volumes and estimated pedestrian and cyclist traffic, indicated unacceptable risk levels without a sterile rock ditch zone or similar. Due to the site geometry however, a rock ditch would effectively sterilise up to 45% of the park area. Rock fences were considered to reduce the width of sterile zones, but the height and verticality of the cliffs would require massive structural fences to contain rock falls originating higher up the cliffs. The proposed use of some sections for recreational climbing, and the preference to allow public access to the air-raid shelters which were tucked into the base of the cliffs, resulted in the decision to exclude rock ditches or fences as a viable remedial measure (City Design, 2010).

Figure 3 - Typical Tuff jointing with wedge failure at right at crest

Because of the prominence and aesthetic value of the cliffs, coloured sculpted shotcreting was specified. The successful contractor used his own system, registered as 'Natracliff'. This resulted in a finish which matched the existing rock face, effectively hiding the presence of shotcrete. Rock bolts were also specified as having recessed heads, sunk 100mm into the rock face and covered with coloured mortar to disguise their position. Figure 3 shows a completed section of Tuff face.

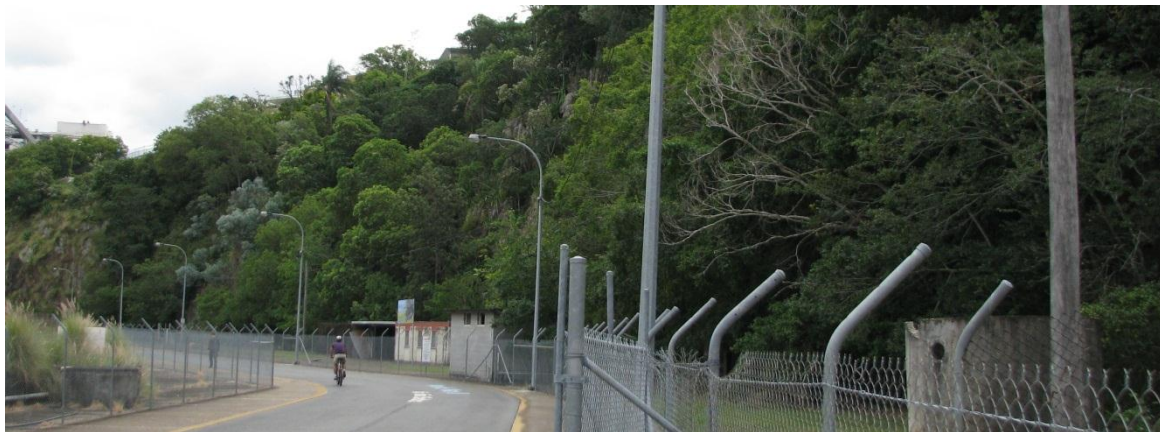
Initial estimates of stabilisation quantities were undertaken for the preparation of tender documents. Inspection of the cliff face was initially obscured by dense vegetation with an estimated 70% of the cliff face covered. The vegetation included large trees including figs and a wide variety of weed species and grasses. Where the rock face could be inspected, an assessment of the rock quality together with likely scaling, bolting and buttressing volumes was completed. Once the quantities were determined, a 30% contingency buffer was added to the initial estimates to cover unforeseen stabilisation requirements, given the limited areas that could be assessed prior to clearing. The unconformity section was considered to contain the most unknowns, with almost all of this section covered with dense vegetation (Figure 4).

Figure 4 - Original cliff appearance at unconformity location, showing heavy vegetation and proximity of bikeway.

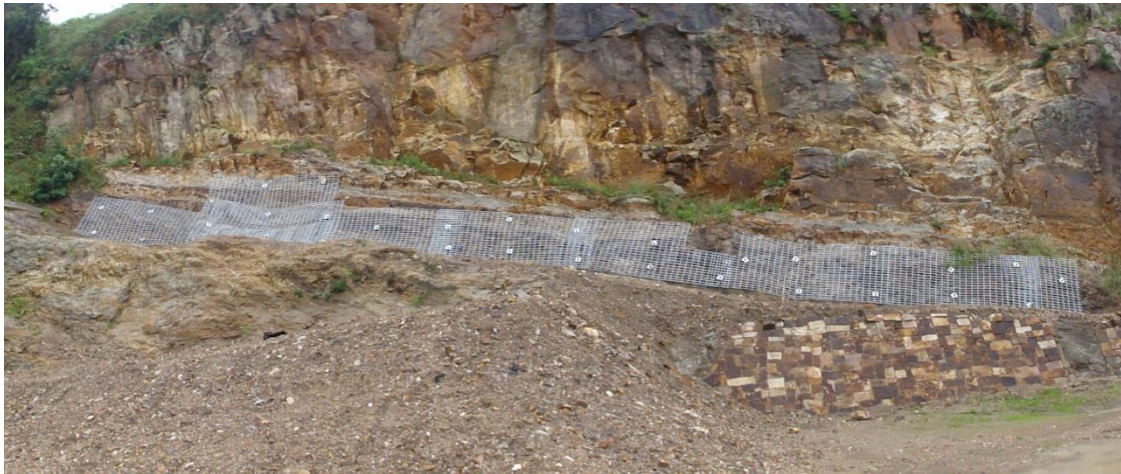
the river and CBD. Within the unconformity, up to six large fossilised tree trunks could be clearly identified, together with the contact of the Brisbane Tuff over the Neranleigh-Fernvale Phyllites. The highly weathered unconformity zone had caused under cutting of the upper strong Tuff deposit which led to toppling failures over the years. When the scaling had been completed in this area, the unconformity zone was cleaned to less weathered rock resulting in a wide bench between the toe of the unconformity and stronger Tuff above. The initial intention was to leave the unconformity unsupported and visible as this was one of the best exposures within the Brisbane area. However due to the highly erodible nature of this material, once exposed and subjected to rainfall, the material slaked and eroded. This led to slumps and failures, including a larger slip in January 2011 following prolonged intense rainfall. Rather than covering the uniformity with shotcrete, a rock bolt and mesh design was implemented (Figure 5).

Figure 5 - Unconformity treatment after initial collapse in January 2011.
