# Identification, Management and Reduction of Slope Instability Hazards within the Wellington Regional Metro Railway, New Zealand

R. Justice<sup>1</sup>, MSc, TMIPENZ and G. A. Cassidy<sup>2</sup>, MSc, CEng (UK), MIMMM, FGS.

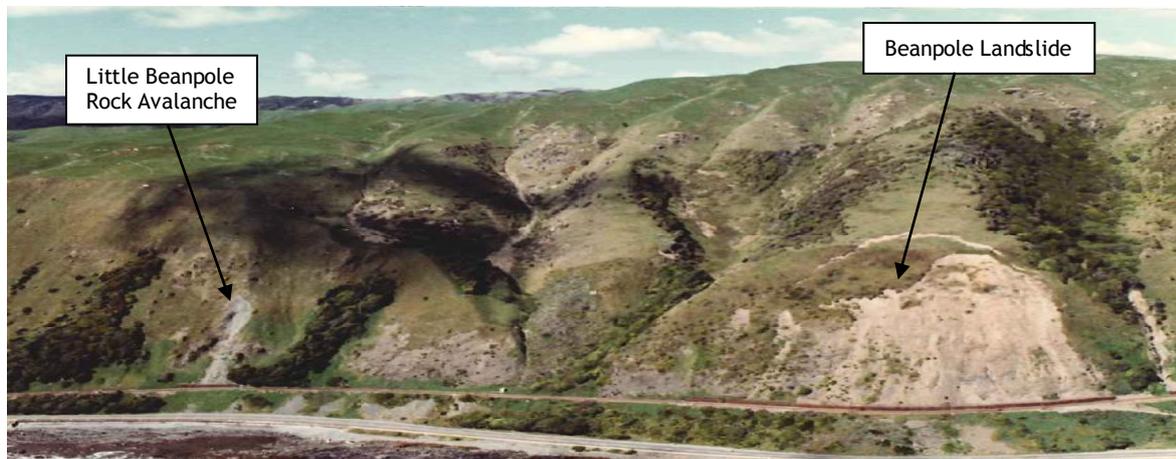
The Beanpole landslide was centred on a broad spur that rises moderately steeply (approximately 45°) from sea level. The Beanpole landslide was a notorious spot on the NIMT with instability extending over a 50+ year period. In a report published in 1981 the New Zealand Geological Survey indicates that the slide could be first identified on aerial photographs flown in the 1940's. Up until the late 1970's the landslide gradually increased in size to the extent shown in Figure 2 below.

Inspection reports from the early 1960s indicate that rockfalls or scree slides were an almost daily occurrence. On 5 May 1962, what was believed to be the biggest slide to have ever blocked the NIMT occurred. Initiated by prolonged heavy rain, the slide mass was estimated at 4000 tonnes and buried the track with 3-4m of material.

Figure 2: 'Beanpole Landslide' prior to excavation in 1990 (RHS) and "Little Beanpole" (LHS). Photograph taken in 1981 and included in the 1981 report by the New Zealand Geological Survey.

The majority of slope instability events at Beanpole in the period from the 1950s until the mid 1980's are interpreted to be a result of movement of the main slide mass and oversteepening of the toe of the landslide. The toe material then failed and evacuated downslope as scree slides to the level of the track below. The growth pattern of the slide since it was first recognised was thought to indicate a progressive upslope migration of the unstable area.

Although formed approximately 30 years ago, the scarp from the 1980 failure remains substantially clear of vegetation (Figure 2) and frequent small scale instabilities continue to occur. Periodic rock blocks continue to fall from the scarp, with recent blocks observed being caught by a simple timber catch fence structure.

In 1990, New Zealand Railways made the decision to undertake bulk excavation works to remove the main slide mass. This involved the removal of approximately 31,000m<sup>3</sup> to form a series of benches approximately 4m wide with batter slopes between 4m and 40m in height.

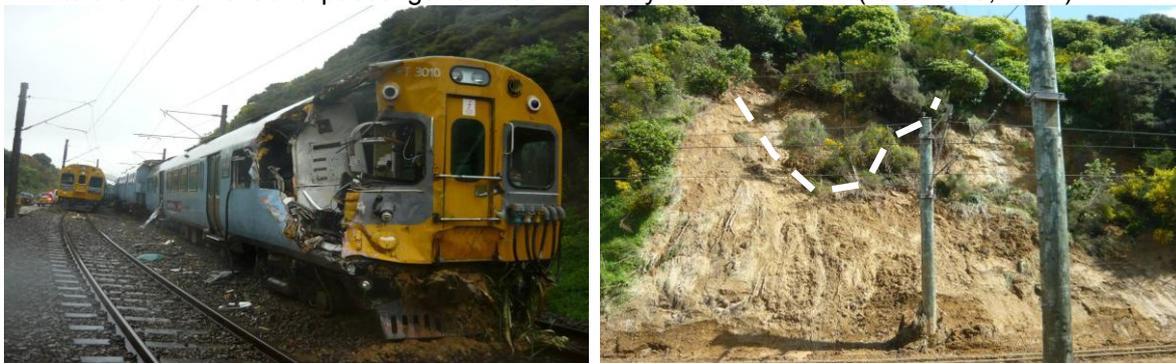
- A) Failures from within paleogullies cut into the Greywacke rock. A recent derailment and collision between two EMUs between Plimmerton and Pukerua Bay was the result of concentrated water flow down a paleogully feature and resulting land instability (Figure 3) refer TAIC (2012).
- B) Sheet sliding of soil material (including alluvium and colluvium) over rock. This style of failure led to the derailment of a passenger service near Maymorn on the WL (refer TAIC, 2010).

Figure 3: Damaged EMU (left) due to derailment and collision on the NIMT in September 2010 as a result of a slumping failure from a paleogully (outlined on right photograph).

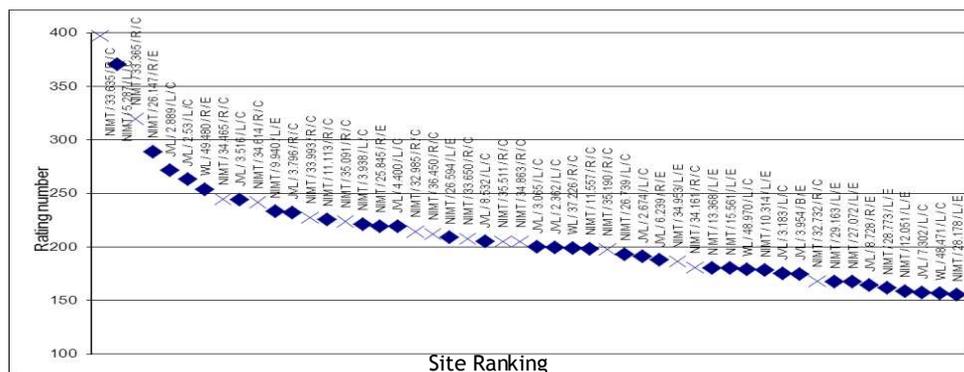
Over 180 sites were surveyed within the Wellington Regional Metro area and Figure 4 illustrates the highest ranked slopes that were identified. In summary:

- The three highest rated sites are cuttings located on the NIMT
- The fourth highest site is located at Tunnel 2 on the JVL
- Of the 10 highest rated sites:
  - Four are cuttings at tunnel portals
  - Two are embankments
  - The remaining four sites are cuttings above track at locations away from portals
- A total of 15 sites between North and South Junction (NSJ, between 32.7km and 36.5km on the NIMT) are within the top 50 sites in the Wellington Area, including eight sites within the top 20. The highest ranked sites between North and South Junction are typically located adjacent to tunnel portals and involve steep rock slopes above the tracks.

Figure 4. Plot of highest ranked slopes recorded within the Wellington Metro area. Slopes between North and South Junction are indicated by a cross.

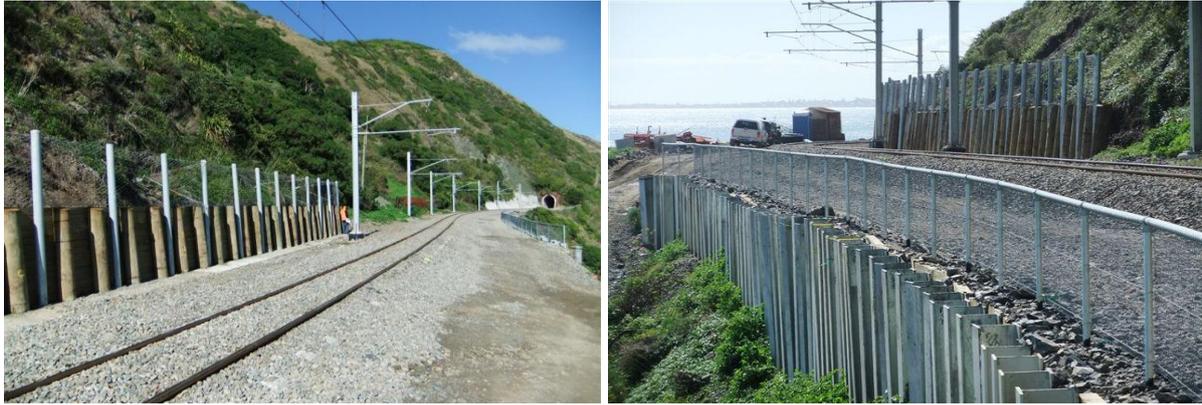
Figure 5. Completed timber pole wall with catch fence (left) and driven steel soldier pile wall (right).

**A timber pole retaining wall with catch fence** was installed at the infamous Beanpole Corner where the new rail alignment saw the track cut the toe of the existing slope. Given the historical slope instability at this location, it was agreed to design a two tier solution. First a timber pole cantilever retaining wall was designed to retain the steep cut of up to 3m at the toe of the slope, which comprised large diameter, treated timber poles set into a reinforced concrete base pad for ease and speed of construction. Within the same concrete base pad were steel circular hollow sections used as catch fence posts, rising 1.5m above the top of the timber retaining wall. Rockfall netting with top and bottom wire ropes was used to complete the catch fence (illustrated in Figure 5 below).

**A driven steel soldier pile wall** was installed to support the track and formation at a location immediately south of Beanpole corner where the new rail alignment saw the track move out away from the current slope platform, towards the sea. Borehole information at this location indicated the depth to rock was in excess of 12m so the wall was designed to act effectively in cantilever without the need for tie backs which would have added time and cost to the tight construction programme. Utilising large UC sections, top driven by crawler crane mounted equipment, this wall was designed to maintain its strength and integrity even if some of the soil material in front of the wall is lost during a seismic event, therefore creating a relatively low maintenance solution (illustrated in Figure 5 above).
