The paper was published in the proceedings of the 11th Australia New Zealand Conference on Geomechanics and was edited by Prof. Guillermo Narsilio, Prof. Arul Arulrajah and Prof. Jayantha Kodikara. The conference was held in Melbourne, Australia, 15-18 July 2012.

Mitigating the risk of slope instability and rockfall to railway lines in Wellington, New Zealand

D. Mason¹, P. Brabhakaran¹, J. Duxfield¹ and R. Justice²

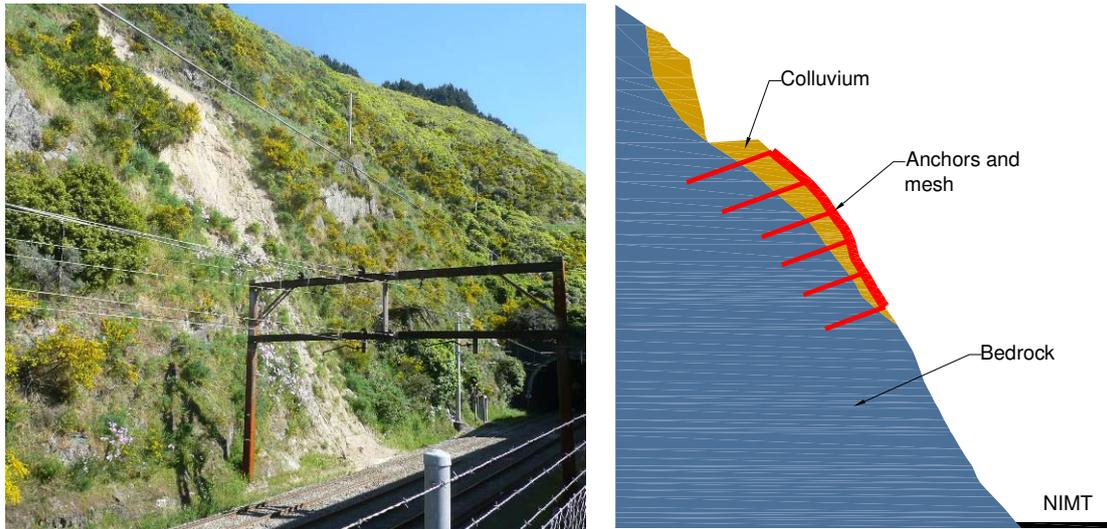
Figure 2. The slope at Tunnel 2 on the NIMT: (a) site photograph and (b) schematic cross section

The slope above the railway lies at angles of 45° to 60°. Bedrock outcrops are present at both ends of the site, with the main instability issues posed by a thick infilled gully in the bedrock surface (paleogully). In this paleogully, colluvium of up to 3 m thickness exists over the bedrock. This soil comprises layers of silt, clay and silty gravel over broken rock (coarse gravels and boulders), with competent bedrock beneath. The greywacke bedrock is typically slightly to moderately weathered and moderately strong to strong. Pronounced groundwater seepages emanating from the paleogully area have been observed following prolonged or heavy rainfall.

The principal mode of instability is soil slips within the colluvium-infilled paleogully, and this part of the slope was therefore the target for slope stabilisation. The physical works were predominantly done by roped access and hand-held drilling equipment. Because of the proximity of the slope to the tracks and overhead cables, the main part of the works was carried out during a Block of Line closure of the railway in December 2010 and January 2011.

- 52 grouted anchors, 3 m to 10 m long, to stabilise the slope and protect against deep seated slips. Slope/W was used in the design and specification of the anchors.
- 7 sub-horizontal drain holes to prevent excess groundwater pressure from building up in the soils
- Wire mesh and galvanised wire cables over the stabilisation area to retain any loose blocks
- Erosion protection matting over the bare soil areas to help retain the surface soils

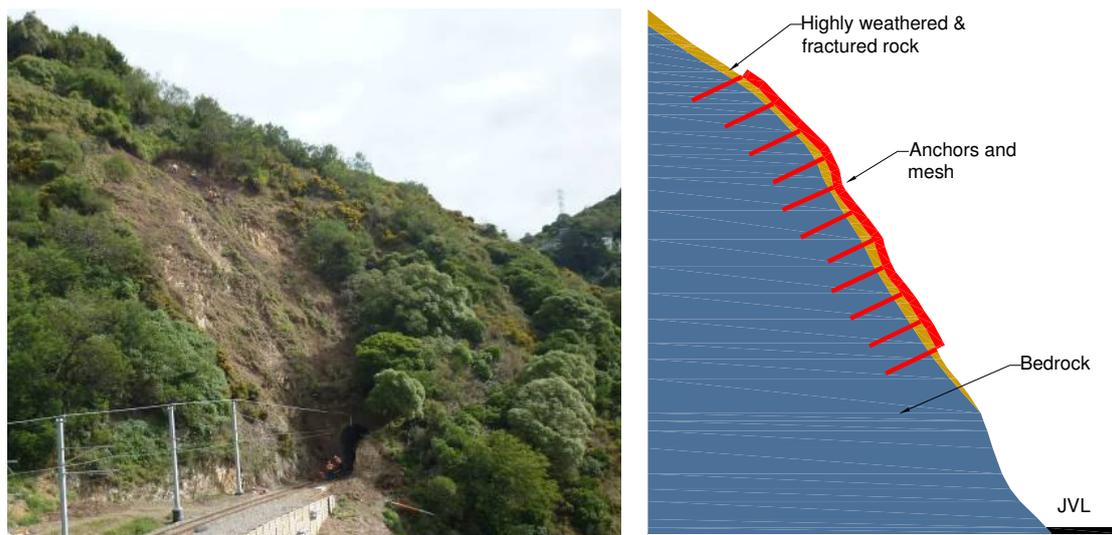
Figure 3. The slope at Tunnel 2 on the JVL: (a) site photograph and (b) schematic cross section

Tunnel 2 on the Johnsonville Line is located in Ngaio Gorge near Kaiwharawhara, approximately 3 km north of Wellington. At the southern portal of the tunnel, steep hillslopes rise 40 m above the railway (Figure 3). These slopes were steepened when the approach to the tunnel was excavated, which has resulted in ongoing instability issues as the slope unravels/erodes back to a more stable angle. This has presented an ongoing risk to the railway line of landsliding and small rockfalls.

Two main areas of instability are present on the slope. These areas are where the slopes are steepest (steeper than 45°) and consist of exposed soil and highly weathered and fractured rock. Based on inspections and assessment of the ground conditions, the slope was partitioned into zones of failure susceptibility, with the highest susceptibility in the upper part of the slope and a lower susceptibility zone in the lower to middle parts of the slope.

The highest hazard from slope instability is posed by a layer of openly jointed, moderately to highly weathered greywacke of about 2 m to 4 m thick in the upper part of the slope. This material is actively eroding by a combination of fretting/spalling of loose blocks and shallow-seated slumps of weak material.

The lower part of the slope comprises more competent and intact bedrock than the upper slope, and instability controlled by persistent structural discontinuities within this slightly to moderately weathered bedrock presents a lower slope failure hazard.

- 114 grouted rock anchors, 4 m long, to protect against failures developing in the unstable near-surface zone of weak rock. Slope/W was used in the assessment and design of the anchors.
- 5 sub-horizontal drain holes at the top of the site to reduce groundwater infiltration from the hillslope above.
- Wire mesh and galvanised wire cables over the entire stabilisation area, with erosion protection matting over selected areas, to reinforce the surface materials and retain any loose or unstable blocks.

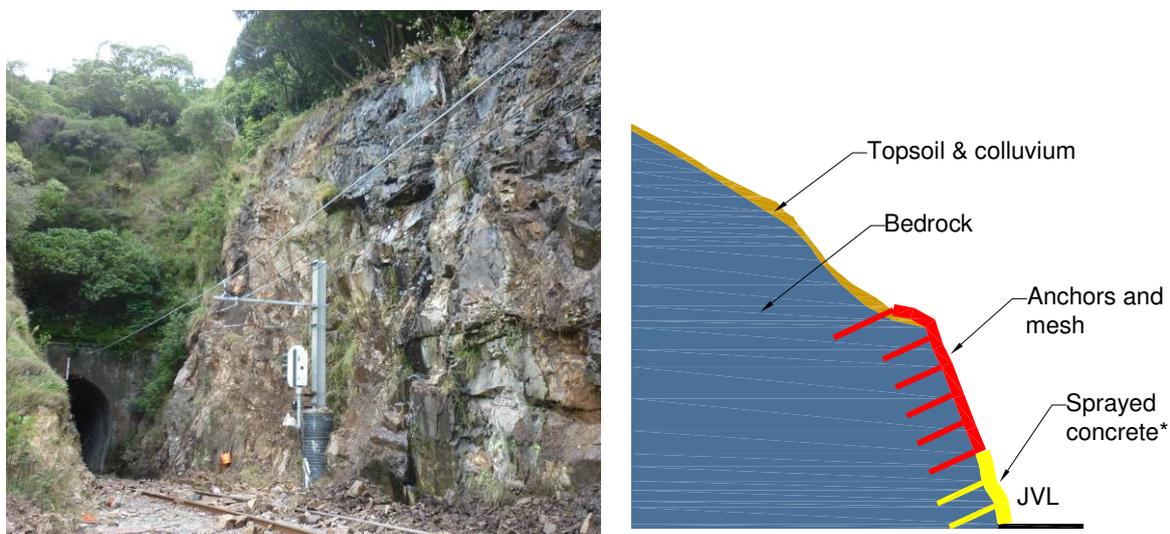
Figure 4. The slope at Tunnel 3 on the JVL: (a) site photograph and (b) schematic cross section.
* Anchoring and sprayed concrete proposed to be carried out at Christmas 2012

Tunnel 3 on the JVL is located approximately 300 m up the line from Tunnel 2. To the west of the tunnel the railway lies within a box cutting. The slope on the southern side of the tracks consists of a 10 to 15 metre high and 50 m long cutting that lies at an average angle of 70° to 80°, with some overhanging areas (Figure 4). The railway lines are particularly exposed to the slope failure hazards at this site, as the slope is prone to rockfall and the tracks lie 1 to 3 m from the toe of the slope.

The dominant modes of slope failure are fretting, spalling, and shallow planar and wedge failures/dropouts. The rock exposed in the cut face appears slightly relaxed and dilated along steeply dipping joints (c. 80°) that are sub parallel to the cut face. This is presumed to be due to gradual relaxation of the surficial rock mass towards the railway line since the slope was cut in the late 19th Century. Large scale planar or wedge shaped failures are not considered to present a significant risk to the railway under static conditions.

- Scaling of loose and unstable rock.
- 55 grouted rock bolts and pins, 3 to 4 m long, to protect against planar and wedge failures. Rocplane and Swedge were used in the slope assessment and rock bolt design.
- Rockfall netting to protect the railway from debris smaller failures.
- Sub-horizontal drain holes on the face and subsoil drainage measures on the hillslope above and the face.

- Grouted rock bolts to retain any unstable blocks and protect against wedge failures.
- Sprayed concrete over the base of the slope to protect the railway from rockfall. Sprayed concrete is preferred over netting to avoid the risk of bulges in the netting should any failures occur.
