# Geotechnical investigations for the oil Refinery in Novi Sad, Serbia

M. Djogo<sup>1</sup>, Ph.D. and M. Vasić<sup>2</sup>, Ph.D.

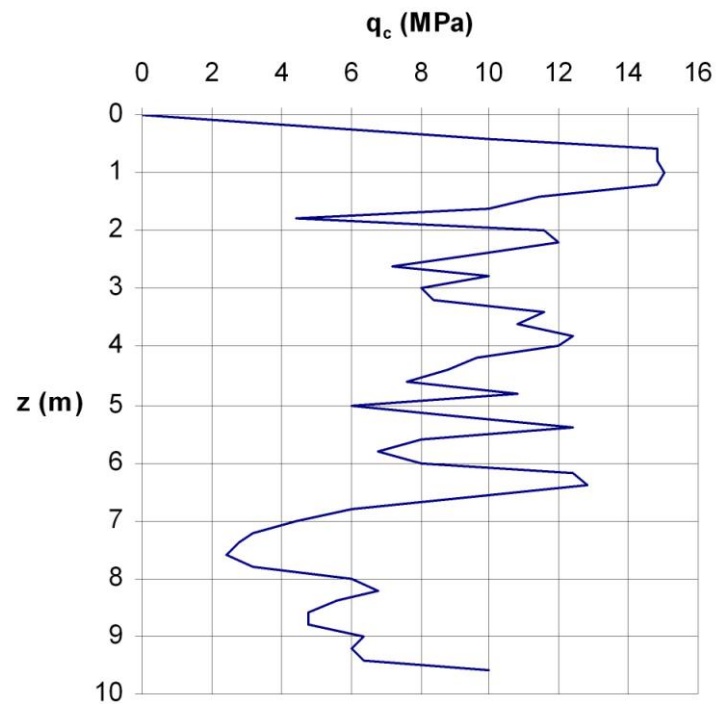
Figure 2. CPT diagram for reservoir G16

Comprehensive terrain investigations involved investigative boreholes and static penetrations. These investigations determined that certain parts of the refinery did not contain the unfavorable muddy soil. Figure 2 shows only one typical experimental static penetration diagram (CPT). The diagram shows that the terrain consists only of sands without lentiform muddy layers.

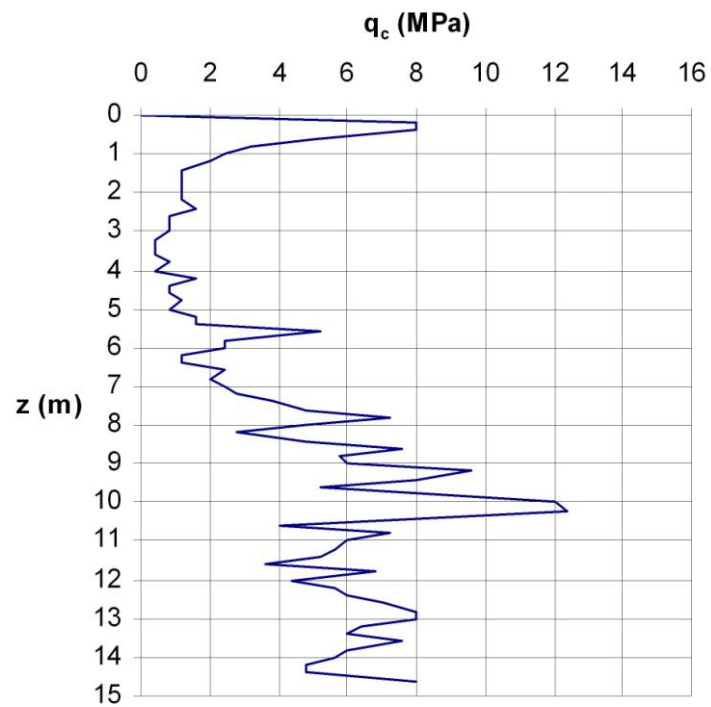
Figure 3. CPT diagram for the tall Visbreaking column

Most of the area covered by the refinery consists of muddy soil and humus which were not removed below the foundations of the structures. Figure 3 shows just one typical experimental static penetration diagram. This diagram shows that the terrain contains a lentiform layer of mud up to a depth of 5 m. It is this poor soil that causes the occurrence of uneven settlement in the structures.

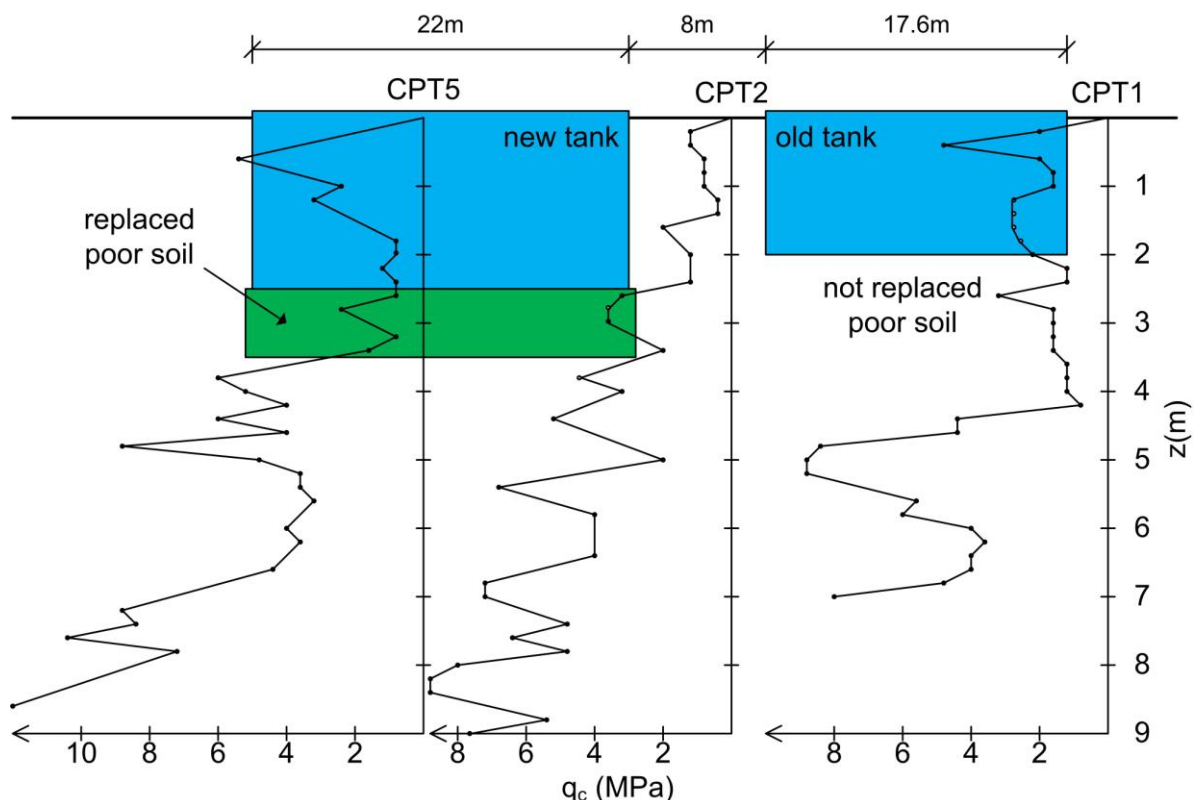
Figure 4. CPT diagrams for the new and old neutralizing tanks

The damage on the old neutralizing tank was caused by inadequate funding on poor soil and cracking of the tank due to uneven settlement and by the aggressive effect of the liquid in it. It was determined that the deformation and damage were very severe. The tank is unevenly settled so that one end sank by 9 cm compared to the other end. There are numerous cracks in the tank, and the damage along the cracks and the damage to the concrete in the walls and the floor slab are extremely severe. Caverns formed along certain cracks in which the reinforcement was completely destroyed along with the concrete. Due to the specific need for the tank to remain in function and the extremely difficult and expensive repairs, it was proposed that a new neutralizing tank be constructed.

The new tank was constructed next to the old one. The old tank has not been used since the new one was constructed. This prevented the further pollution of the environment. Investigations of the new tank determined that the poor muddy soil must be replaced with large-fraction stone. This would prevent the errors which accompanied the founding of the old damaged neutralizing tank. Figure 4 shows characteristic experimental static penetration diagrams for both tanks. In penetration zone CPT1 below the old tank, there is poor soil, which was not replaced, up to a depth of 4.2 m from the surface of the terrain. On the opposite end of that tank the poor soil extends to a shallower depth. Such terrain composition led to the uneven settlement and cracking of the tank followed by the leaking of an aggressive fluid and its harmful effect on the concrete, reinforcement and the environment. In the case of the new tank, the poor soil had completely been removed in the foundation digging phase.

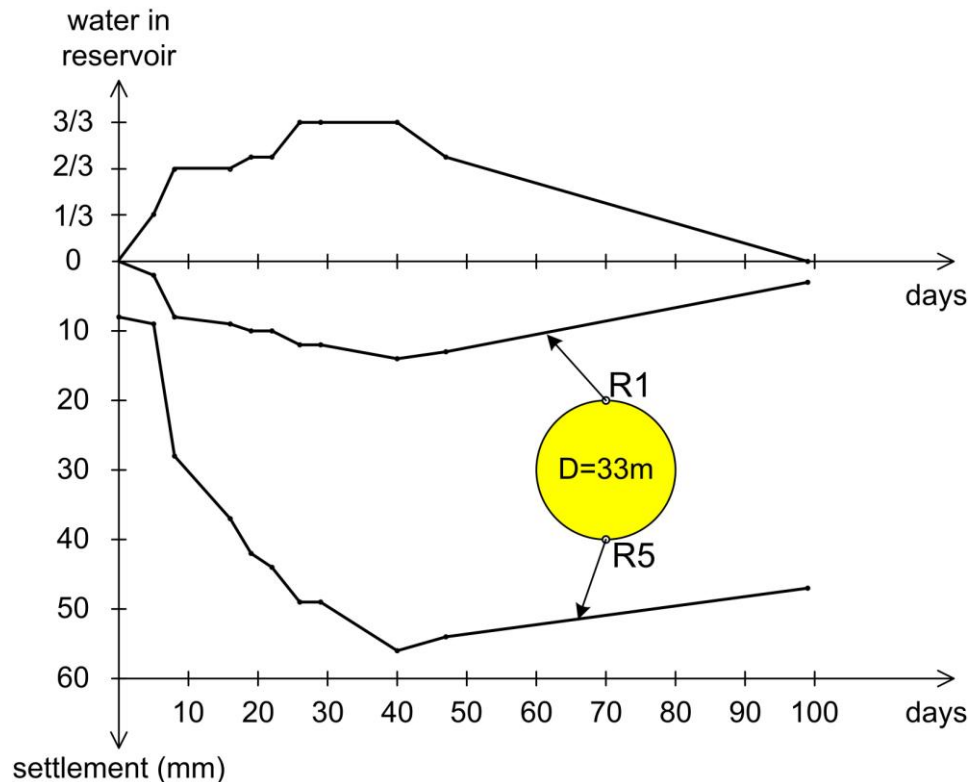
Figure 5. Diagram of the settlement of reservoir N5 during its test filling

The third group of structures was damaged in the 1999 bombing campaign. Afterwards, a large number of reservoirs was rebuilt and their exploitation was resumed. The presented case here is that of reservoir N5 with a volume of 10000 m<sup>3</sup>, which received a direct hit in the foundation. As a result, the foundation soil below the reservoir was weakened in the bomb's blast radius. During the rebuilding of the reservoir, this foundation soil was not sufficiently repaired. This was confirmed by the measured extent of settlement in reservoir N5 during its test filling (Figure 5).

The settlement diagrams show that there is significant differential settlement which is the consequence of the insufficiently prepared foundation terrain and the properties of the foundation soil. The increased settlement on measuring point R5 was located in the area where reservoir N5 received a hit during the bombing campaign.
