The paper was published in the proceedings of the 7th Australia New Zealand Conference on Geomechanics and was edited by M.B. Jaksa, W.S. Kaggwa and D.A. Cameron. The conference was held in Adelaide, Australia, 1-5 July 1996.

A Note on the Origin of Wet Seams in Embankment Dams

P.M. James

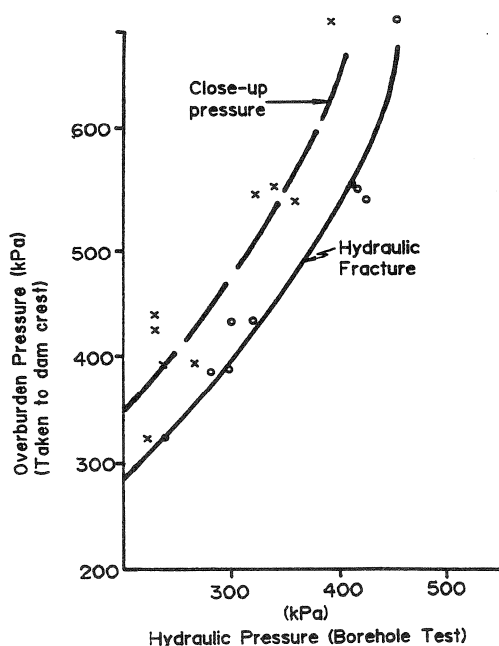
This prediction is supported by a series of tests at various elevations in the Alvita Dam, Seco de Pinto et al (1985). Figure 3 is a graphical representation of the published results, showing that hydraulic fracture of the core required pressures almost equal to the maximum overburden load. Such pore pressures would not, of course, be available from the reservoir head. The second point to be noted from the figure is that the "close-up" pressures lie only marginally below the hydraulic fracture line. In other words, cracks which are formed by hydraulic fracture seal up again when the pressures are marginally reduced. This contradicts one of the above observations made by Sherard regarding piezometers responding on a one to one basis with reservoir fluctuations.

Figure 3. Hydraulic fracture tests, Alvita Dam.

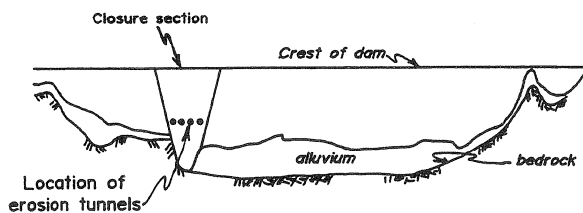
One reason for the reluctance to make any assumption or finding on poor compaction probably stems from the fact that such a finding involves wider issues of performance, supervision, and control testing; it can open the way to litigation. Yet, at the Wister Dam, failure came by a series of erosion tunnels at one horizon in the fill forming the closure section, Figure 4 and, despite Casagrande's conclusion, it is suggested that erosion along a porous horizon would appear to be a more logical explanation of the failure than hydraulic fracture. Other data dealt with below are believed to support this approach.

Figure 4. Piping locations in Wister Dam.

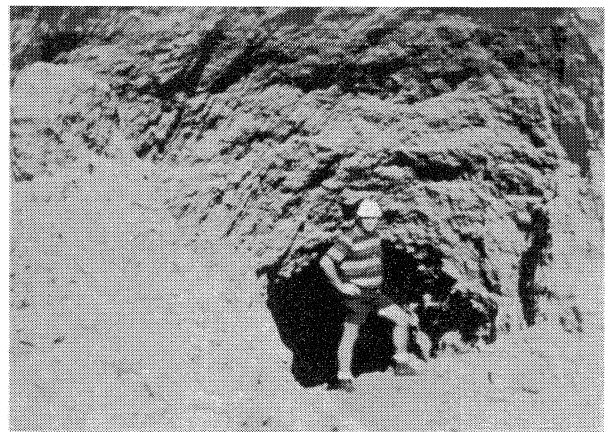
Typical of such failures, this dam failed on first filling. Post-failure inspection revealed a single water-smooth erosion tunnel of approximate dimensions 300 x 600 mm, extending through the embankment at about mid height. The flow of water through this "tunnel" was sufficient to scour out the embankment to its base, producing a passage large enough to walk through upright. At the downstream outlet of this erosion tunnel, shown on the Figure, the base of sequential layers of fill could be distinguished, these being slightly more porous than the remainder of the fill. The soil was dispersive and was subsequently found to be calcitic.

Figure 5. Downstream outlet of piping failure
