# Management of a Suburban Landslide

F.J. Baynes

Consulting Engineering Geologist, Golder Associates, Australia

**Summary** A case history describing a slow moving deep seated landslide that was damaging houses at Rosetta in Tasmania is presented, including a geological model, the management plan developed to cope with the situation, details of stabilisation works and the results of monitoring.

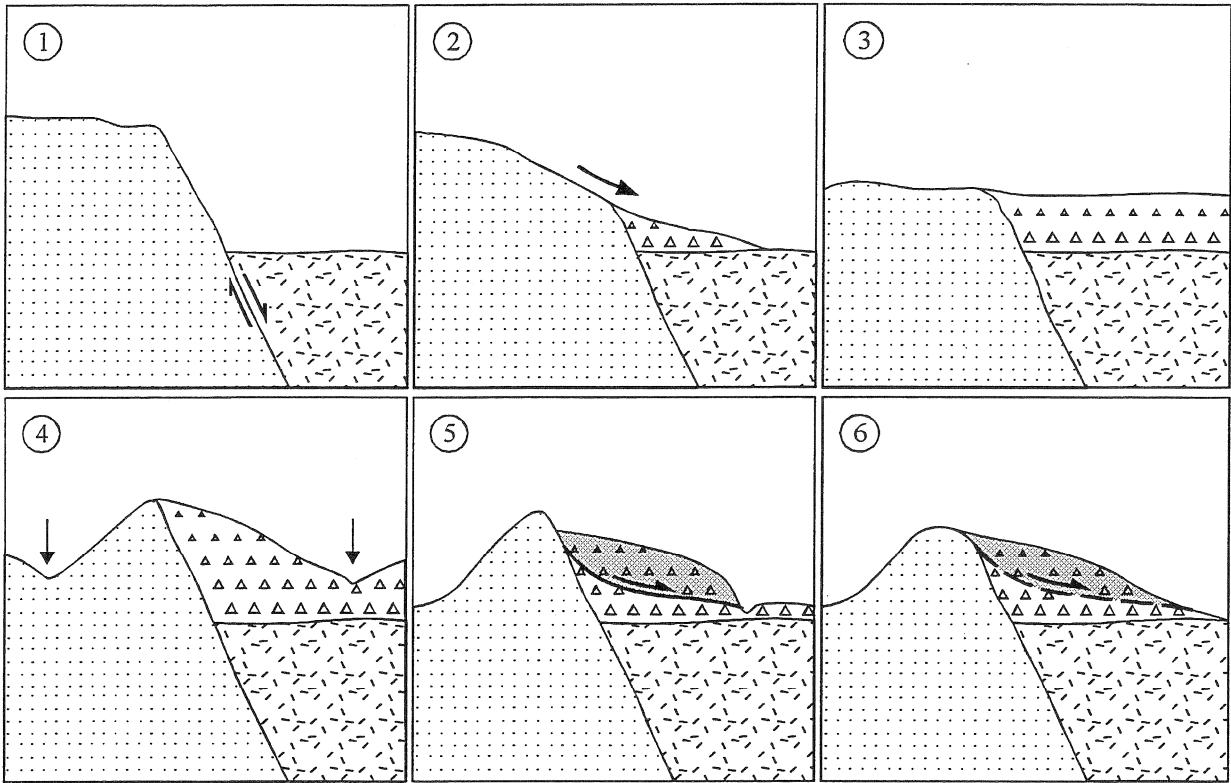
The landslide is located adjacent to part of an inactive fault system that bounds a Tertiary graben, the graben forming the valley in which greater Hobart is located. During the development of the fault system, in the early Tertiary, slope deposits including plastic clays, clayey gravels and boulders, and blocks of rock with dimensions of several meters, accumulated against an active fault scarp. Progressive fault movements during the accumulation of the slope deposits may well have induced shear surfaces within some of the weaker materials. As the landscape developed a remnant of the slope deposit was preserved against a ridge of more competent in-situ rock and the effects of weathering and incision, probably combined with an unusually wet period during the Pleistocene, led to the formation of a deep seated landslide. With time, the surface expression of the landslide, such as the backscarp and the toe bulge, became degraded by superficial slope processes, and no obvious geomorphological evidence of the landslide was discernible when subdivision was approved. This geological model is illustrated in Figure 1.

Figure 1. The Geological Model, 1 - early Tertiary faulting, 2 - accumulation of slope deposits, 3 - development of a mid-Tertiary surface, 4 - incision of the surface, 5 - deep seated landslide, 6 - degradation of landslide features.

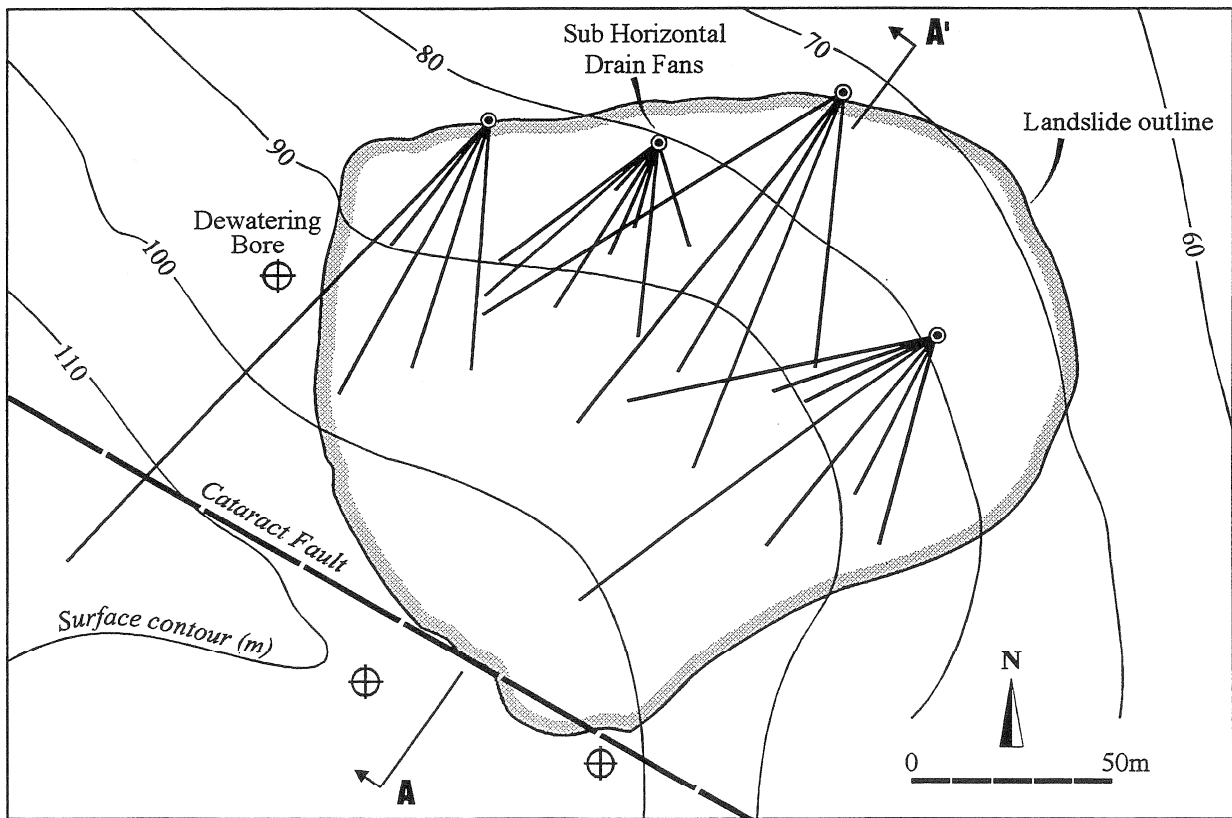
A sketch plan and section through the landslide is presented in Figures 2 and 3. The piezometric surface indicated in Figure 3 is the surface that was measured prior to the commencement of stabilisation works, which was a maximum of a few metres above the basal shear plane and a limitation on the potential for drainage to improve stability.

Figure 2. Plan of Landslide and Stabilisation Works - details of housing omitted.

Three vertical water bores fitted with low volume pumps were also installed to drain the Tertiary slope deposits to the south-east of the landslide and Permian and Triassic strata below the landslide. The bores were located outside the landslide mass to avoid being sheared if movement continued (Figure 2).

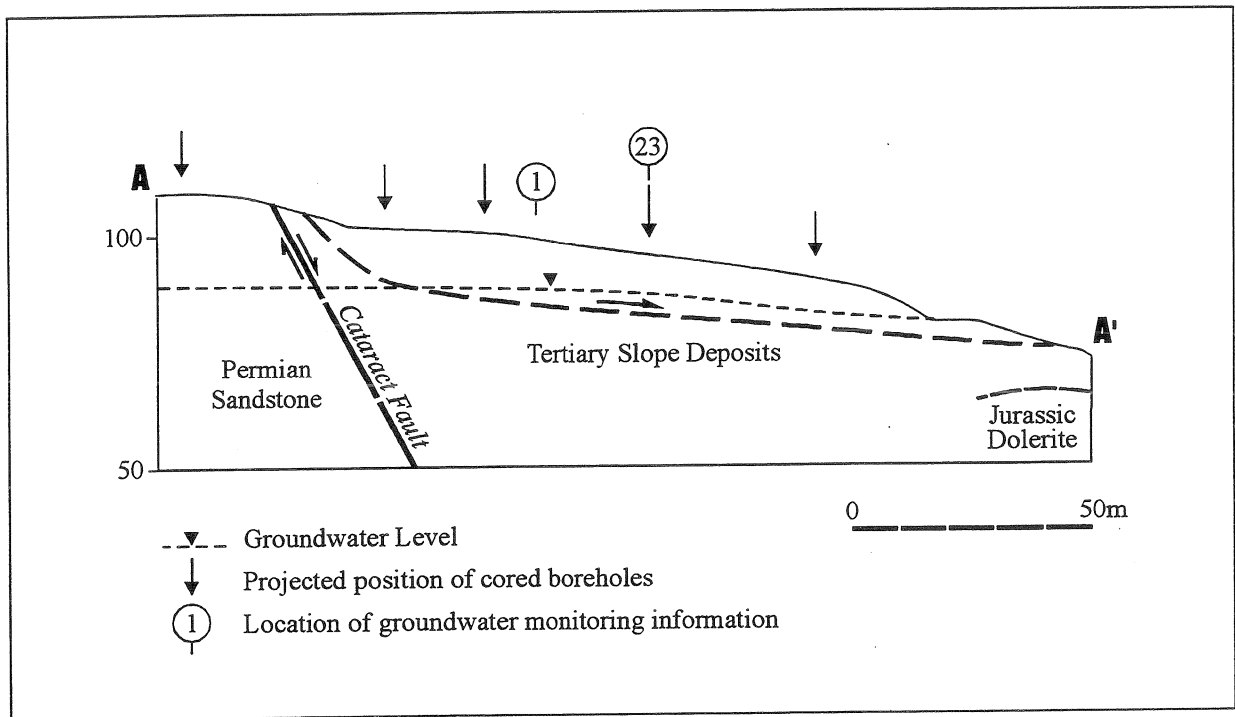
Figure 3. Interpretative Cross Section

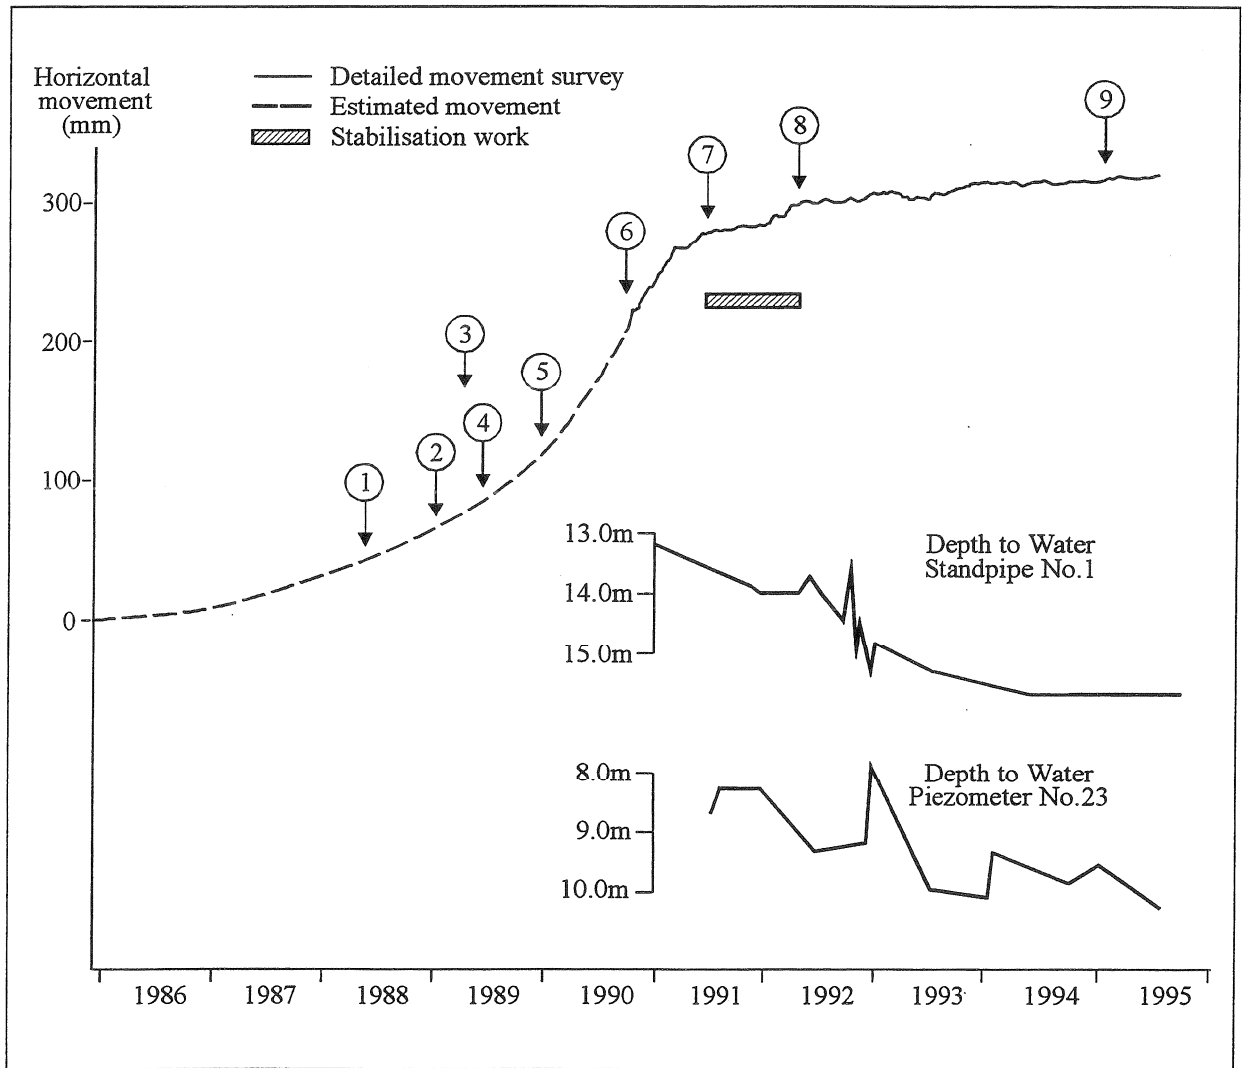
Figure 4. Results of Monitoring, 1 - some house cracking noticed, 2 - obvious signs of structural distress, 3 - majority of house construction finishes, 4 - water main leak, 5 - water main leak, 6 - detailed survey commences, 7 - stabilisation work commences, 8 - stabilisation work finishes, 9 - small movements still discernible.

The horizontal movement of a typical survey point in the upper part of the landslide and the interpreted history of movement prior to monitoring is presented in Figure 4 together with the changes in water levels in some critical boreholes

The results of the monitoring show that the landslide movement rate has progressively reduced following the implementation of the management plan. However, a careful examination of the time plot suggests that the rate of movement may have actually reduced prior to the main stabilisation work, and thus it is not clear which part of the management plan resulted in the reduced rate of movement, although it seems likely that the general reduction in piezometric levels caused the reduction in movement rates.

Piezometric levels in the central part of the landslide mass gradually dropped by about 2 meters following the installation of the drains and the rate of movement has reduced as piezometric levels reduced. However three years after completion of stabilisation works occasional small movements of up to a couple of millimetres every six months can be discerned if the overall record is considered, although such movements are within the error range of any particular set of measurements. It is not clear if these small movements represent landslide activity, movement that the ancient landslide exhibited prior to subdivision, some form of natural hillside creep that could be measured on other slopes if they were to be monitored, or perhaps a consolidation of ground that was in an active state,
