Monitoring an Active Landslide at Howletts Road, Yallourn North

T.J. McKINLEY

Engineering Geologist, State Electricity Commission of Victoria

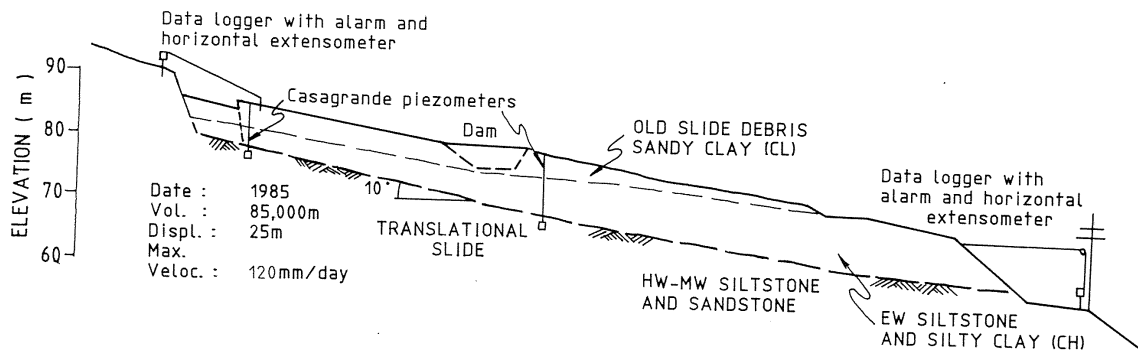
Figure 1 Cross Section of Howletts Road Landslide

A section through the site is shown in Figure 1 and shows the slide is essentially translational (Varnes, 1958) with characteristic grabens at the head of the landslide. The basal slip surface has occurred at a soil/rock interface on a weak seam of clay derived from weathering of the rock. The rock underlying the slide consists of moderately weathered and fractured siltstone and sandstone. The dip of this material varies up to 30° in the area, but it is assumed that the dip of the rock at the landslide is the same as that of the slope.

The material above the slip surface generally consists of silty clay (CH) and sandy clay (CH) extremely weathered sandstone and siltstone, and old slide debris higher up in the profile. The soft weak clay in the slide zone had a high moisture content (49%) and high plasticity (Plasticity Index up to 69%). Direct shear testing of this material gave residual angle of frictions between 10° and 13° with cohesions of zero. Back analyses without groundwater present gave a residual angle of friction of 10°, and with groundwater a residual angle of friction of 13°. Moisture contents in the overlying material are generally much lower (20% to 30%). No groundwater was encountered in the bores on site during drilling or since pneumatic piezometers were installed. The slide surface was well defined by sub-horizontal displacements of up to 50mm observed in bores after the overnight break in drilling operations.

It was decided to use two of the horizontal extensometers to provide an alarm system for toe and crest movements (Figure 1). A shaft encoder was placed on the pulley of the Stevens recorder and this connected to a Jabiru data logger

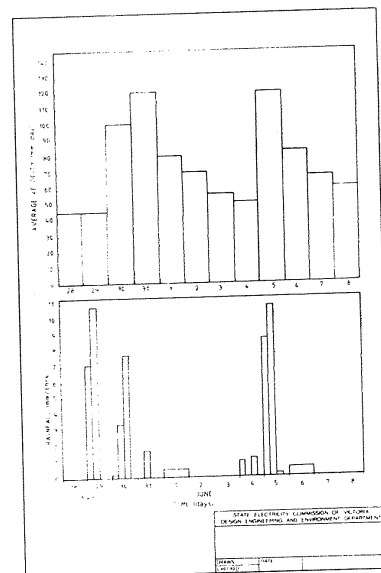
Figure 2 Effect of Rainfall on Landslide Movement

Logging at 3 hourly intervals allowed correlation of movement and rainfall to be examined on both a micro and macro scale. Figure 2 shows a plot of 6 hourly rainfall intensities versus movement. This plot shows that landslide velocity has increased from 45mm per day to 120mm per day after 18mm of rainfall in a 12 hour period and from 50mm per day to 120mm per day after 20mm of rainfall in a 12 hour period. These plots show that response time of landslide movement to heavy rainfall is less than 12 hours.

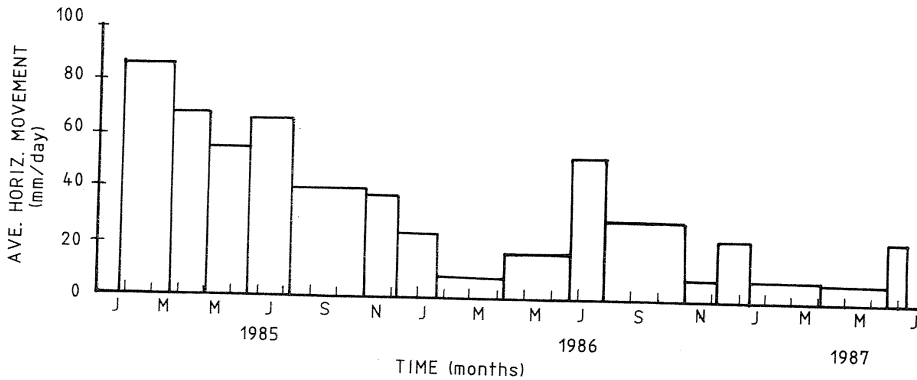
Figure 3 Plot of average movement versus time

This indicates that the landslide in December 1986 required heavier rainfall intensities to reach similar velocities to those of May 1985. Figure 3 is a plot of average velocity versus time and indicates that the landslide has gradually slowed down and is near to reaching equilibrium. This can be shown by comparing average winter velocities in winter 1985 of 66mm per day with average winter velocities of 25mm per day in 1987.
