A Landslide in a Residual Soil's Cut Slope

SUMMARY This paper presents several landslides that have occurred in the same residual soil slope in Rio de Janeiro, Brazil. The solutions that were designed and their performances were also described.

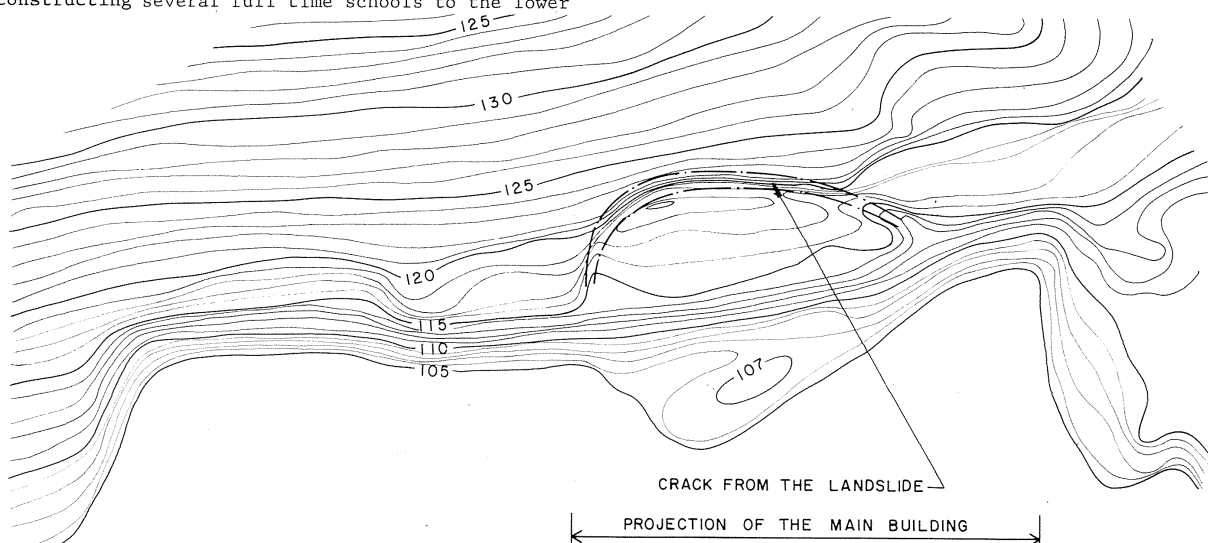
Figure 1 The Landslide topography

By the end of the earthworks, the engineers realized that this topography survey was not very precise, so this seven meters high cut slope turned out to be eighteen meters, 1:1 slope, with no benches.

Considering that it was a slope behind a school, the engineers decided that a higher safety was necessary and indicated a flatter slope with the introduction of some benches. Nevertheless, before any further work was begun, a slide happened in part of the slope just in front of the main building. The figures 1 and 2 show the landslide topography and the cross-section.

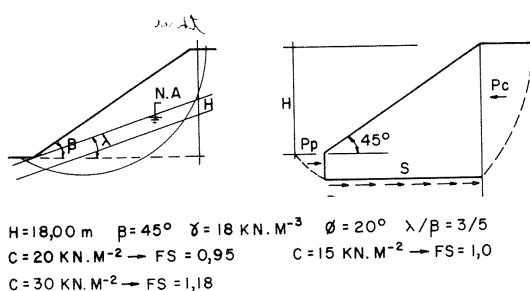
Figure 3 Slope stability of the first designed slope

Unfortunately, as it was a governmental project, the need of an immediate solution and the present economic situation of the state didn't allow neither time nor money to make an adequate investigation. Hence, there was no confidence about the position or form of slip surface. Anyhow, quick back-analysis were made: one using the Kerisel charts (1967) which lead to a safety factor not far away from unity, and another one considering an approach to the tri-planar wedge surface, as suggested in Chowdhury (1978), and shown in Figure 3.

Those considerations induced to two hypotheses to explain the rupture:

- the kaolinitic and very micaceous clayey silt located at the toe of the sliding slope, has lower shearing strength than the surrounding soil.

Thus, as it failed when deconfined, its resistance dropped to the residual value. The stresses transferred to the surrounding soil brought this mass to its failure state.

- the low safety factor, not far from unity, let the mass deform to attain its maximum shear resistance. The "C" horizon, present at the toe of the slope, was a micaceous clayey silt with brittle characteristics which came to a progressive failure.

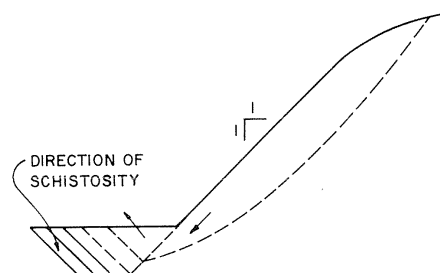
Figure 4 Admitted slip surface

Finally, the presence of slickensides among the collapsed mass emphasized the opinion of the main role of the weak planes inherited from the gneiss bedding. In addition, the visual superficial inspection, performed just after the slide, has given the impression of a bottom failure or yet a wedge one as shown in Figure 4.

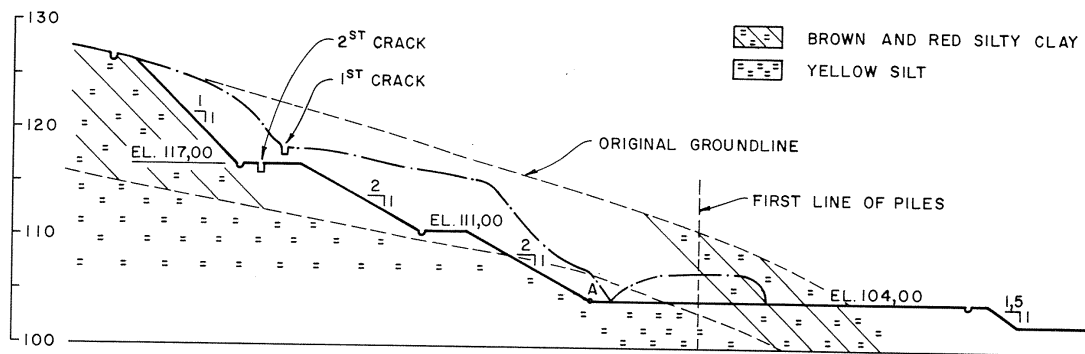
Figure 5 Second designed cross-section

Again, when the earthworks were almost finished, the slope began to present a mass displacement, initially inducing a "crack" on the second bench (from bottom to top) near the outcropping slip surface.

The assumed section according to the above safety factors turned out to be two steps of a 2:1 (H:V) slope into the damaged micaceous material with an intermediate three meters bench, and 1:1 slope in the mature residual soil as shown in Figure 5, on next page.

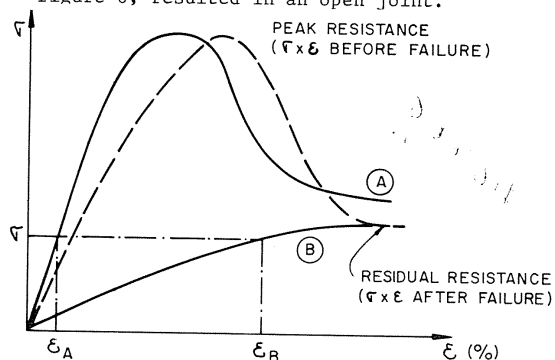
Figure 6 Degree of strain mobilization

The explanation to this fact seems to be clear. The non thixotropic soil in its residual strength needed a larger deformation to mobilize its shear resistance than the not remolded one. Hence, the different degree of strain-mobilization, shown in figure 6, resulted in an open joint.

- (A) NOT AFFECTED MASS
- (B) SLIP MASS REMAINED IN PLACE

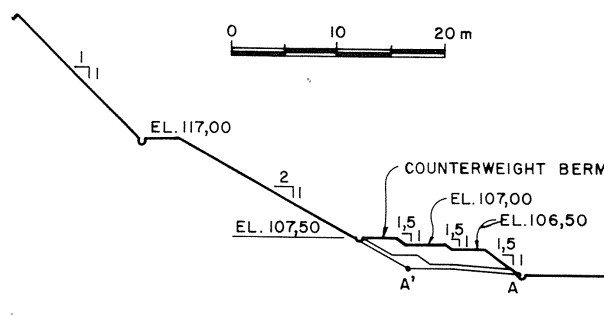
Figure 7 Third design and counterweight berm

However the engineers faced a problem: just before reaching the final level of the earthworks, the crack opened again to about 5 cm.

Finally, the intention of removing all the affected material has led to a solution of cutting 10 meters from A to A' into the toe of the slope as shown in Figure 7.

It was seen that when the earthworks were 0,5 meters above the final level, the joint opened, thus characterizing a limit situation (SF = 1.0). To increase the safety factor at the toe of the slope, an earth counterweight (3.0 meters high) was then designed extending over the limits of the damaged mass as shown in Figure 7.

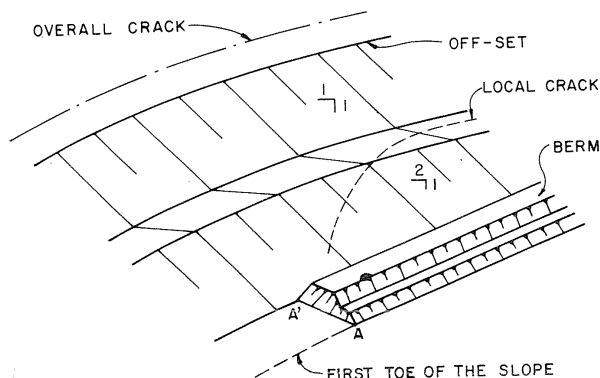
Figure 8 Overall crack and final situation

Though the movement seemed to be under control, an unexpected crack appeared surrounding the whole cut as shown in figure 8.

Then, what had been observed as a small joint became a wide opening (aprox. 30 cm) and step (aprox. 80 cm).

Three things became apparent. First, that the initial potencial slip surface, when the berm was built, had its factor of safety increased, leading the slope to "search" for another potential slip surface.

Second, the berm designed on the damaged toe area should take in account the whole slope stability, and probably should be extended all over the toe of the slope. Third and more important, this creep movement confirmed the trend of the slope to slip over its weak joints.

The final solution was a much larger earthwork whose construction was not completed, because a change in the administration has caused a temporary delay at the educational program thus suspending the civil works. Anyway the displacement has stopped.
