# Analysis of Slope Failure Mechanism at the East Pit of Daye Iron Ore Mine

**Summary** The East Pit of Daye iron ore mine is the deepest iron ore open pit in China. Several slope failures have occurred since the 1970s, and over the years engineering geological and hydrogeological investigations in conjunction with surface displacement monitoring have been carried out. This paper discusses the mechanism of the slope failure and the factors inducing a major landslide of approximately 9000 m<sup>3</sup> in volume which was experienced over the hangingwall of a major fault where large deformations were recorded. The results of engineering geology investigations, hydrogeology studies and surface deformation monitoring are presented.

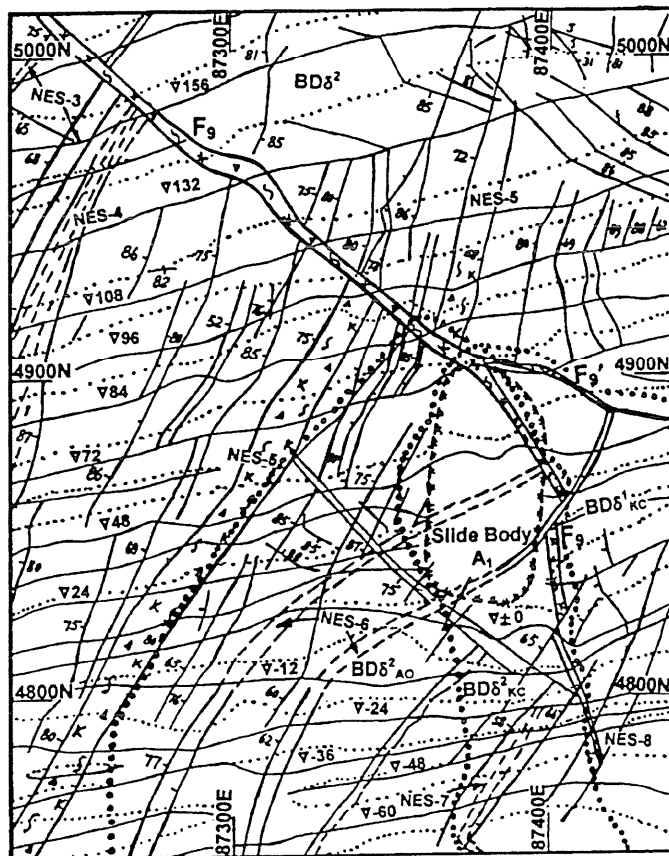
Figure 1. Engineering geology plan of sector A.

The slope stability of this area is controlled by northwest and north northeast trending structures. Fault F<sub>9</sub> is representative of northwest trending structures and cuts the slope at an oblique angle. The fault can be divided into three sections. The first section is defined from 72 mRL and up to the crest of slope with an orientation of 68°/200°. It is 2 ~ 5m wide and highly altered with chlorite, kaolinite, montmorillonite and illite minerals. The fault bifurcates at the 72 mRL and forms sections two and three. The fault on the second section (F<sub>9</sub>') is orientated approximately 60°/180° and disappeared after becoming a smooth plane between 48 mRL to 0 mRL. The third section comprises the lowest part of the fault F<sub>9</sub> extended -84 mRL with an orientation of 60°/220°. The width of the last section of the fault ranges from 3 to 5m. Below 48 mRL, the north-east striking discontinuities intersect the fault F<sub>9</sub> several times and move it south-south west as shown on Figure 1.

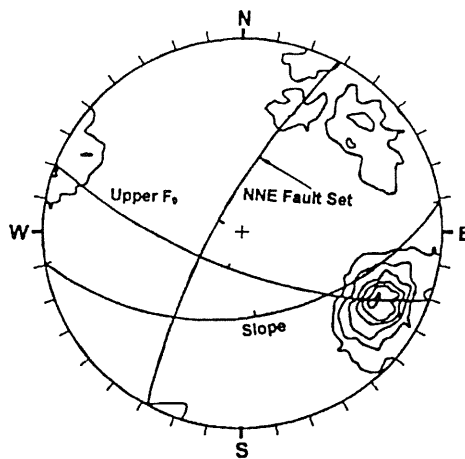
Figure 2. Stereographic projection of main faults and slope.

Several north northeast striking discontinuities, including small faults were present on this pit sector. These discontinuities appeared to control the failure geometry. Figure 2 is a lower hemisphere equal area projection showing pole contours of the north-east striking family of discontinuities. These features are shown with respect to the orientations of the slope sector and the first section of the fault F<sub>9</sub>. Almost 90% of the faults have a northeast strike, with an average orientation of 75°/298°.

The north, north-east striking faults and squeezing zones separated the rock mass into a series of thin layers that were subvertically oriented and plunging towards the free face defined by the slide body  $A_1$  and the slope face. The measured spacing of joints and faults was 0.1 to 0.4m with a maximum of 0.8m. The slope and free face caused by the slide body  $A_1$  weakened the rock mass, which lost confinement. The fault  $F_9$  represented the northeast boundary of the unstable zone. The overall failure was a complex combination of plane shear and toppling. The slope and fault orientations ( $43^\circ/170^\circ$  and  $68^\circ/200^\circ$ , respectively) provided a geometrical condition for a landslide, while the north, northeast structures (oriented  $75^\circ/298^\circ$ ) provided the structural condition for toppling and sliding (see Figure 2).

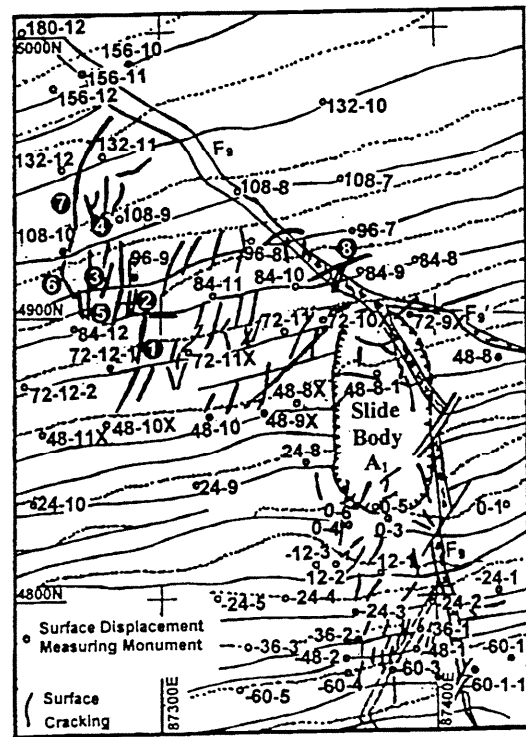
Figure 3. Tensile cracks measured on slope surface.

Figure 3 shows tensile cracks that were oriented to the north, northeast striking faults and fracture zones. Along the west boundary of instability, tensile cracks ①, ②, ③ and ④ on mesh and shotcrete surface were defined between 72 mRL to 108 mRL. When a crack opening between 10 to 40 cm in width was recorded a 15m of deformation was experienced towards the northwest. New tensile cracks (⑤, ⑥, ⑦) were also formed at this stage. Crack ③ that was near a surface displacement monitoring point 84-9 around 84 mRL was developed in 1993. This crack which crossed the fault  $F_9$  from hangingwall to footwall had a measured width of 760 to 1000 mm in early 1995. However, the weathered and altered broken rock under the shotcrete in the footwall did not move all the time. Cracking in the shotcrete around the footwall slope surface was induced (pulled and squeezed) by the movement of the hangingwall rock masses.

Observation of the loading conditions on the slope indicated that the rock mass in the slope had been disturbed following the initial  $A_1$  slide. Deformations with a subsequent stress redistribution were experienced all the way to 180 mRL as shown in Figure 3. Production from the pit continued with the slope deepening from 336m to 396m when the second slide occurred.

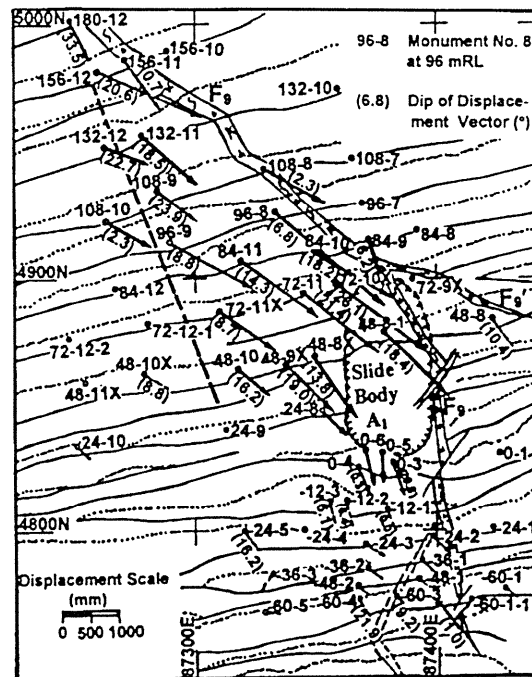
Figure 4. Slope surface displacement vectors.

Figure 4 shows horizontal displacement vectors of the hangingwall slope within 50m of the fault  $F_9$ , where displacements were measured with SETA 20 laser transit and the monitoring period was 3 days to one month depending upon the precipitation and displacement rate experienced. The vectors above 48 mRL are almost parallel to the strike of fault  $F_9$ . The maximum horizontal displacement of 2417.0 mm was recorded at monument 96-8 up to June 7, 1996. Figure 4 also shows that the slope below 24 mRL deformed with a maximum displacement of 550 mm recorded. Several measures were adopted to enhance the stability of the lower part of the slope, including a repair of the drainage ditches on 156 mRL and 96 mRL. Rail piles were installed on the bench berms. Subhorizontal bolts (15 to 20m long) in conjunction with mesh and shotcrete were also used.

Analysis of the displacement vectors suggests that the largest horizontal movement was experienced near the fault  $F_9$ . Very small deformations were recorded in the west side of the unstable area. Overall, the failure geometry became gradually narrower, and the recorded displacements decreased from 48 mRL to 180 mRL (see Figure 5). The slide is deeper close to the fault  $F_9$  and becomes more and more shallow westwards. Thus, at a first glance, the shape of the failure initially looks like a wedge. However, an in depth investigation and analysis suggests that the mode of this failure is a toppling and plane shearing.

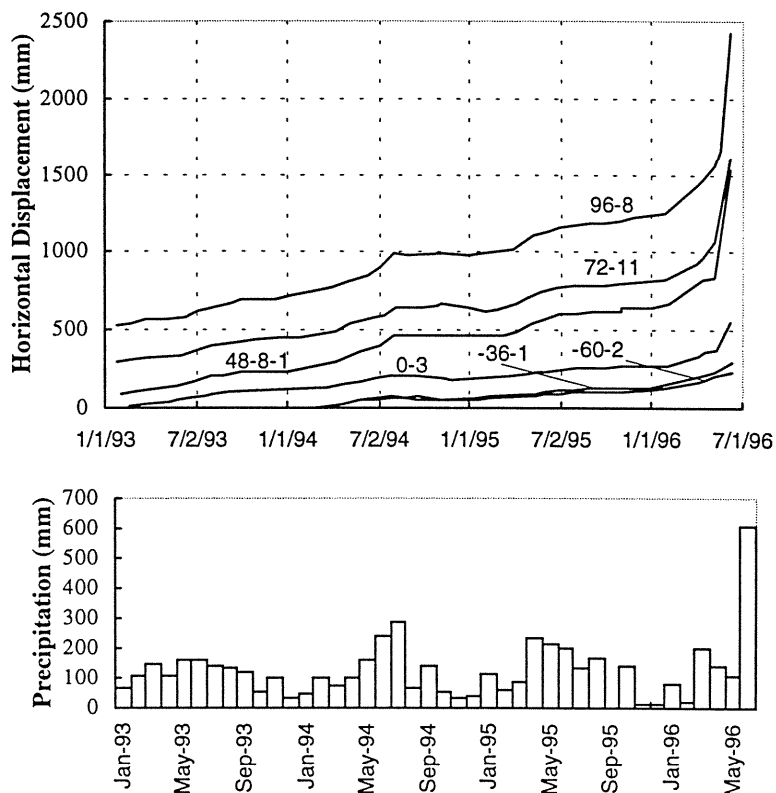
Figure 6. The relationships of horizontal displacement versus time and precipitation.

The external forces accelerating and promoting the displacement and finally leading to failure were slope ground water pressure. As mentioned before, diorite rock masses and the faults filled by kaolinite and montmorillonite are relatively impermeable. In the rainy season, water infiltrated into open joints, faults and tensile cracks, creating a build up of water pressure. The heavier the rainfall, the higher the water pressure in the tensile cracks and open fractures. Another effect of water was softening and strength reduction of the rock mass. Figure 6 and Table 1 shows displacements and their rates at different seasons on the six surface monitoring locations. The data suggests an increased rate of movement in the rainy season. Little changes were experienced during the dry seasons. The critical displacement rate monitored was 2.0 mm/d. The data showed that above this limit, a slope failure would be developed. An increased rate of displacement (up to 24.0 mm/d) that eventually led to failure was experienced in May and early June of 1996. Excessive rainfall had been experienced from March to July when the failure occurred. In March, it almost rained daily with a maximum precipitation of 197 mm/day. In June, the total rainfall was 609 mm. Finally, the failure occurred on July 2 when a 117 mm rainfall was experienced.

Analysis of Figure 6 and Table 1 indicates that the surface displacements were linked to rainfall and increased steadily from March to June. The slope was under a typical progressive failure condition as described by Savely (1993).
