The paper was published in the proceedings of the 8th Australia New Zealand Conference on Geomechanics and was edited by Nihal Vitharana and Randal Colman. The conference was held in Hobart, Tasmania, Australia, 15 - 17 February 1999.

Movement History and Sensitivity to Rainfall of part of Brewery Creek Slide, New Zealand

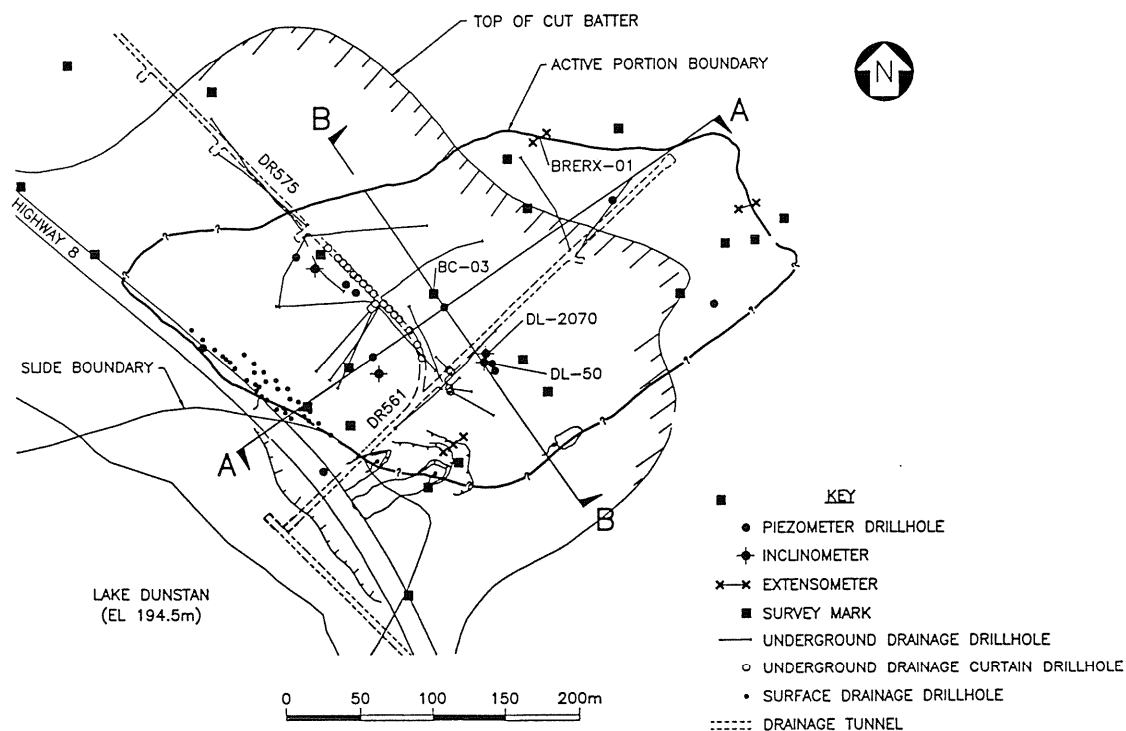
Figure 1. Layout and instrumentation of Brewery Creek Slide 'Active Portion'.

The reactivated area (Figure 1) became known as the "Active Portion". It has an estimated volume of one million m³.

The model is summarised by Figures 1 to 3. The slide mass consists of chaotic schist debris and the failure surface for the Active Portion is a narrow clay gouge located within the 11 metre thick sheared and crushed zone forming the Basal Failure Zone (BFZ) of the main landslide. The active failure surface is difficult to identify from drillcore but has been modelled from inclinometer data and surface evidence. Failure occurs along a comparatively shallow (maximum depth 27m below present ground surface) curvi-planar surface bounded by steep lateral margins and the headscarp.

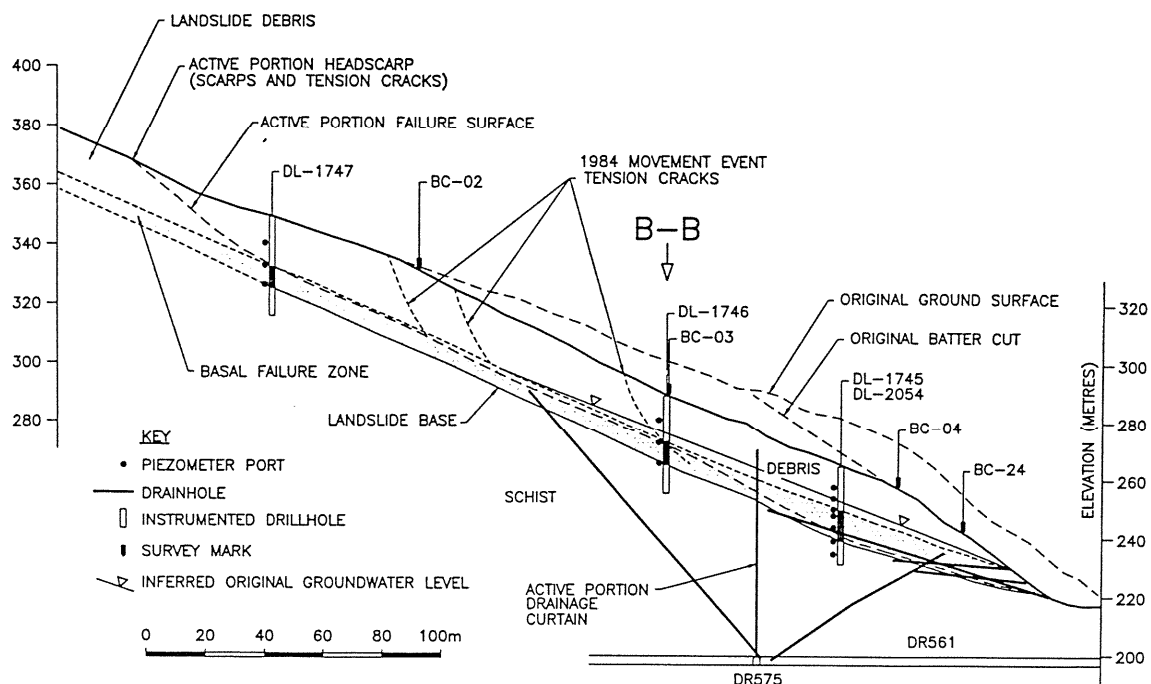
Figure 2. Cross section AA, looking down valley.

The Active Portion contains thin, highly compartmentalised perched aquifers, predominantly within the sheared and crushed rock of the BFZ and the lower part of the slope (Figure 2). The aquifers are fully above reservoir level and were not affected by lake filling. The sub-basal aquifer and aquifers within other parts of the main slide mass, which were affected by lake filling, do not affect the Active Portion.

The base of the perched aquifer is close to the base of the BFZ. Both permeabilities and piezometric levels within the aquifer are highly variable, making it difficult to confidently determine the head acting on the Active Portion failure surface. Higher permeabilities are inferred to occur in areas of shattered rock.

Surface works involving the repair of tension cracks and runoff control at the head of the slide were carried out in February–March 1993. In addition, from April to August 1993 a vertical drainage curtain (23 holes) was installed from the tunnel to

provide more positive control of infiltration into the slide mass (Figure 2).

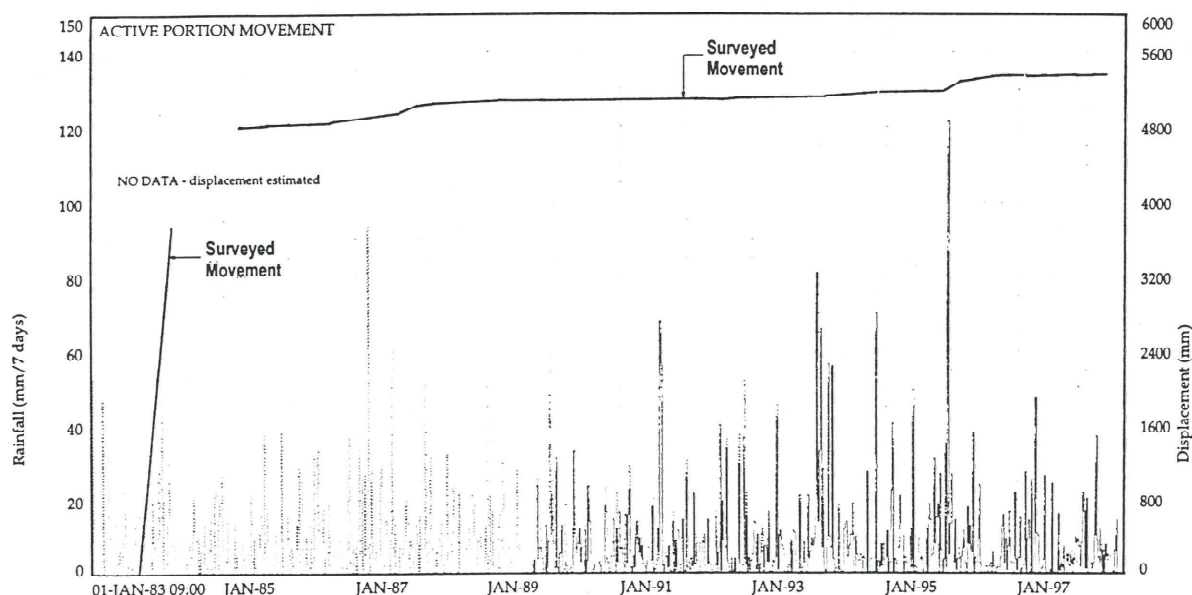
Figure 4. Active Portion movement history since 1983 compared with weekly rainfall.

Failure of a 200 metre wide zone occurred in September 1983 when the 1.4H to 1V batter was nearing completion and the excavation exposed a 1.5m thick sheared zone containing a sandy silty clay gouge (Bryant *et al* 1992). Tension cracking developed at EL 300 m, up to 100 m behind the head of the cut slope, and approximately 0.5M m³ of material was activated. Little water was inferred to be present in the slide although minor seepages were observed on the cut slope just above the BFZ. Surface survey monitoring indicated quite consistent movement rates of up to 25 mm/day. Approximately 4 m of movement was measured between September 1983 and March 1984 (Figure 4).

Back analysis, assuming a dry slope, was used to design remedial measures involving removal of 0.6M m³ of material from the head of the active area. This work was implemented in two stages between April and October 1984. The initial earthworks caused accelerated movements (reported as up to 700 mm/day on 5 April) as a result of localised head loading but the rate reduced to a reported 60 mm/day by 8 April as the material was removed. The total movement caused by head loading is not known, but is estimated as about 1 metre (Figure 4).

The remedial works appeared to arrest the movement, but 6 months after completion of the earthworks, new tension cracks developed up to 100 m behind the crest of the remedial excavation. Survey monitoring of 5 permanent deformation marks commenced in April 1985. From April to August 1985, Pillar BC-03 (Figure 4) indicated a movement rate of 0.14 mm/day (50 mm/yr). A further 6 marks were added in September 1985.

The initial reactivation of this section of the Brewery Creek Slide was clearly caused by earthworks for the highway. As shown by Figure 4, almost all of the monitored movement of the slide occurred as a result of the construction activities. The head unloading carried out in 1984 reduced measured movement rates from 25-30 mm/day (approx. 10 metres/year) to creep rates less than 25 mm/year.

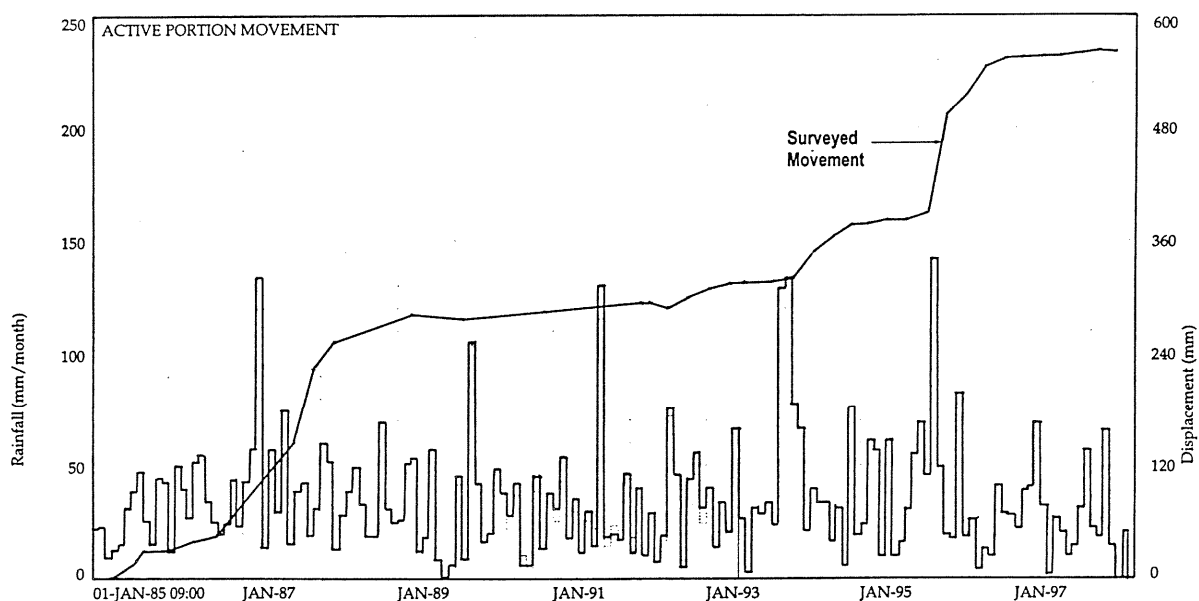
Figure 5. Active Portion movement history since 1985; cf. monthly rainfall.

Between December 1990 and April 1991 drainage tunnel DR575 was driven across the slope beneath the Active Portion. Fourteen drainholes were drilled up into the Active Portion from the tunnel between May and July 1991. Following rain over a 10 day period, piezometric rises of up to 0.6 m were recorded in August 1991. The creep rate increased to about 12 mm/yr between August and October. About 6 mm of movement occurred (Figure 5).

sheared off by this event. Movement continued at a rate of about 130 mm/yr for several months (Figure 5) with a slight increase when piezometric levels again rose during the winter. The movement rate slowed from August when piezometric levels fell below EL 280.9 m in indicator piezometer DL-50C and the total drainage flow reduced below about 30 l/min. Movement ceased in October 1996.

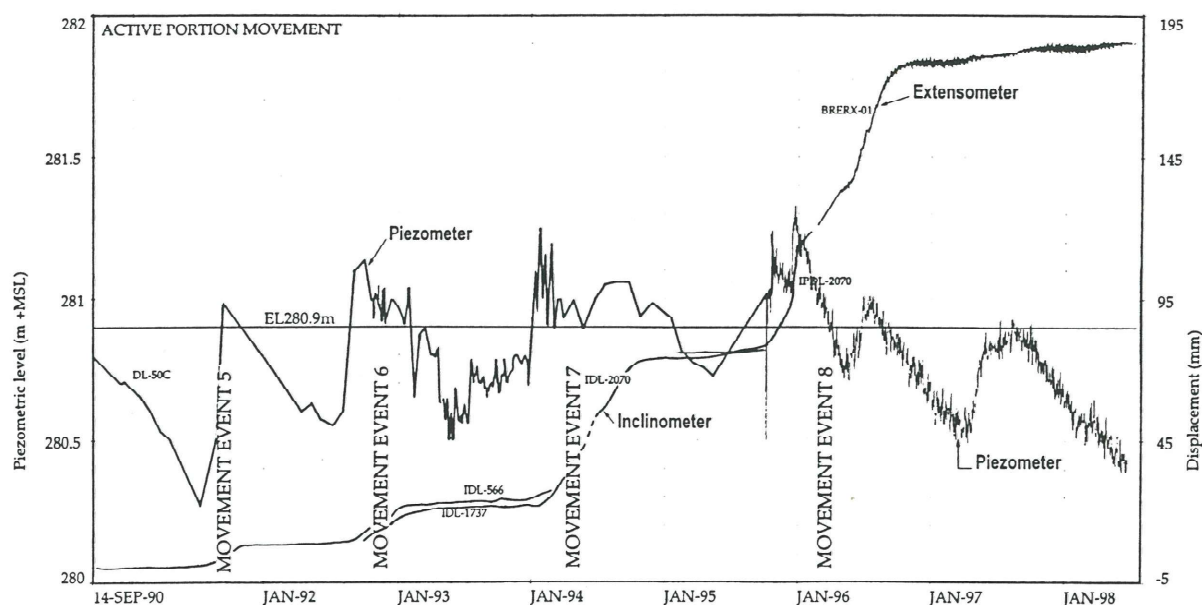
Figure 6. Active Portion movement history since 1990 compared with DL-50c piezometric level.

an associated increase in the movement rate of the Active Portion being detected. As shown by Figure 6, since 1990 there is a clear relationship between certain rainfall events, increased piezometric levels in the perched aquifer and accelerated movements.

There is a reasonable correlation between slide movement episodes and the piezometric level in the indicator piezometer DL-50C, with movement generally occurring when it rises above EL 280.9 m.
