# The Rockfall of Huzzas Cliff, Gracetown, Western Australia

F.R. Gordon

B.Sc., A.O.S.M., F. Aus. I.M.M.  
 Director, Gordon Geological Consultants, Australia

**Summary** On the 27th of September 1996, four adults and five children died in a rockfall at Huzzas Beach, Gracetown. They were sheltering from rain under a large overhang at the base of a limestone cliff while watching a surfing carnival, when the cliff collapsed without warning. The rockfall was 10m high, 20m wide and about 4m thick and produced some 1,440 tonnes of rubble. The cliff consists of four bands of weakly lithified eolianite with interbedded paleosols and calccrete caprock layers overlying a rock platform of boulder conglomerate and marine limestone. The overhang was 3m deep and 3m high and was roofed with calccrete caprock. Widely separated calccrete infilled vertical 'joints' formed discontinuities. The limestones can absorb up to 40% moisture and driving rainfall provided the trigger for collapse. The rockfall has been analysed as the failure of a cantilevered beam. The maximum bending stress in the dry was 40kPa, and when wet, 48kPa. Failure occurred when the bending stress equaled the reduced tensile st

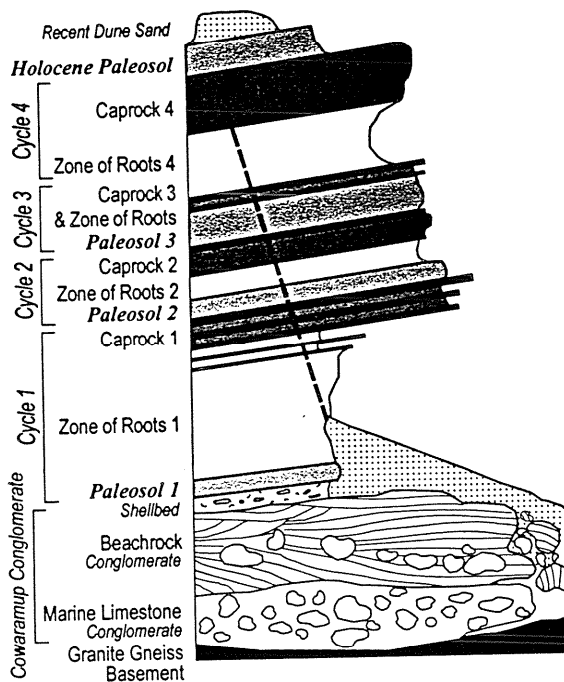
Figure 2. Cowaramup Bay Rockfall Diagrammatic Cross Section before 2.45pm 27/9/1996

The rockfall included four cycles of eolianite and fossil soils which made up all of the cliff face except for the surface caprock layer (Figure 2). The rockfall was some 10m high and about 20m wide and was up to 6m deep, with an average depth of about 4m. The back scarp or plane of separation of the rockfall was planar (Figure 4). The rockfall contained about 720m<sup>3</sup> of rock and sand, or about 1,440 tonnes of rubble. The weaker layers broke down to sand during the rockfall movement.

The cliff face was made up of 10 subhorizontal bands of calcareous rock (Figures 2 and 3) with widely differing strengths and porosities. The bands have a certain degree of coherence gained during diagenesis. The outer surface of the cliff

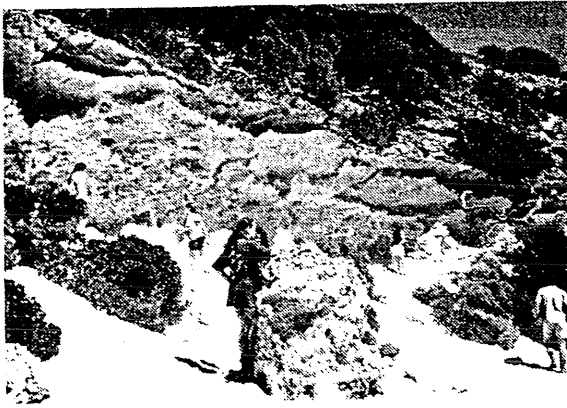
showed grey coloured case hardening except where erosion is active (lower overhang) and the colour is yellow (Figure 3). Eolianite limestones have sparse natural joints which are vertical, and are usually parallel to the cliff face or less frequently, at right angles to it.

In early 1996, a secondary school group examined the cliff and took several photographs including the bottom overhang (Figure 3). These photos show two vertical 6m long parallel joints at right angles to the cliff face located on the east side about the eastern margin of the rockfall. One of the joints was filled with calcrete. The other some 2m distant shows breakage of the calcrete infilling and some erosion has occurred, indicating initial settlement of the block to the west i.e. in the rockfall area.

Figure 3: Rockfall area, overhang with sheet calcrete caprock, vertical joints LHS.

Slab failures frequently leave overhanging roofs above the failure plane (Figure 4) and this may become a site for further slab failure (Selby, 1993). The Gracetown rockfall fits into the category of a slab failure with a well defined, planar separation

face and a large overhanging roof left after the rockfall (Figure 3).

The initial tension joint presumably formed parallel to the cliff face near the top of the rockfall as lateral confining pressure was released through cliff erosion or there may have been a natural joint present, infilled with calcrete. The tension crack may have extended vertically and laterally until a set of natural joints (Figure 3) was intersected.

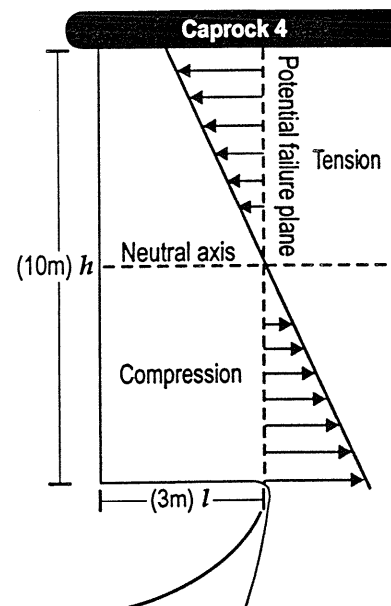
The overhanging block of a slab type failure can be analysed as though it was the cantilevered end of a beam protruding from the cliff face (Figure 4).

With such a cantilevered beam a bending stress acts as a tensile stress on the top half of the protrusion and as a compressive stress on the bottom half. (Maekado, 1990).

Figure 4. Stresses acting due to self-weight on a protruding, rectangular, unjointed body of rock or soil. (after Selby 1993)

For the wet or saturated conditions that prevailed at the time of collapse when the unit weight was increased to  $18 \text{ kN/m}^3$  and the strength of the caprock was reduced from that of its dry state, then the bending moment  $M$ , is  $16200 \text{ kNm}$ , and  $Z$  the modulus of section is the same as for dry conditions ( $333 \text{ m}^3$ ) so the maximum bending stress is  $48 \text{ kPa}$ . Failure then occurred.

The tensile strength of the Caprock 3 layer in the rockfall can also be determined by back analysis, as the critical overhang distance is known to be  $3.0 \text{ m}$ ; then from equation (4)  $\sigma_t = 48 \text{ kPa}$  (sat).

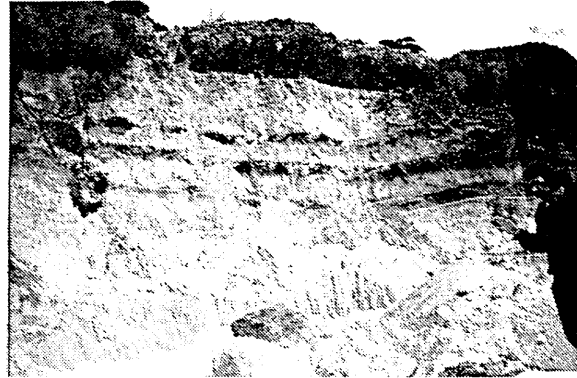
Figure 5: Backscarp with top caprock overhang since removed, Paleosols are darker bands (Photo taken 28/09/96).

The top caprock layer that was removed after the rockfall was about 1.4m thick and had a UCS of 15MPa and thus an estimated tensile rock strength of about 1.5MPa.

about 5.6m before failure occurred. The overhang left in place after the rockfall was up to 5m. This was removed the next day.
