Compaction Grouting in Waste Rock

SUMMARY A large mine structure is supported on a well founded concrete wall at one end and on deep mine waste fill at the other. When additional filling was carried out behind the structure substantial differential settlements were found to occur and a range of possible solutions is discussed. A penetration/compaction grouting method was successfully adopted but there were considerable difficulties in execution, principally due to problems of drilling in loose unstable soils containing very hard boulders.

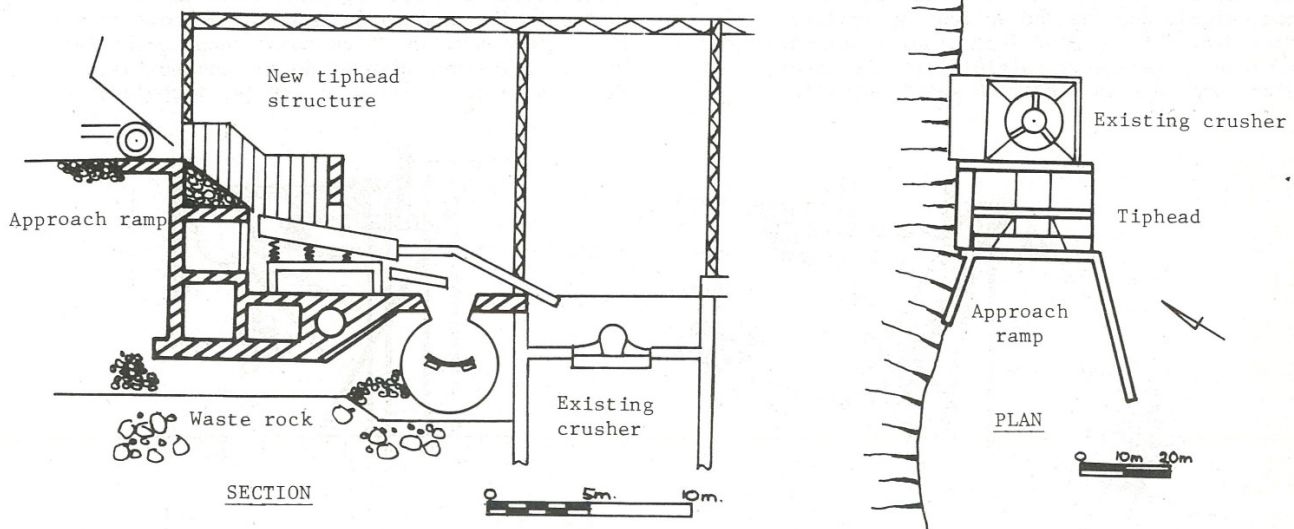
Figure 1 - Tiphead structure

The concrete structure consists of a 22.5 m square 1.5 m thick slab with two 6 m x 3 m "wings". The rear retaining wall is 17 m high and buttressed by the dump hopper walls. At the West side the base slab is supported on a 3.5 m thick blanket of selected fill overlying mine waste. The slab spans the loadout tunnel and is supported on the reinforced concrete wall of the existing crusher at the East end. The crusher itself is founded on bedrock. The foundation level of the structure is about 6 m below the original surface of the dump.

A simplified cross section through the structure is given on Figure 1.

By mid July 1978, 11 m of waste rock had been placed in the approach ramp fill area to the West of the structure. As the foundation of the building was constructed 6 m below original ground level, this represented an effective increase in the depth of overburden of 5 m. Settlement monitoring was carried out at a number of points and over a two week period, the average rate was recorded at about 2 mm/day, with a peak value of 5 mm in one day at one point.

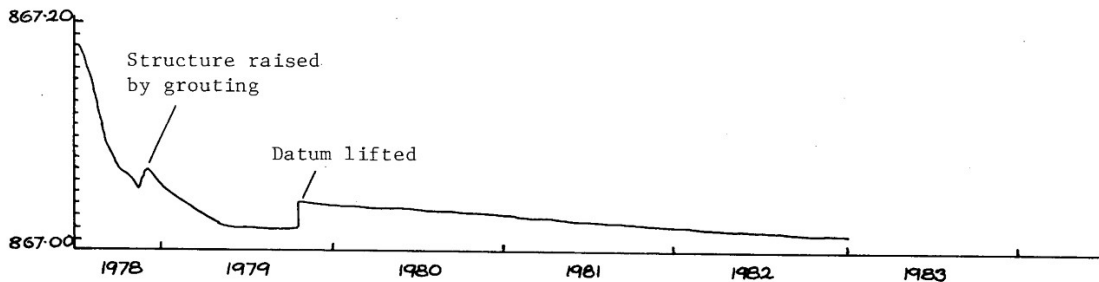
Figure 3 - Settlement plot

Daily monitoring of settlement was carried out during the grouting programme and intermittent measurements made thereafter. For comparison purposes during grouting, levels were taken at two points about 15 and 30 m from the structure. For long term monitoring two points were established at a distance of 80 m from the structure. Settlement records during and after grouting are shown on Figure 3.

During initial filling in July 1978 a maximum daily movement of 5 mm was recorded. This rate dropped to about .5 mm per day after 10 days and then increased to about 1.2 mm per day 8 days after grouting had started as a result of the weight of the grout and the introduction of water. Unseasonal heavy rain, in excess of 84mm, occurred from 3rd - 6th August after several months of dry weather. On the first day run off water from the mine haul road found its way to the structure and two "sink holes" developed on the South side. An estimated 250 m³ of water ran under the structure before diversion bunds could be erected, and the settlement rate quickly rose to an average of 2.6 mm per day.

during October. In November 43,000 m³ of fill were placed and compacted to stabilise nearby slopes, and this caused an immediate increase to about 1.5 mm per day. However, at a reference point remote from the structure, the rate rose to 13.5 mm per day indicating that the grouting had caused very substantial reductions in settlement rates.

A settlement/log time plot shows that the structure is continuing to settle at a reducing rate, somewhere in the range of 10-20 mm per log cycle. The total movement is presently about 240 mm.
