A Study of House Foundations at Elizabeth East, South Australia

K.C. PILE

SUMMARY The results of observations extending over 17 years on the foundations of 16 houses are presented. The houses are of brick veneer construction with timber floors, built on shallow strip external footings and internal dwarf walls. The soil is an expansive red-brown clay 12 metres deep. It is concluded that the movements of external walls are mainly due to soil moisture changes resulting from domestic activities such as gardening, and that the pattern and magnitude of movements are unpredictable. An attempt is made to assess the relevance of the currently used methods for footing design proposed by Walsh and Mitchell. It is found that these methods do not model the observed long-term soil deformations accurately. Nevertheless for the soil deformations at the 16 sites in the study, footings properly designed by either of the above methods would perform satisfactorily.

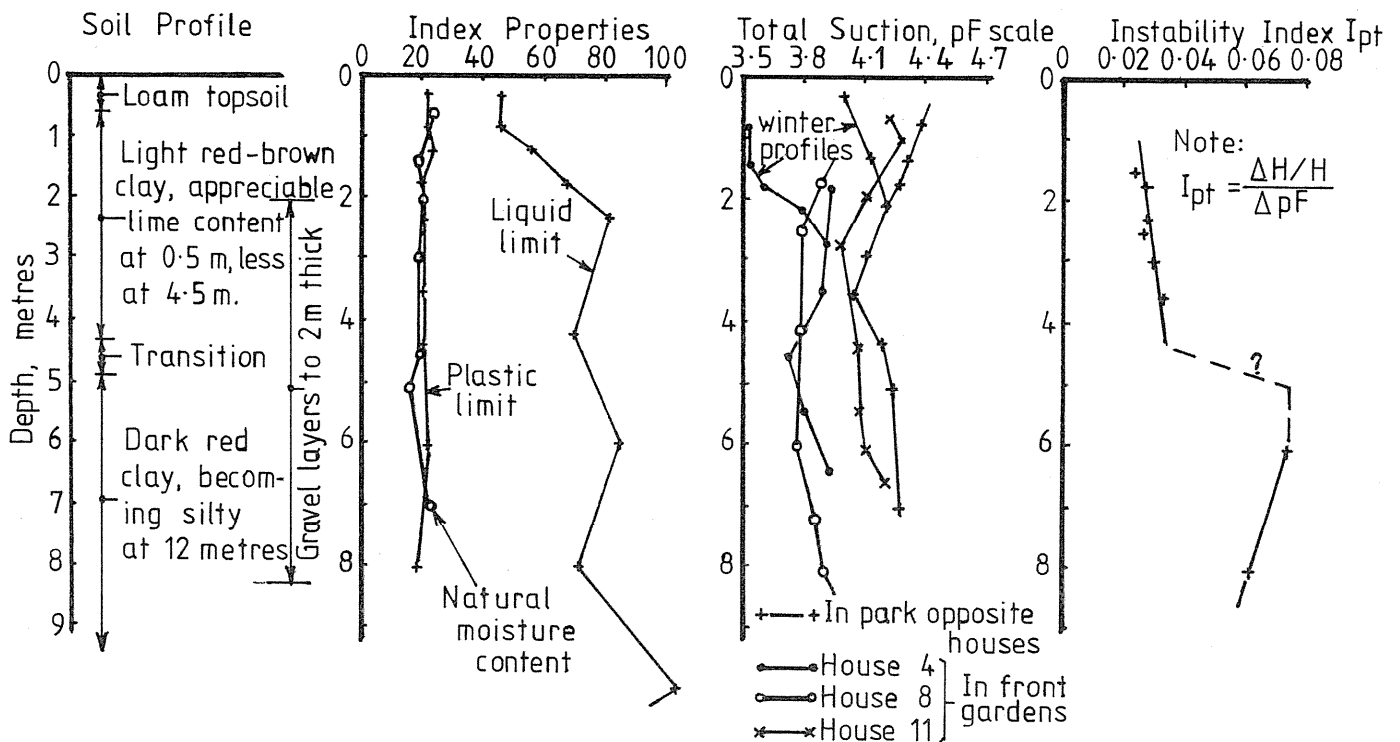
Figure 1 - Soil Profile and Properties

time, included determination of liquid and plastic limits (W_L and W_p), plus volumetric shrinkage. The W_L and W_p results are plotted in Figure 1.

The SAIT soil tests included measurements of total suction, and both swell pressure and magnitude of swell as a result of saturation in an oedometer. The latter showed that the entire soil profile to 12 m is in a desiccated state and is capable of swelling under overburden pressure on wetting. A few tests for instability index were made by drying to controlled suction values, as well as some additional liquid and plastic limit tests. Figure 1 shows suction profiles for the soil in the park and in the gardens of three houses and also some instability index results.

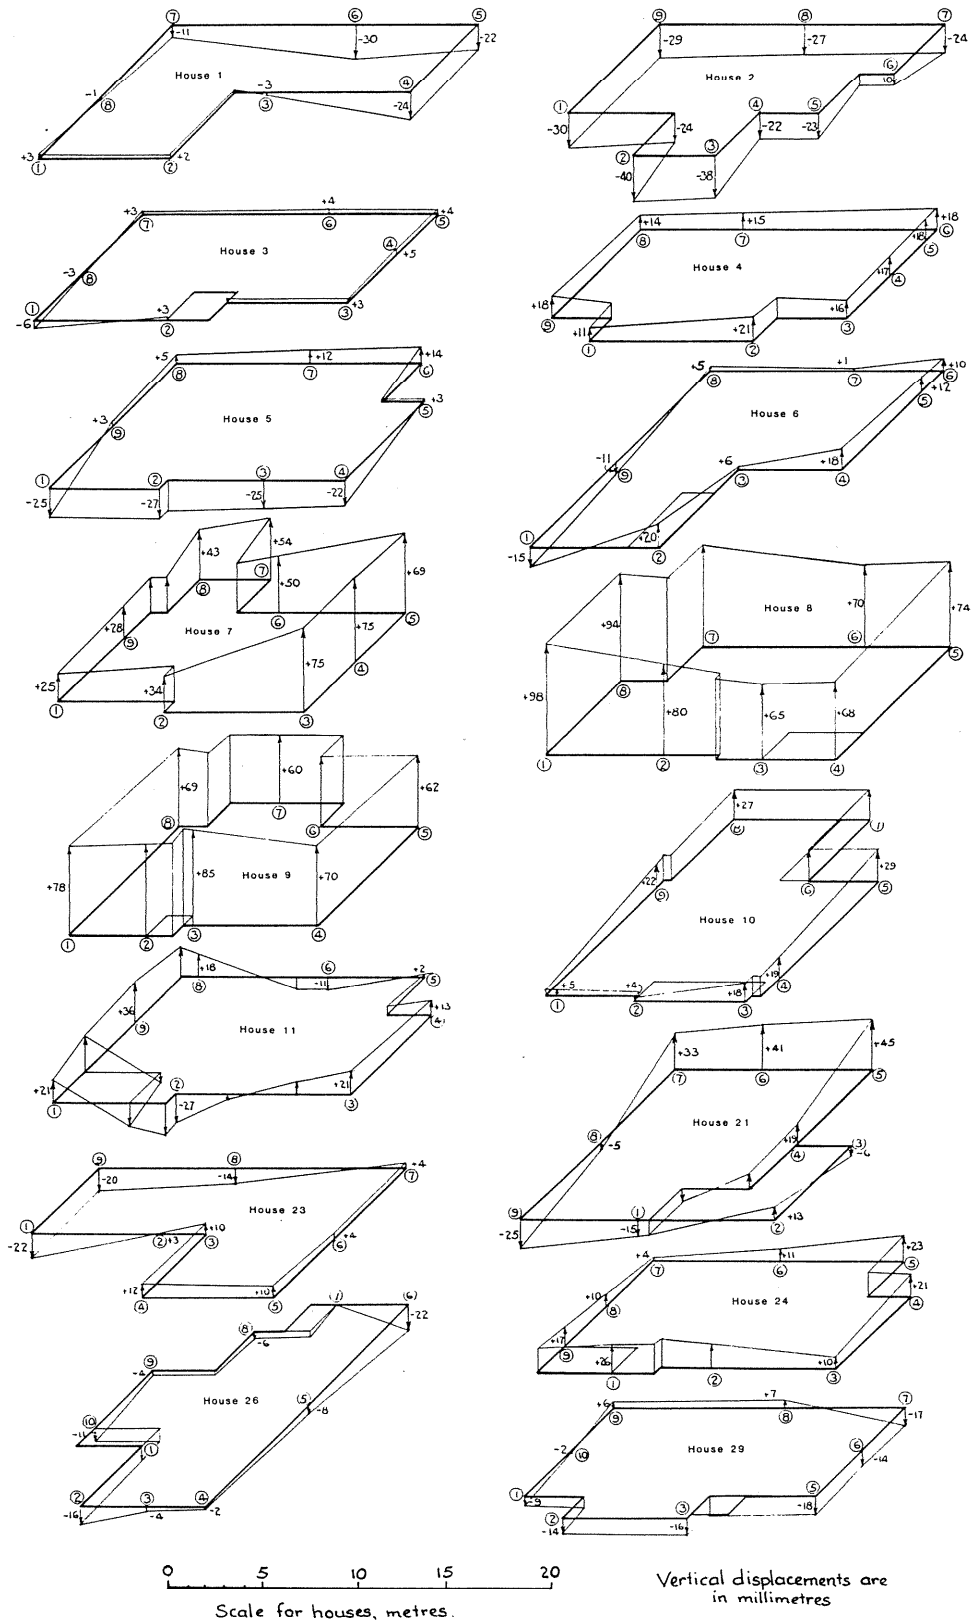
Figure 2 - Vertical Movements of External Walls

For the 16 houses with shallow footings, vertical displacements of the outer walls are shown in Figure 2. Some houses have moved at a fairly uniform rate since construction, especially Nos. 8 and 9, which have large heaves with relatively small differential movements. For others, such as No. 1, differential settlement became apparent several years after construction, probably due to the establishment of large trees.

The movements plotted in Figure 2 show a wide variation of deformation patterns, especially considering that the houses are similar in size and design, and the soil profile is relatively uniform. Table II attempts to categorize the movements. One fairly obvious conclusion is that the houses on lime stabilized sites (Table I) moved as much or more than those on untreated sites, suggesting that the stabilization was either not deep enough or not effective in distributing the lime through the clay.

House No.	Pattern	Actual Deflection Ratio
11	Heave of short sides, total movement 50 mm. Brick walls severely cracked.	$\frac{1}{300}$
1,23	T shaped houses with settlement of one leg. Hogging at re-entrant corner	$\frac{1}{930}$
2,6,7,21, 24,26,29.	Overall twisting deformation. External walls generally with negligible bending deflection.	$\frac{1}{1000}$ max.
3,4,5,8, 9,10.	Houses stable, or experienced planar tilting.	$\frac{1}{1500}$ or less

to the outer walls. Thus, for houses with large heaves, i.e. No. 7, 8 and 9, the dwarf walls have heaved by up to 80 mm, even though the soil just below them has dried out. It is concluded that the large heaves have deep-seated origins and are due either to wetting up of the very reactive clay from 4 to 12 metres in depth, or to a slow geological movement. If the latter is true, house No. 11 may be on a discontinuity in the underlying outwash plain material.

From Figure 2 and Table II, only one of the 16 houses has deformed in an edge heave pattern, i.e. No. 11 which has a differential movement of 50 mm. Two houses, Nos. 1 and 23 have a hogging shape, probably due to settlement caused by trees. Seven houses have twisting type deformations which have resulted in cracking, even though the external walls have little bending deflection. The remaining 6 houses have undergone planar displacement with differential movements much smaller than current design values.
