Flexural Slip, An Often Neglected Hazard

P.M. JAMES

SUMMARY Flexural slip seams, resulting from tectonic folding, are typically manifest as bedding plane shears in sedimentary rocks and foliation shears in metamorphic rocks. Residual or near residual strengths apply along the seams, depending on the intensity of folding and rock type. Although of great lateral extent and frequent occurrence, these seams are often missed during site investigations; when encountered, they are sometimes incorrectly diagnosed. Major redesign of dams and occasional dam failures have resulted from a non-recognition of the hazard, while landslides initiated by these features have been wrongly attributed to progressive failure. Illustrative examples are described from the literature and the writer's experience.

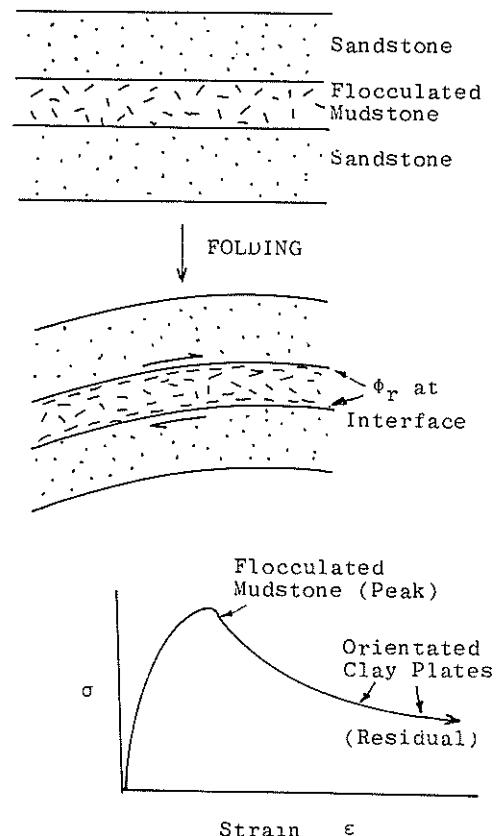
During folding, or flexure, there is of necessity some displacement between the various units of a geological formation, Figure 1. In a sedimentary series, this is usually taken up along the bedding planes of the more argillaceous members. In metamorphic rocks, where rapid changes in lithology might not be present, the flexural slip planes tend to be more widely spaced, but again they typically occur on discrete horizons, parallel to the foliations.

Fig. 1 Folding of a sedimentary sequence to produce residual strength at the argillaceous interfaces.

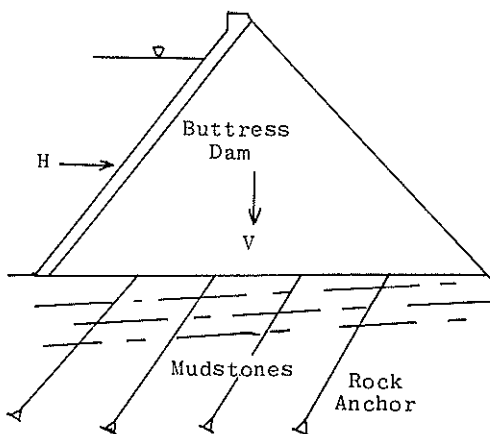
Prior to visiting the site in 1965, the writer identified on air photos what appeared to be a large dip slope slide on the same right bank. It seemed reasonable to assume that sliding had occurred on a mudstone bed and, further, that the mudstone might well have been weakened by flexural slip. Initial excavations for the dam confirmed this view. The mudstone was found to be sheared along its contacts with the quartzite although, elsewhere, it could have been described as a reasonably sound rock. It was, of course, the sound rock which had been retained in the drill cores.

As the strike of the beds approximated to the direction of the dam thrust, the sheared horizons in the mudstone posed a potential hazard to dam stability. A program of testing, with multistage in situ shear tests and complimentary laboratory tests was set up. Residual strengths with $\phi = 18^\circ$ were obtained, (7). As a result of these findings, the dam was anchored by high tensile steel cables which are still functioning satisfactorily today, Figure 2. Detailed descriptions of the geology and anchor design are given in (8).

Fig. 2 Muda Dam, a 30 m high concrete buttress dam was founded on a quartzite-mudstone series. As a result of folding, the mudstone interfaces exhibited residual strengths, necessitating foundation improvement in the form of cable anchorages.

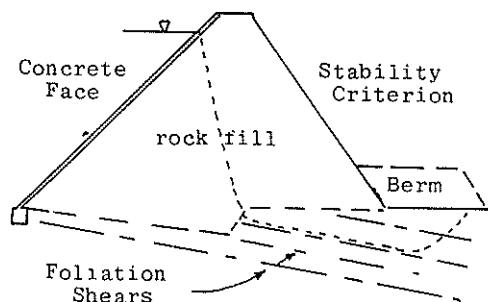
The rocks of the Kotmale area are hard Pre Cambrian gneisses with interbedded marbles known locally as limestones. The series is strongly foliated and has been moderately folded in Mesozoic times to produce a downstream dip of sixteen to twenty degrees at the dam site, with a component into the left bank. A typical dam section on the foundation is shown in Figure 3.

Fig. 3 Kotmale Dam, showing the foliation dip at the dam site. Six or seven major foliation shears were encountered in each abutment, traceable over tens to hundreds of metres.

Nothing unusual had been revealed by several drilling programs prior to construction. However, early excavation for a diversion tunnel revealed a band of highly weathered material in the sound rock, which contained a continuous, polished, surface parallel to the foliation. About this stage, doubts were expressed by client representatives as to the true origin of this and other similar features. Opinions were proffered that the polished surfaces were superficial features. Their continued existence at depth, in the diversion and other tunnels, generally dispelled this view. In any event, striations on the mirror-like surfaces showed movement had been in a direction at right angles to the dip, which ruled out gravity mechanisms. Displaced vertical dykes in the rocks gave direct evidence of the amounts of movement, measurable in tens of centimetres.

Multistage in situ shear tests were undertaken on the seams, together with a comprehensive laboratory program. Minimum strengths of $\phi = 12^\circ$ were obtained on first shearing of laboratory specimens. In situ tests gave a corresponding first shear value of $\phi = 15^\circ$, in the direction of dam thrust. There was little or no drop in strength on repeated shearing.

During later excavations on site, blocks of fresh rock, ten metres or more in plan dimension, slid down dip on inclinations as low as sixteen degrees. The majority of these were initiated by blasting, but the continued movement of the blocks confirmed that the value of the angle of shearing resistance, for very large areas, do not exceed that obtained for in situ tests by any significant amount.

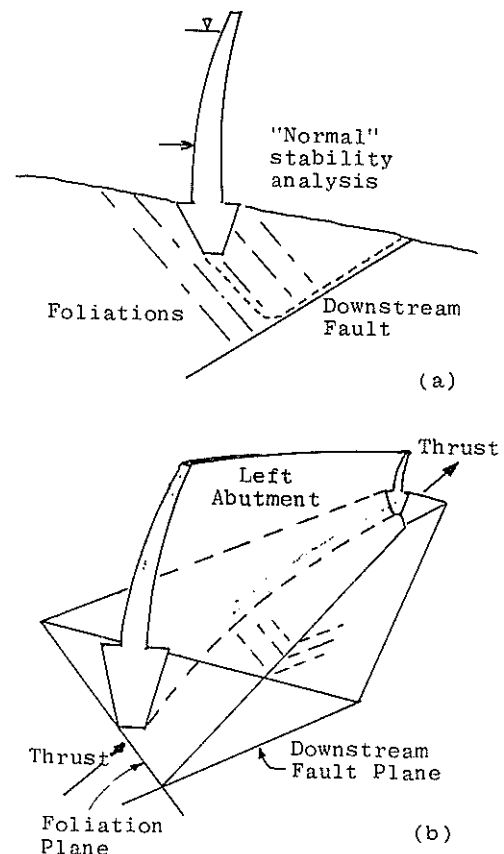
i) An enormous wedge of rock underlying the left abutment disappeared in the failure. The wedge was bounded on the downstream side by a fault, on the upstream side by a foliation plane, Figure 4.

ii) A stability analysis of the section in Figure 4 a, during design, gave an adequate Factor of Safety.

If we take a three dimensional view of the left abutment, Figure 4 b, we can see that both the line of the fault and the foliation strike lie subparallel to the abutment thrust. This situation produces a wedge of rock bounded on both sides by planes of weakness; this was the wedge which disappeared. The resistance to the dam's thrust along this wedge is provided only by the strength of the two discontinuities: a fault zone and a foliation

shear. The strengths along both would be unlikely to exceed and angle of shearing resistance of about twenty degrees.

A simple analysis of the stability of this wedge, (14), makes such a failure mechanism logical, without the need to call on any excessive uplift pressures.

Fig. 4 Malpasset Dam, showing sections a) normal to the axis, which gave an adequate Fof S, and b) along the left abutment alignment, where weak discontinuities bounded the wedge of rock which was removed during the failure.

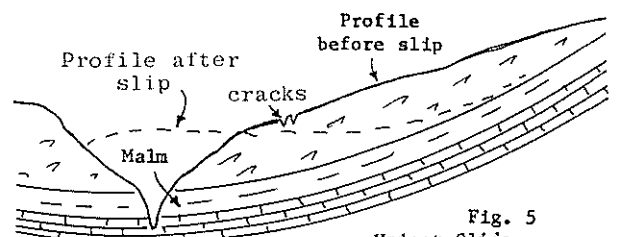
Fig. 5
Vaiont Slide

Perhaps the most spectacular slope failure in recent times has been that at Mt Toc, above the Vaiont Reservoir. Here, a series of folded Alpine sediments dipped towards the valley, Figure 5. Failure took place in the Malm: thinly bedded limestones and marls. An analysis by Skempton (15) indicated a ϕ value of the order of 16° was required, for the relevant ground water and reservoir levels.

This slide thus has all the attributes of an example of failure along bedding plane shears which are the result of flexural slip. It is apparent from the
