Study of A Case of Unsuitable Structural System on Heterogeneous Soil

M.M. REYAD

Associate Professor of Soil Mech. and Found. Eng., Building Research Center, Cairo, Egypt

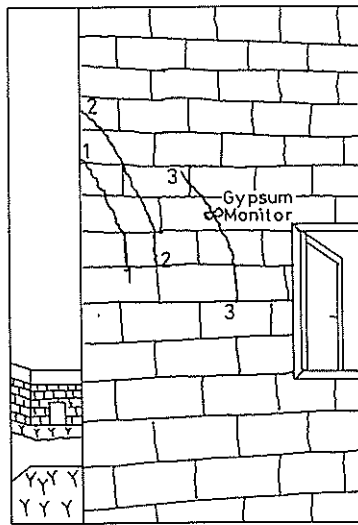
On January 1988, about 80% of the houses were completed and began to be occupied by the dwellers. After about six months, unexpected hair cracks began to appear in most walls. The cracks have gone wider and wider and the deterioration was very clear to human eye. The author was responsible for studying the case and solving the problem.

Figure 1 Cracks in an exterior wall

Thin and moderate cracks are filled with new effective filling material. Damaged walls must be removed and rebuilt again after considering the necessary safety precautions. All inspection chambers must be replaced by new chambers constructed of reinforced concrete base and walls acting as one unit and must be properly insulated. Compacted clean sand is placed under their bases and behind the side walls. Water and sewage lines must be inspected, repaired or replaced and coated by granular soil. Compacted clean sand layer with reasonable thickness must be placed under floor tiles. All buildings have to be surrounded by wide footpath with suitable outwards slope to avoid water accumulations. Green areas must be irrigated by mechanical sprayers to avoid flooding. Maintenance works must be done regularly.

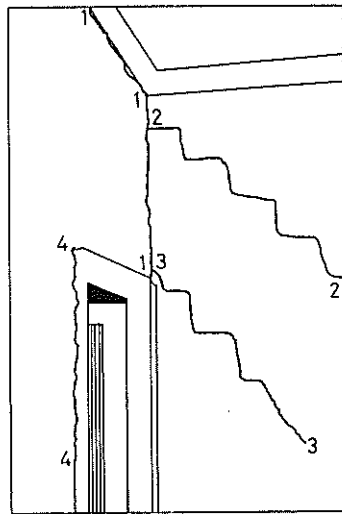
Figure 2 Cracks in an interior wall

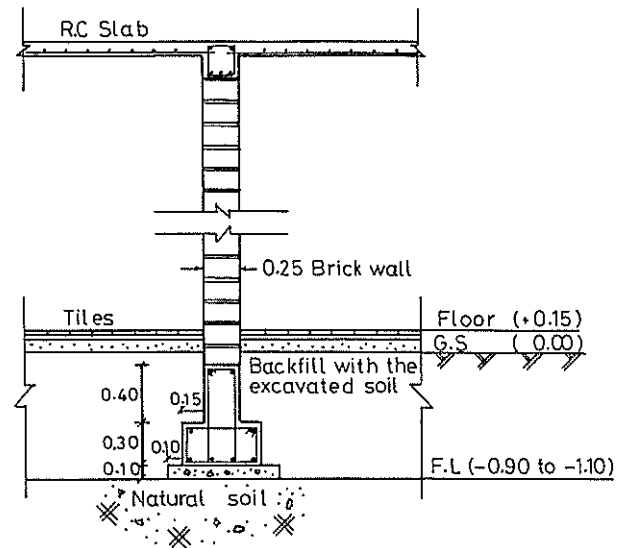
Houses are built according to the wall bearing system. The building consists of continuous strip footings under the brick walls which carry the reinforced concrete roof slab through reinforced beams. The test results indicated that the used bricks conform to the standard specifications but the joining mortar suffers from lack in cement content, moreover, some bricks were placed besides each other without any mortar. Concrete elements were in good condition and their strength was acceptable. The different crack indicators showed that the movement was still going on and most cracks were still going wider so that they reached 12 mm in some walls. Some cracks had a broken path around the bricks while some others had cracked the bricks themselves. Figures 1 & 2 show sketches for some cracks as examples and figure 3 shows the structural system of the houses.

Houses are founded on shallow foundations consist of continuous strip reinforced concrete footings on the shape of inverted T-section resting on 10 cm thick plain concrete strips under the whole length of the bearing walls as shown in figure 3. Foundations rest directly on the natural soil at depth ranging between 0.90 & 1.10 m below ground surface. They were well designed, well constructed and they were in good condition without cracks, no rust and the concrete strength was acceptable.

Figure 3 Typical section in interior walls and existing foundations

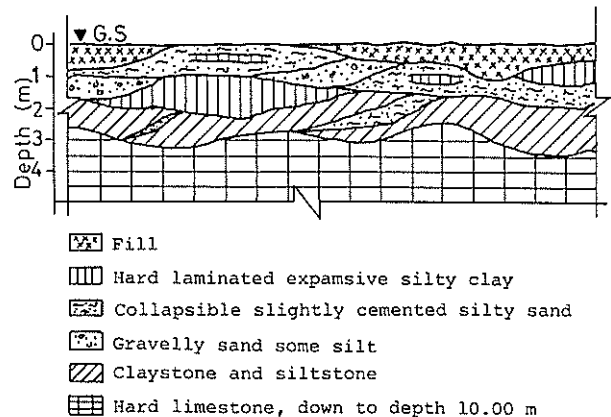
extends at some locations down to depth 3.5 m, consists of random formation of heterogeneous soils. It contains fill, collapsible slightly cemented silty sand, expansive hard laminated silty clay, claystone and siltstone. All these kinds are found in different thicknesses, at different depths, in random succession and may lie within the area of the same building. Figure 4 shows the erratic formation of the soil in the upper layers.

As it is well known that the effect of water on such soils is so dangerous, any source of water will cause very complicated soil behaviour and the definite result will be differential movement along the continuous footings. Buildings could not tolerate or withstand the occurred movement because their structural system does not afford sufficient rigidity and cracks began to appear.

Figure 4 Typical geotechnical section in the bearing stratum

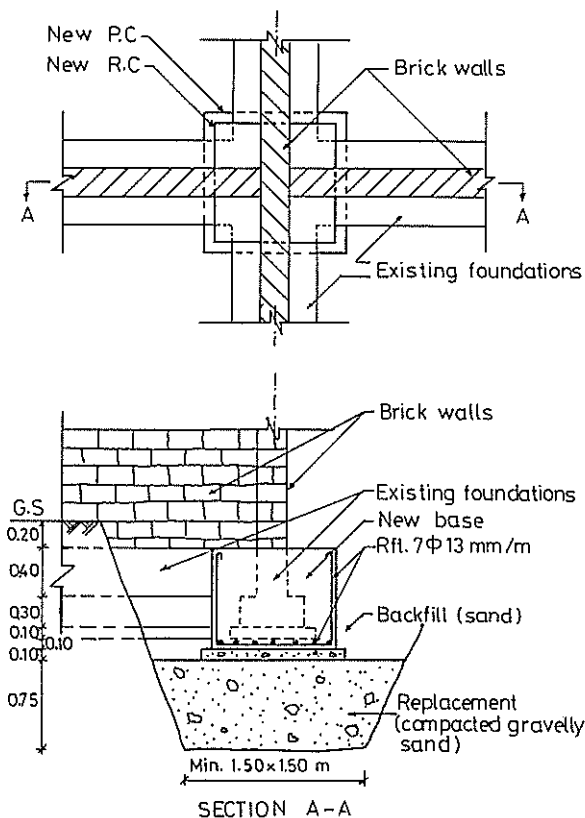
Figure 5 The proposed soil replacement and the new foundation support

Buildings must be strongly shored up to avoid any movement. Soil is removed out at the points of intersection of the existing foundations to make excavated pits with minimum dimensions 1.50 x 1.50 m down to depth 0.95 m below the present foundation level as shown in figure 5. The bottom of excavation is regularly soaked for 72 continuous hours and the accumulated slurry is removed, then it is strongly compacted. The replacement material is gravelly sandy soil with traces of fines. It is compacted on three equiheight layers of 0.25 m each. Compaction is done at the optimum moisture content to gain minimum 95% of the maximum dry density as predetermined experimentally from the Modified Proctor Test with minimum value 1850 kg/cu.m for each layer.

The new foundation support is shown in figure 5. It consists of reinforced concrete base resting on 0.10 m thick plain concrete. The reinforced concrete base has minimum dimensions 1 x 1 m and with sufficient height to surround and envelop the existing foundations at their intersections. Clean sand must be used for backfilling around foundations.
