# Risk of Mine Related Subsidence at Ocean View

G.B. FARQUHAR  
B.E., B.D., M.Sc., D.I.C., M.I.C.E., M.I.P.E.N.Z.  
Senior Geotechnical Engineer, Worley Consultants Ltd  
B.J. DOUGLAS  
M.Sc., Ph.D.,  
Principal, Barry J Douglas Geological Consultants

**SUMMARY** In July 1989 a subsidence pit appeared in a residential area at Ocean View above the one hundred year old abandoned Walker No. 1 Coal Mine. Subsidence hazard for the residential area was examined. The extent of the mine was assessed together with overlying ground conditions and condition of the mine. Strata overlying the mine were found to be extremely weak. Mine workings were found to be deteriorating and in an open and flooded condition. The subsidence pit was attributed to localised catastrophic collapse of the mine roof and consequent subsidence of water charged sandy gravel into the mine opening, causing the sudden collapse at the ground surface. Other similar pits were observed above nearby abandoned mines. The risk of further subsidence pits forming was assessed to be very probable. Fourteen private properties were determined to be at risk, and the degree of risk to residents and property was assessed as 'risky to

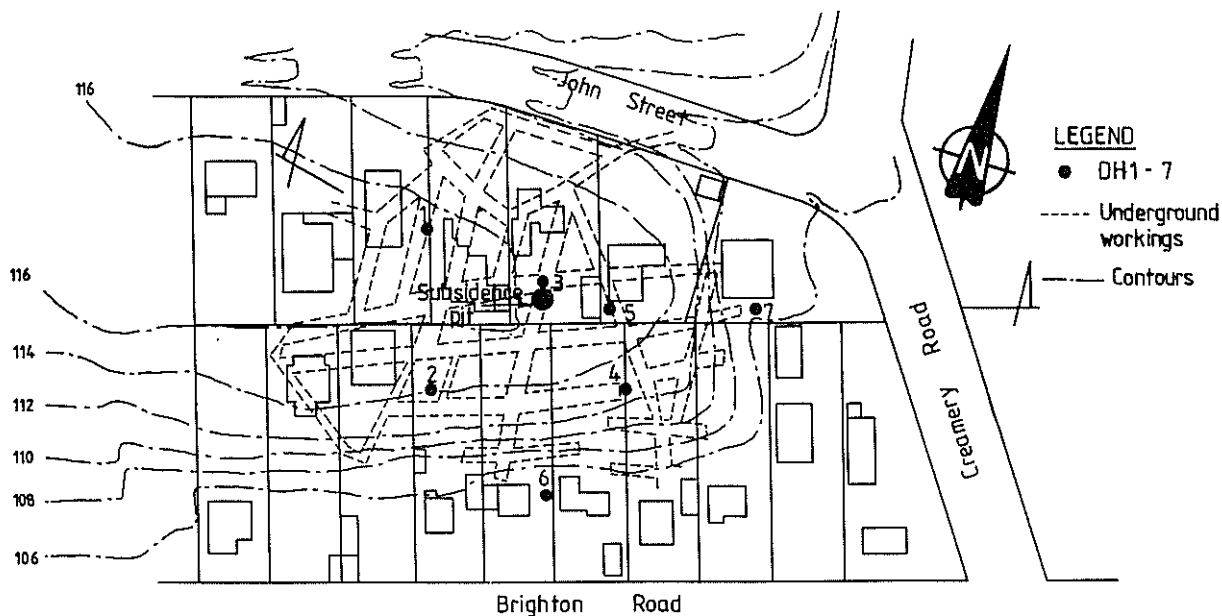
Figure 1 Site plan

Six mine plan overlays scaled to the topographical plan were generated in an attempt to establish an accurate orientation for the mine map. On the basis of geologic and hydrologic data the mine was believed to be confined to the area beneath the high terrace and not to extend beneath the low-lying previously swampy ground. On the basis of historic and topographic features the approximate location of the mine portal was determined to be on the north facing slope of the gully now modified to form John Street. The resulting plan overlay model is shown on Figure 1.

Most of the technical information required to evaluate subsidence hazard was derived from 7 drillholes, located as shown on Figure 1. Access for drilling was restricted. An inspection was made of the exterior surfaces of buildings in the area. No indications of large scale ground settlements were detected although significant settlement of one corner of a house was observed. The Local Authority conducted

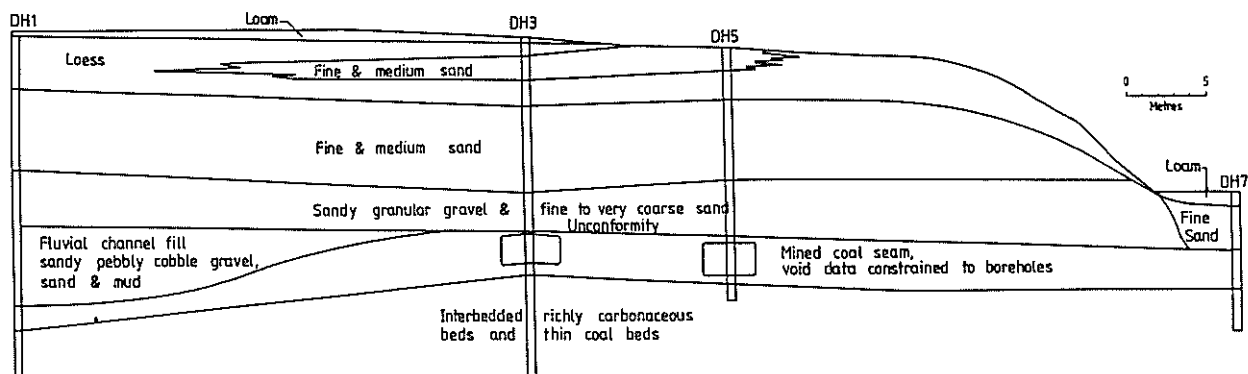
Figure 2 Geological section

The ground profile in the area of the mine is depicted in Figure 2. Hillgrove Formation (Pleistocene) sediments overlie the coal bearing Taratu Formation (Upper Cretaceous). The Hillgrove Formation (9-16 m thick beneath the high terrace) consists of the following general profile:

Depth (m)	Stratum
0 - 4	Soft to stiff clay and very fine sandy mud (Loess)
1 - 9	Medium dense fine to medium sand
8 - 12	Very loose to loose sandy gravel and fine to coarse sand
12 - 16 (DH1)	Mud and sandy cobble gravel
8.5 - 9 (DH2)

Formation except to the west (DH1 & 2) where a succession of fluvial silts, sandy cobble gravels and sands, infill a channel deeply entrenched into the underlying Taratu Formation.

The Taratu Formation consists of numerous thin, laterally inconsistent fine grained carbonaceous beds of clays, silts, coal and fine sands. These sediments are extremely weak to very weak. The 1.4 - 3.6 m thick, laterally continuous, moderately strong, main coal seam occurs at or close to the top of the Formation. Beneath the high terrace the top of the coal seam varies between 11.2 and 16.0 m below ground surface. The Taratu Formation strata dip gently south eastward at 4° - 6°.

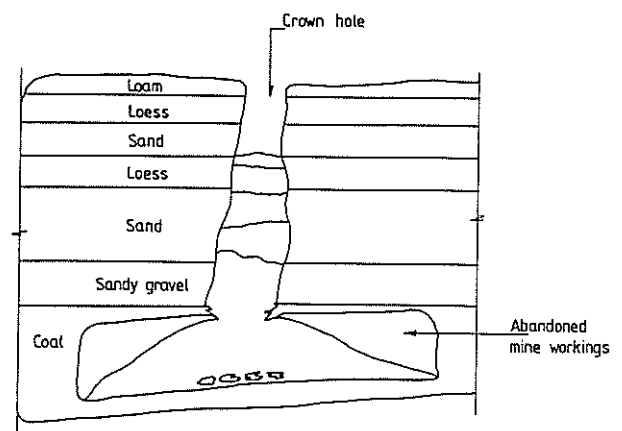
Figure 3 Crown hole formation

The major mechanisms of mine deterioration in room and rance workings are roof collapse, crushing of pillars and floor heave. By far the greatest problem is roof collapse as evidenced at the Walker No. 1 Mine and nearby mines. At the cessation of mining supporting timbers would either be withdrawn or allowed to rot away allowing the roof strata to collapse into the open workings. The process of upwards collapse would continue until the workings and the collapsed ground above it were completely choke-filled with debris. Where the collapse reaches the ground surface a subsidence pit or trough (crown hole) is formed. This process is illustrated in Figure 3.

Several formulae can be found in the literature as to the maximum height of collapse that might be expected to occur. (Subsidence Engineers Handbook 1975; Healy and Head 1984). For a seam thickness of 1.2 m and a bulking factor of 15%, a conical shaped collapse could be expected to occur up to a height of 20-34 m i.e. greater than the

thickness of overburden above the mine.

Dunrud and Osterwald (1980) observed that the total depth of subsidence pits may be nearly as deep as or sometimes even deeper than the height of the mine workings because collapsed material may spread laterally into the mine opening, particularly where water is present in the mine. It is believed that the surface in the John Street subsidence pit collapsed 3.5 m above flooded coal workings excavated to a height of 1.1 - 1.7 m.

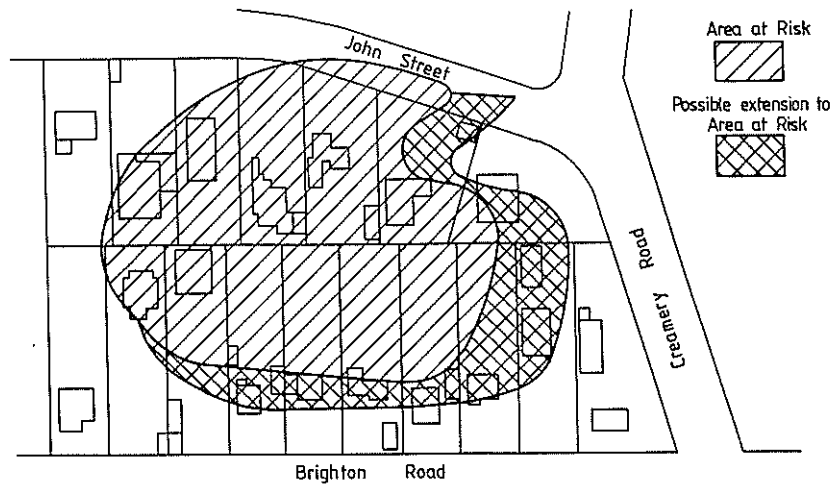
Figure 4 Areas of risk

The 'area of risk' for ground subsidence is shown on Figure 4. It is derived from an overlay of the various mine models and comprises two areas:

1. Area of risk.
2. Possible extension to area at risk.

Results from the drilling on the low-lying area did not prove the absence of mine workings. Therefore a 'possible extension to the area at risk' was included. This area was identified as requiring further investigation to confirm whether mine workings extend below it.

Option 3 was the most feasible method of preventing migration of voids and formation of subsidence pits. The existence of voids that had partly migrated towards the ground surface was considered unlikely. Because the

workings were inaccessible, injection of grout would be done through drill holes. The cost of in-filling the mine by grouting was estimated as \$900,000 in 1990.
