# Assessing Geotechnical Risk of Instability between Adjacent Mining Operations – A Case Study

M. DUNBAVAN  
Ph.D., M.A.G.S.

M.Sc., M.A.I.M.M., M.A.G.S., M.G.S.A.  
Managing Director, Boyd Mining Pty Ltd

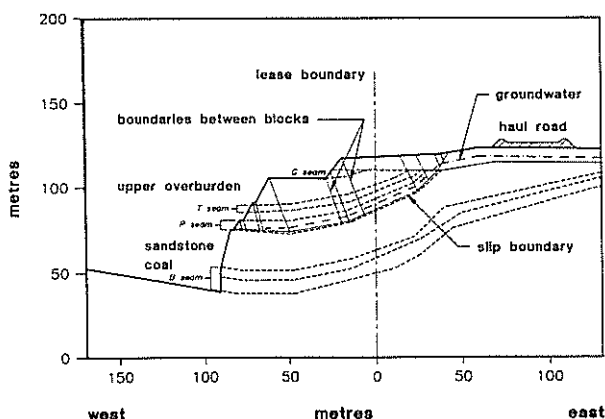
Figure 1 Lease boundary geology and structure

Instability first occurred in March 1989 during stripping to the base of the upper overburden, exposing P Seam. Pit limits at the time of first instability are shown in Figure 1, with the toe of the (basal) B Seam 110 m west of the lease boundary, and the toe of the P Seam layer 90 m west of the same boundary. Movement was concentrated at the roof of T coal horizon or above, with a scarp ultimately forming behind the planned highwall crest.

With further extraction along the boundary, slip of the upper overburden occurred during excavation of a bench to a level just above the roof to the T Seam. To reduce the hazard to mining operations from continued rock movement, the slope above bench level was dozed parallel to bedding at an angle of approximately 35°. During excavation of the next bench, movement occurred along the base of the P Seam initially in the northern portion of the panel when the toe of the slope was only 20 m west of the lease boundary (see Figure 1). Movement was accompanied by significant floor heave indicating the failure surface lay in the floor beneath P Seam. Movement in the slope extended over the full length of the panel, but movement along the base of P Seam diminished to zero at the southern panel limit, where the toe of the seam was located at 50 m west of the boundary. The scarp of the failure developed at its current day position at 90 m east of the lease boundary (see Figure 1).

For stability analysis, a two dimensional method was adequate in representing broad geological features and the proposed terrace mining method for overburden removal. Samma's limit equilibrium method was selected from a range of methods applicable to non-circular slip mechanisms. The main advantages of Samma's method for this case were use of a non-circular slip boundary and specification of non-vertical block interfaces within the sliding mass together with shear resistance on those interfaces. Figure 1 illustrates a typical cross section with the slip mechanism used for slope design.
