Landslide and Uplift of River Bed in Tal Valley, Garhwal Himalaya

SUMMARY In January 1990, a landslide occurred in Tal Valley of Garhwal Himalaya which caused uplift of the river bed by 6-8 m (upto April, 1990). Initially the rate of rise was 2 cm per day which gradually decreased, however, the process is still continued. A detailed geological and geotechnical studies of the area revealed that the slope mass movement was a rotational sliding with slumping triggered by heavy rainfall. The gravitational forces exerting upon highly weathered and sheared material formed a slip surface in the upper part of the slope which is terminating below the river bed. The paper highlights the mechanism of the slide which has been found directly related to the rise of the river bed.

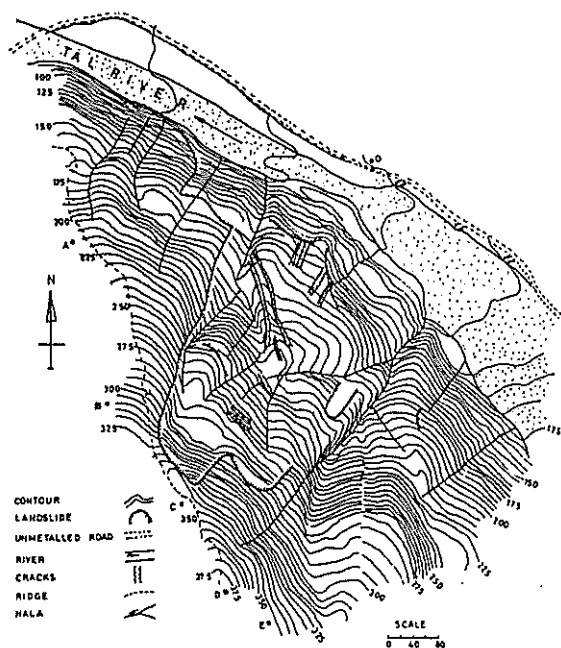
Figure 1 Map of slide area

In the middle portion of the slope, the landslide activity has resulted into development of numerous cracks mostly longitudinal or transverse to the slope. The length of the cracks varied from 10 m to 150 m, whereas width varied from few cms to 1 m and depth from 2 to 4 m. Many minor cracks obliquely branching out from the major cracks were also present. During the course of survey, it was observed that the areas lying between the cracks commonly showed several slumped portion clearly indicating subsidence of the slope. In spite of the fact that the slope was reasonably well vegetated, yet it was marred by tilted and uprooted trees.

In order to have better understanding of the sliding phenomenon in this region, it was planned to carry out detailed scientific investigations of the area. It involved detailed geological, geomorphological and geotechnical surveying and mapping of the area, monitoring the rise of river bed and displacements in cracks. A contour map alongwith the location of slide boundary and major cracks was prepared (Fig.1).

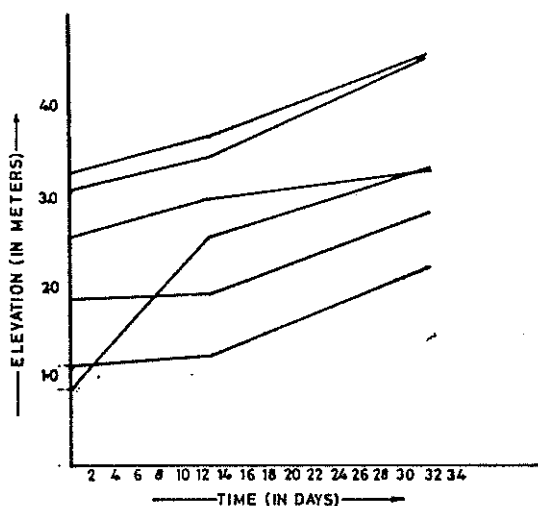
Figure 2 Rise of river bed with time

Iron distance meter, from a fixed bench mark. The observations were taken at different time intervals for assessing the horizontal and vertical displacements. The analysis of the monitoring data clearly exhibits that there was no considerable movement in the horizontal direction, whereas there was significant change in vertical direction. Due to the rise of river bed, most of the markers fixed on the outer profile of the uplift portion got covered with debris and some tilted forward. The angle of tilt varied from 7 to 45 degrees. The rise of different portions of the river bed was found to vary from 0.75 to 2.5 meters in thirty days indicating an average rate of rise of 1.5 cm/day (Fig.2).

The monitoring data confirming the rise of river bed has led to the conclusion that the area is still rising, though it is not uniform throughout. The river bed material being very loose almost without any cohesion could not resist the stresses which are pushing up the material. The counter resistance of the rocks below the river bed must have been responsible for the uplift. Hence the uplift of the river bed is directly related of the nature of the slide.

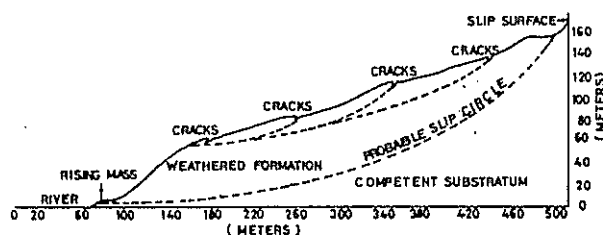
Figure 3 Section showing mechanism of slide

This is a successive rotational landslide in the weathered rock formation consisting of sandstones interbedded with Shales (Fig.3). Evidence of sliding at the interface of shale and sandstone are prominent & large displacements have been inferred due to presence of slickenside surfaces.

It has also been observed that just at the interface of sandstone and shale the particle size of clay material is very fine which indicates that initially because of breakdown of bigger particles proportion of the clay size fraction at the boundary tends to decrease but later on clay fraction records marked increase, as could be expected corresponding to large movements (Mehrotra, 1988). The another important feature is wet conditions of clay surface which indicates high water retaining capacity and obstruction to the water flow causing high pore pressure for sliding to take place.

The evidences produced by the formation of successive layers clearly point towards successive rotational failure of weathered rockmass overlying a hard substrata.
