# Beanpole Corner Landslide Stabilisation

G.J. SAUL

Senior Engineer, Works Consultancy Services Ltd

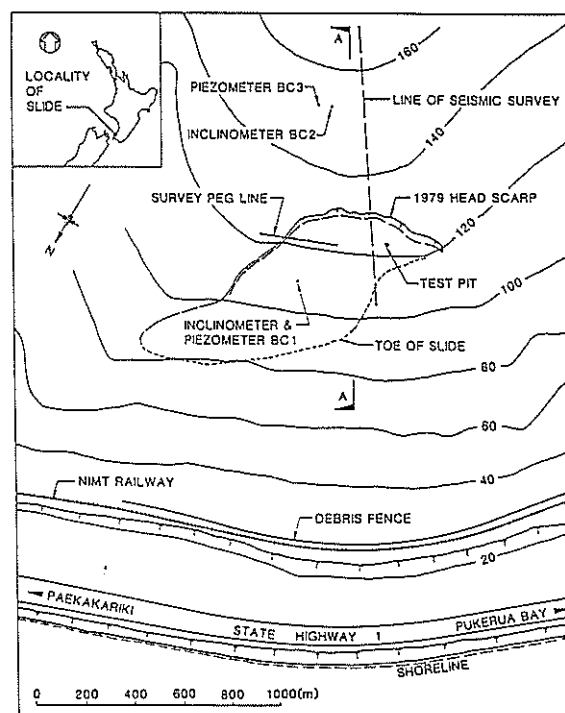
Figure 1 Plan of Landslide Area.

The Beanpole Corner slide is a shallow rockslide located on a broad spur above the railway line. The landslide has a long history of instability which started before 1940 as a small slide just above the railway line and progressed 65 m up the rock slope in a series of failures, one of which derailed a freight train in the 1960s. During 1979, a portion of the slide is believed to have moved up to 5 m during or following a period of heavy rainfall and continued creep movement was observed. This portion was located on the head slope immediately above the steeper rockface, 65 m above the railway. The positions of these features are shown in Figure 1.

The position of these investigations and instruments is shown on Figure 1.

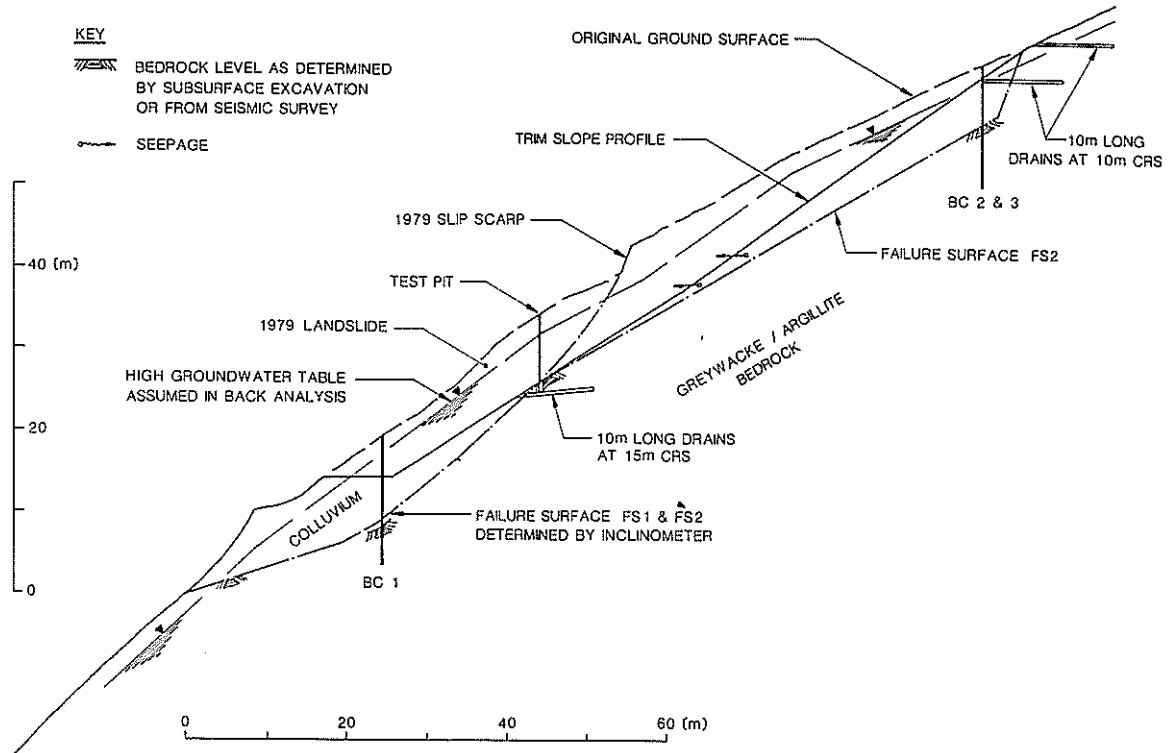
Figure 2 Cross Section A-A through Landslide.

The location and geometry of the active failure surface was determined from the results of both investigations and monitoring, with inclinometer results providing the most valuable data. The failure plane was believed to lie within the thick silty clay layer. Figure 2 illustrates the section geometry adopted for slide analysis and remedial works design. Total slide volume was estimated at 30,000 m<sup>3</sup>.

A geotechnical model of the slide was established which comprised ground topography based on available survey data, the failure surface geometry derived from subsurface geological observations and surface mapping together with material strengths derived from back analyses of the slide. The model is illustrated in Figure 2.

Back analysis assuming limiting equilibrium conditions and two different piezometric cases (dry and wet slopes) were used to determine material shear strength parameters for remedial work design because materials in the slide base were variable and it was not possible to establish shear strength with certainty. The piezometric line assumed for the wet slope case is shown in Figure 2. These analyses yielded the following effective shear strength parameters:

The "wet slope" parameters were considered more representative of the materials observed and high ground water conditions inferred during the movement event. Therefore the wet slope strength parameters were adopted for final design. Limit equilibrium analysis of the geotechnical model was carried out using the vertical slice Sarma method (1). The stability analysis results for the following three cases are presented in Table 1:

Drainage is generally more cost effective than earthworks for improving slide stability. However, because of the uncertainties in the specific relationship between slide movement and groundwater pressure, uncertainty in level of control achievable with drainage, and the possibility of progressive upslope development of the slide, slope trimming was adopted as the primary means of stabilizing the slide. The extent of slope trimming was determined from analysis and is illustrated in Figure 2.

Slope trimming involved a 60 m high cut at a grade of 1.4H to 1V and removal of 31,000 cubic metres of material. Earthworks were carried out between January and September 1990. Material was cut from the slope and pushed into and down a side gully to the railway line where it was loaded out by trucks to a dump site. Excavation was halted while trains passed beneath the site because of the steep slopes and potential for boulders loosened by construction to roll downslope and bounce over the debris fence onto the railway.

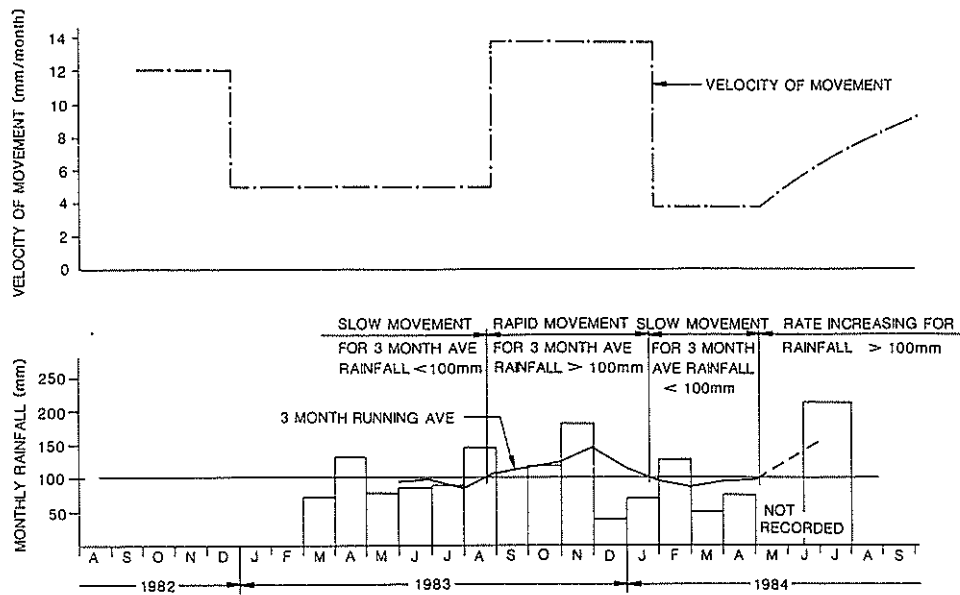
Figure 3 Graphs of Slide Velocity and Rainfall.

Accurate determination of piezometric levels was not achieved from the pneumatic piezometers although water was observed seeping into the test pit at 5 m depth. Correlation of slide movement with rainfall indicated that increased movement occurred when the three month average rainfall exceeded 100 mm, which suggested a link between slide stability and piezometric pressure. Figure 3 illustrates the correlation developed.

The movement history prior to 1982 is uncertain although there is anecdotal evidence of a slide displacement of up to 5 m following heavy rain in 1979. Monitoring of slide movement using survey pegs began in mid 1982 and Figure 3 illustrates the history of movement up to 1985, and the relationship between rainfall and slide velocity. Movement continued at an average rate of 70 mm/year from 1985 to 1989. Inclinometer BC1 in the active slide was sheared off in December 1983 after 70 mm of deformation in 11 months. Inclinometer BC2 confirmed that the slope
