The leaning tower of Pisa: End of an Odyssey

M.B.Jamiolkowski - Technical University of Torino, Italy

This paper describes the geotechnical stabilisation of the Leaning Tower of Pisa carried out in the period 1990-2001 by the International Committee for its safeguard and consolidation.

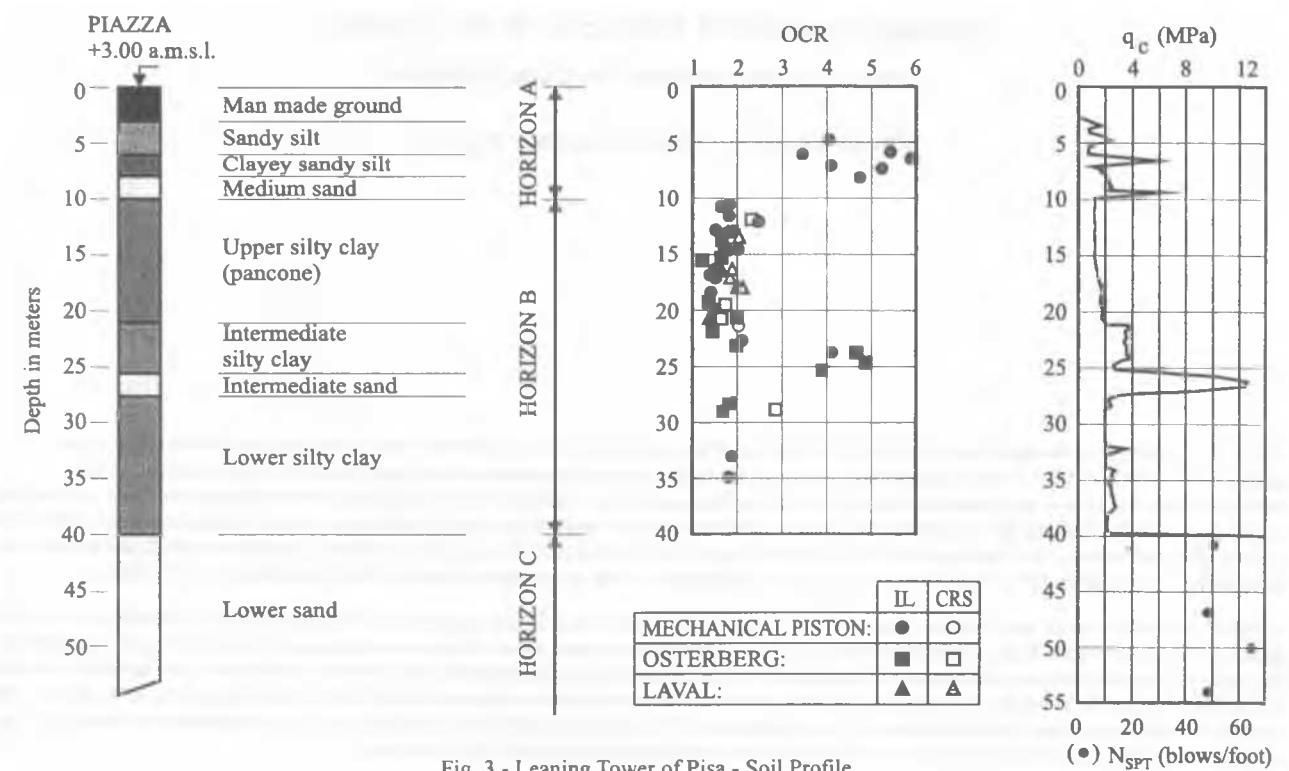
Fig. 3 - Leaning Tower of Pisa - Soil Profile.

Fig.3 shows the soil profile and a typical CPT profile representative of soil conditions in the proximity of the tower. Three distinct horizons can be recognised: Horizon A, approximately 7 m-thick estuarine deposits, laid down in tidal conditions, of sandy and clayey silts having at the bottom, a 1.5 to 2 m thick layer of fine sand. Based on the samples retrieved from the borings and on piezocone tests results, this sand layer becomes more silty-clayey and thinner from the North to the South edge of the plinth (Fig.4).

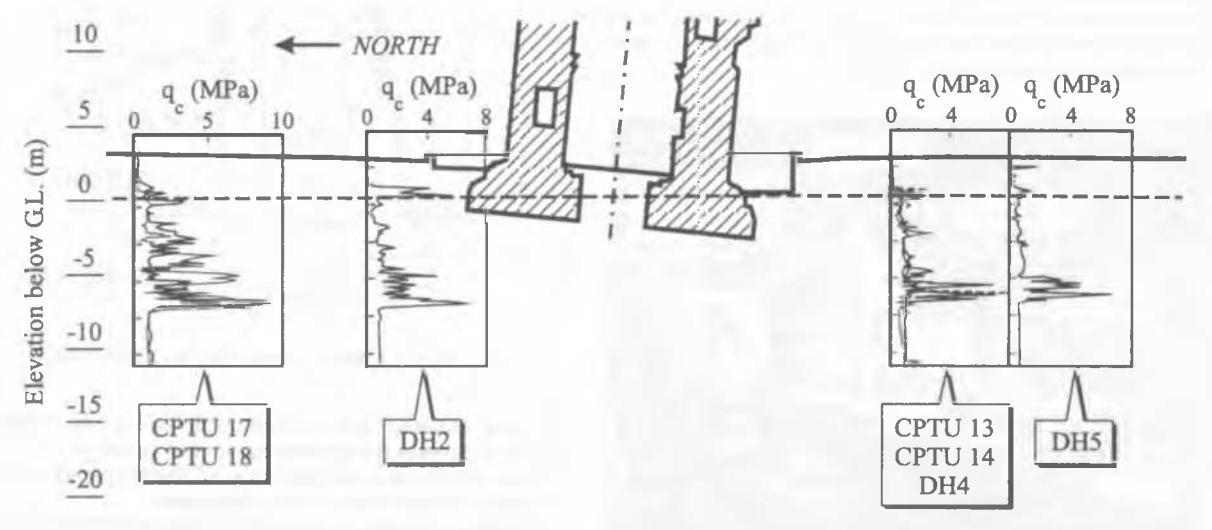
Fig. 4 - Leaning Tower of Pisa - Cone Resistance in horizon A, North-South Cross-section

- Spatial variability of soil compressibility and permeability [Terzaghi (1934), Mitchell et al. (1977), Croce et al. (1981)].
- Based on the CPT profiles shown in Fig.4 it can be postulated a higher compressibility of Horizon A at the South side than the Northern one.
- Local bearing capacity failure and the resulting confined plastic nomenon, applicable to the Tower of Pisa, have led concordantly to developed during the second construction stage in the upper Pancone clay B-1, see Fig.6 [Mitchell et al. (1977), Leonards (1979)].

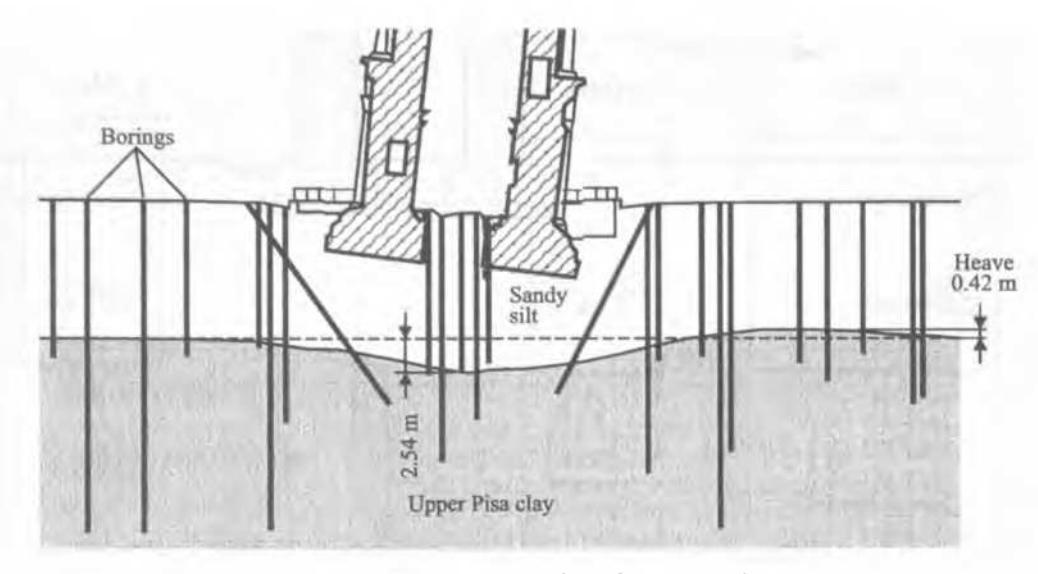
In Fig.7 is shown the soil profile beneath the Tower corresponding to the N-S cross-section. It shows that the contact between Horizon A and Pancone clay, which is horizontal under the entire Piazza, under the Tower has a dish-shape depression just beneath the plinth indicating that the average settlement at the contact between the two formations is close to 2.5 m. Moreover, if we take into account the best estimate of what could have been the average settlement of the soils belonging to Horizon A, we end up with an overall average settlement of the Tower around 3.0 m. An upheaval of the Pancone clay with a magnitude of 0.4 m is also evident at the South side (Fig.7), testifying that at some stage during its construction, the Monument approached a situation very close to the bearing capacity failure.

Fig. 7 - Settlement and heave of surface of upper Pisa clay.

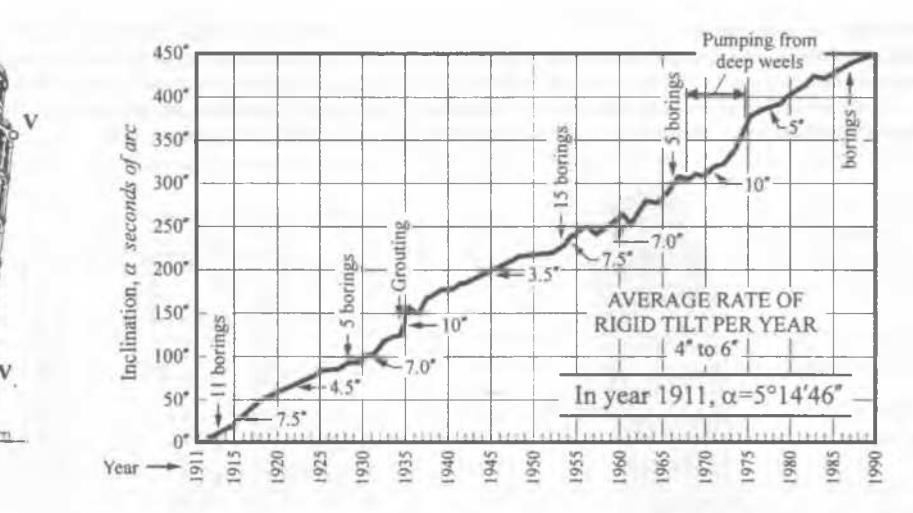
The modern monitoring of the Tower's inclination started in 1911, see Fig. 10. Ever since, the Tower has continued to increase its tilt, at a slightly increasing rate. In fact, according to Burland (1990) who attempted to subtract from the measured inclination the effects of perturbations due to environmental changes and to various anthropic activities performed around the Tower, the rate of inclination per annum increased from 3" in the forties to 5" to 6" in late eighties.

Fig. 10 - Inclination of Leaning Tower of Pisa.

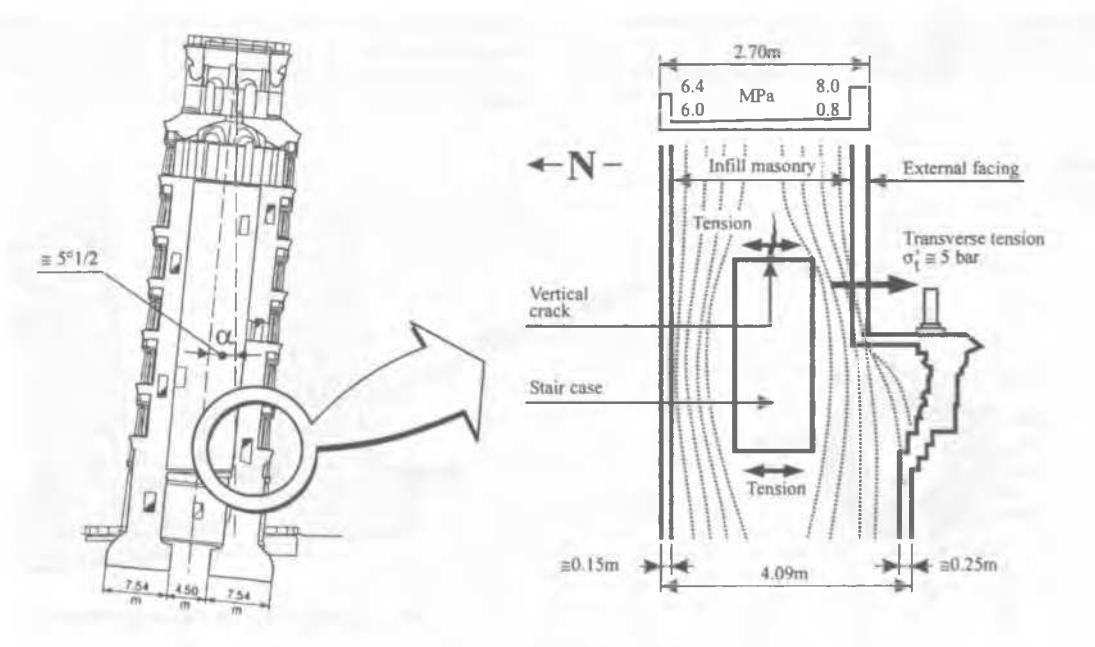
Moreover, in 1989 the Governmental Committee declared the scarce safety margin of the Monument with respect to a possible masonry collapse of the most severely stressed South section of the tower between the 1st and 2nd cornice. In this section of the masonry very high compressive stresses exist in the external (>8 MPa) and internal facings (>6 MPa) (Fig. 15). In addition:

- in correspondence of the first cornice, the heavy stressed external facing is laying directly on the infill masonry (Fig.15);
- there is an obvious weakening of the tower shaft due to the opening of the stair case;
- voids and cracks in the infill masonry as well as lack of the bond strength between it and facing (Fig. 16);
- severe stress concentrations in the bedding joints of the marble stones of the facings (Fig. 16).

Fig. 15 - Leaning Tower of Pisa - Critical section of the masonry.

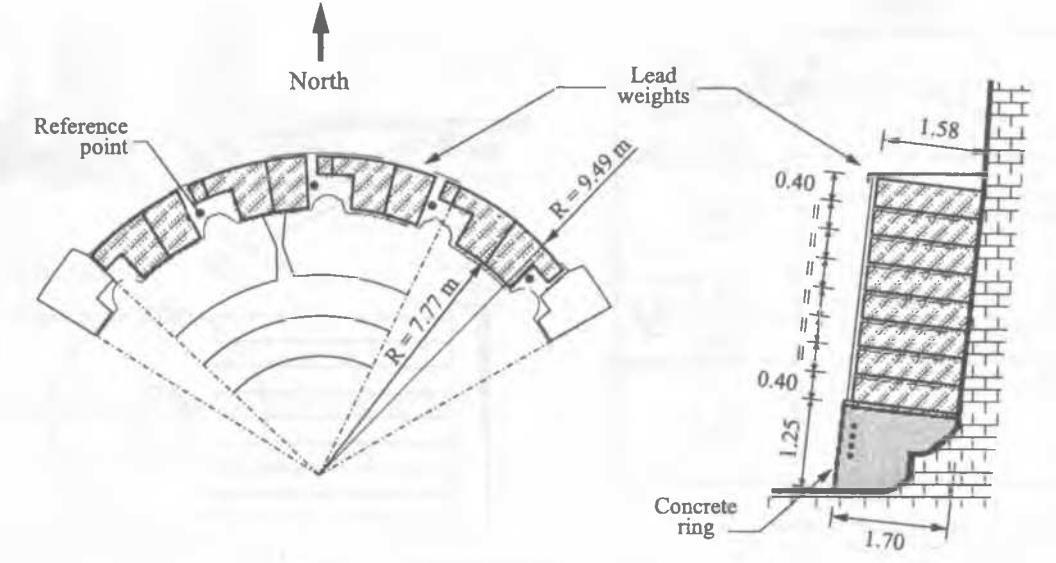
Fig. 19 - Counterweight on North edge of Tower plinth.

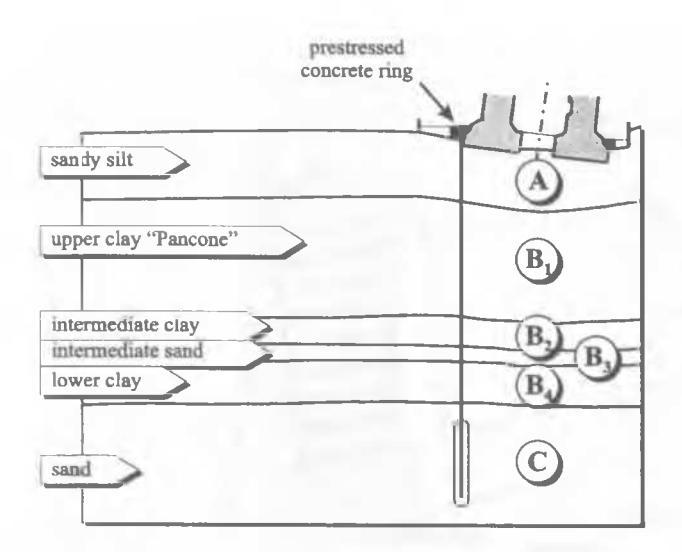
Fig. 21 - Ten Anchors solution.

In view of the positive response of the Tower to the counterweight, and to overcome its visual impact, it was decided to replace the lead ingots by ten deep anchors having each a working load of 1000 kN (Fig.21). This intervention was conceived as an intermediate measure between the temporary and the final one.

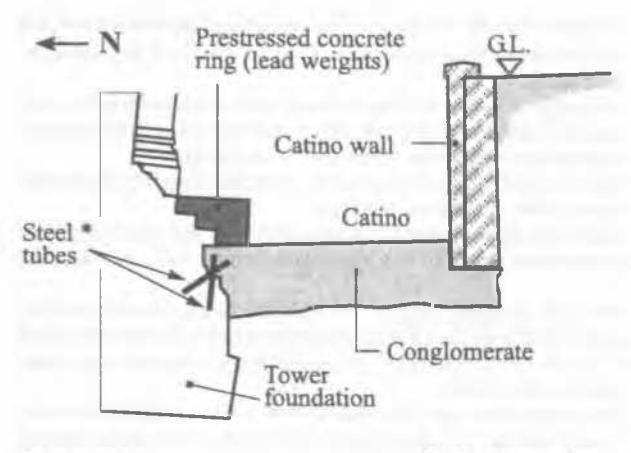
During the implementation of this solution it was discovered that in the past there had been two attempts to enlarge the Tower foundation:

- The first, probably due to Della Gherardesca, who during the construction of the catino, placed around the Tower plinth a 0.7 to 0.8 m thick layer of conglomerate having the same width of the catino.
- The second was implemented by the local authority for public works that in mid thirties had redone the catino. During this intervention, involving the cement grouting of the Tower plinth, the under-catino conglomerate was connected to the foundation by means of steel tubes 70-mm in diameter and approximately 700 to 800 mm long. Information about this work was never reported in the official documents and was unknown to the professionals dealing with the Tower until the summer of 1995.

Fig. 22 - South section of Catino - Configuration in year 1993.

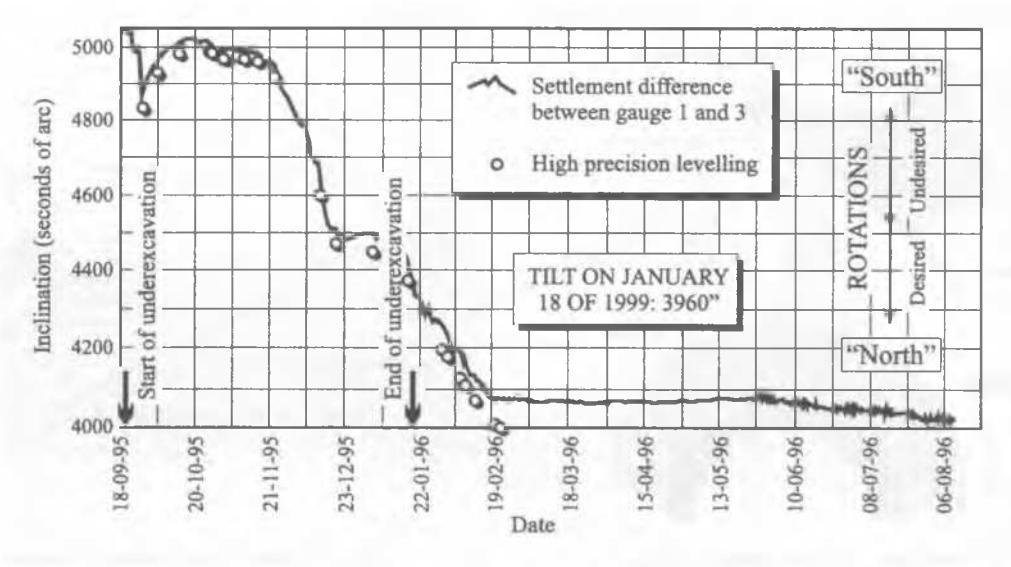
Fig. 27 - Underexcavation Field Trial - Inclination of Plinth in Plane of Maximum Tilt.

and was loaded eccentrically with concrete blocks. Both the footing and the underlying soil were heavily instrumented to monitor settlements, rotations, contact pressure and the induced excess pore pressure during the experiment. After a waiting-period of a few months allowing to develop the major part of consolidation settlements, the ground extraction was started by means of inclined borings 168 mm in diameter, as schematically shown in Fig.26. The underexcavation was performed by removing gradually the soil from Horizon A through a procedure, shown in Fig.26, that made it possible to reduce the inclination of the trial plinth by almost 1000" of arc, as documented in Fig.27.

- A critical penetration exists under the plinth and if the extraction hole exceeds it a rotation of the foundation in the undesired opposite direction is experienced, occurrence that happened in September 1995 as can be detected from Fig.27.
- By means of an appropriate sequence of ground extraction operations it was possible to steer the plinth movements both in N-S and W-E plan as required.
- On February 1996, soon after the completion of the underexcavation, the trial plinth came to rest and up to January 1999 exhibited only negligible movements.

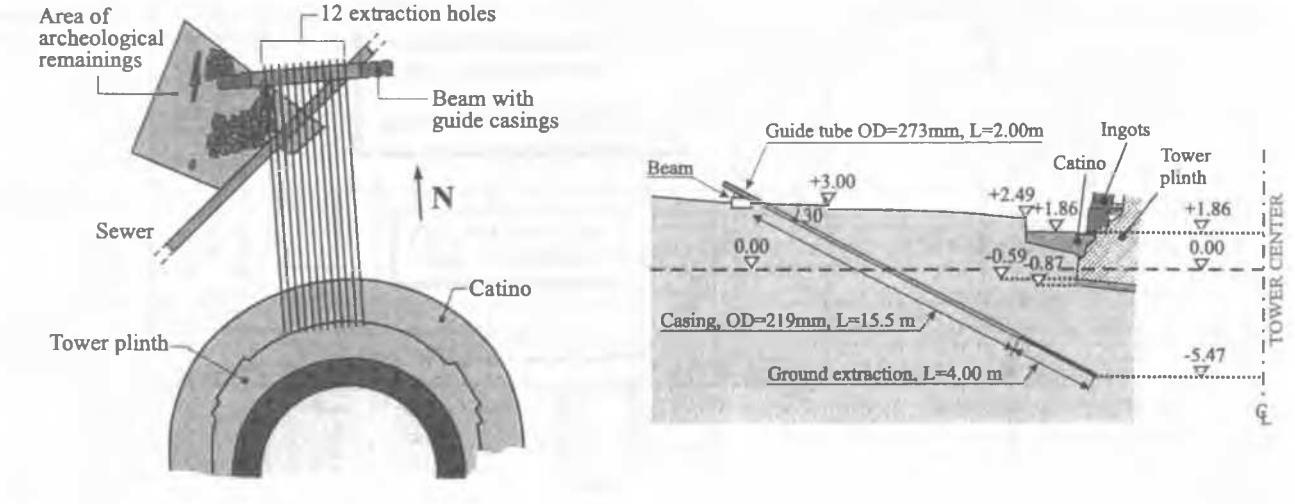
Fig. 29 - Preliminary underexcavation scheme.

The preliminary intervention started on February 9th, 1999. It was completed on June 6th, 1999. All together 7 m³ were extracted from the twelve holes shown in Fig.29. Out of this value only $\cong 1.2$ m³ were dug out under the plinth and the remaining volume under the catino. The maximum penetration of the central extraction holes (Fig.29) under the North edge of the foundation was limited to 1.5 m.

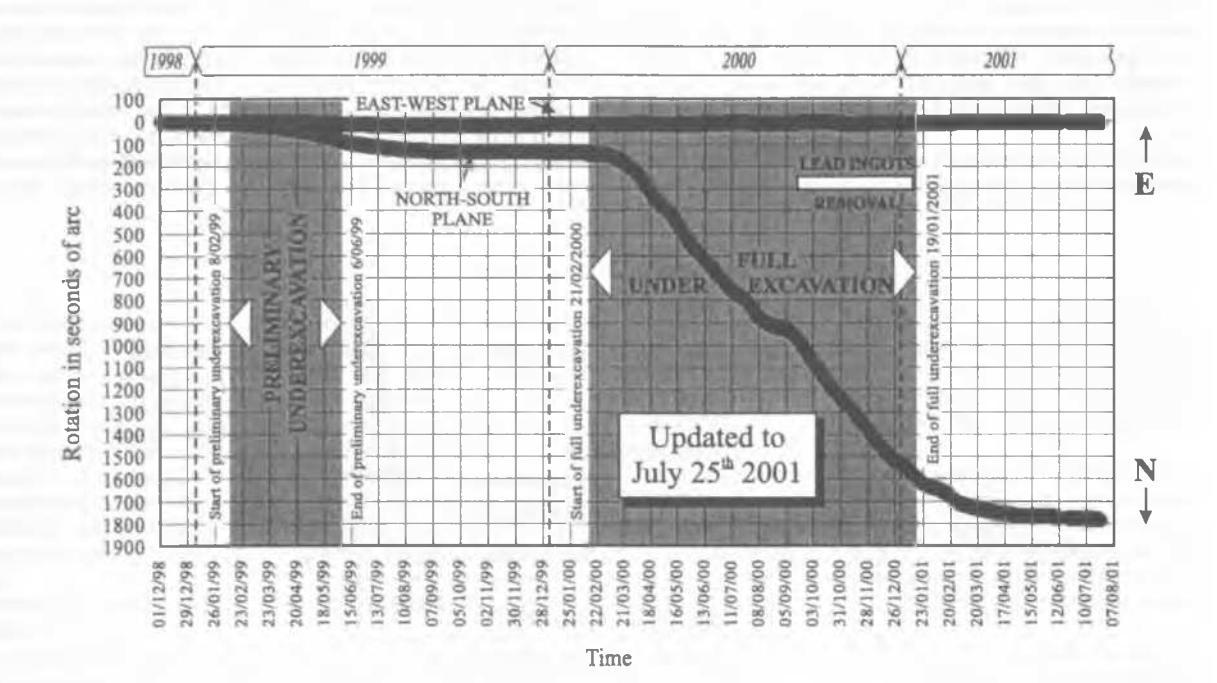
The Tower responded satisfactorily in terms of observed rotations and settlements to the preliminary underexcavation, see Figs.32 and 33, from which one can infer the following:

The response of the Tower to the final ground extraction is summarised in Figs. 32 and 33. At the end of this intervention the inclination of the Tower was further reduced to 1621 seconds of arc. Ever since in absence of ground extraction the Tower continued its rotation Northward approaching in July 2001 the value 1788 seconds. If we add the 54 seconds resulted from the lead counterweight, the total reduction of the inclination reached 1842 seconds, which corresponds to a reduction of 446 mm of the overhang, one tenth of the value recorded in 1993. During the preliminary and particularly during the massive underexcavation the Tower resulted, for all practical purposes, motionless in the East-West plane. During the massive ground extraction, see Fig.33 the South edge of the plinth further rose and reached the value of $\cong 12$ mm confirming the extremely positive response of the Tower to the adopted stabilisation measure.

Fig. 32 - Tower, rotation during underexcavation.

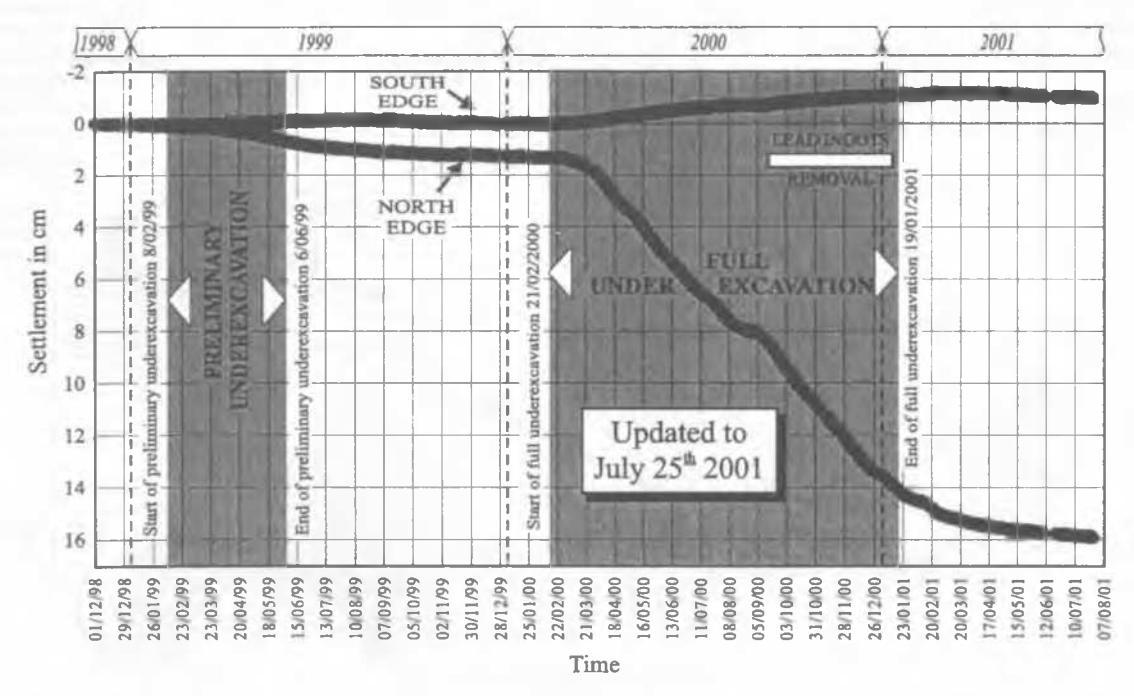
at 12 mm, see Fig.33. The observed behaviour evidentiated two positive phenomena: a) the point of instantaneous rotation is located within the imprint of the plinth; b) as a consequence, a small reduction of contact stresses under the highly stressed Southerm edge of the foundation occurs.

Fig. 33 - Settlement of Tower plinth during underexcavation.

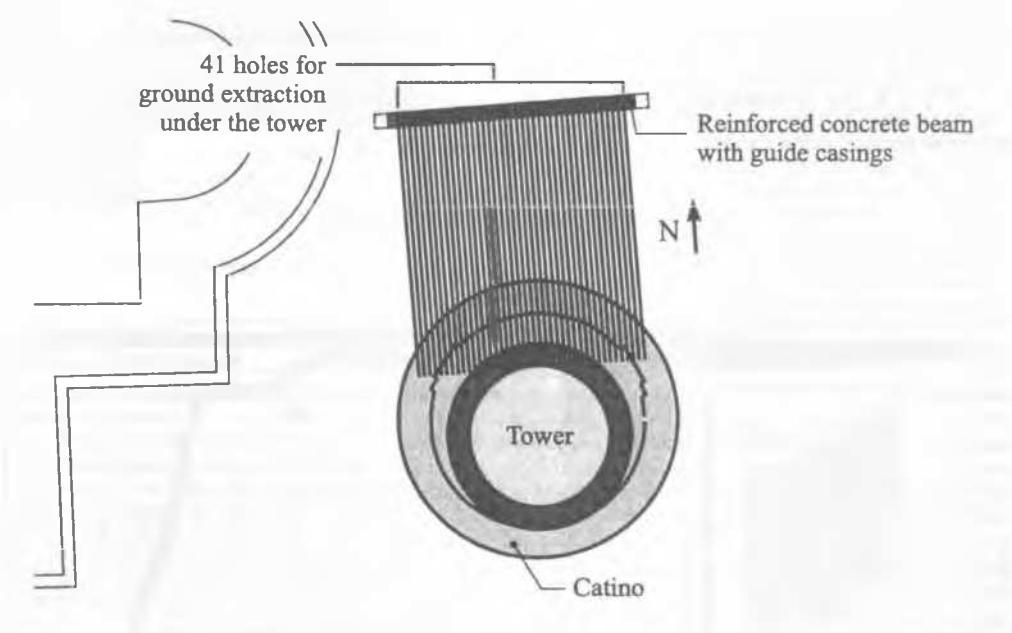
Fig. 34 - Final underexcavation scheme.

In view of the encouraging response of the Tower to the preliminary intervention, the Committee carried out the full underexcavation aimed at reducing the Tower's inclination by 1800 seconds of arc. The intervention was started on February 21st, 2000 and was performed using 41 extraction holes, as shown in Fig.34.

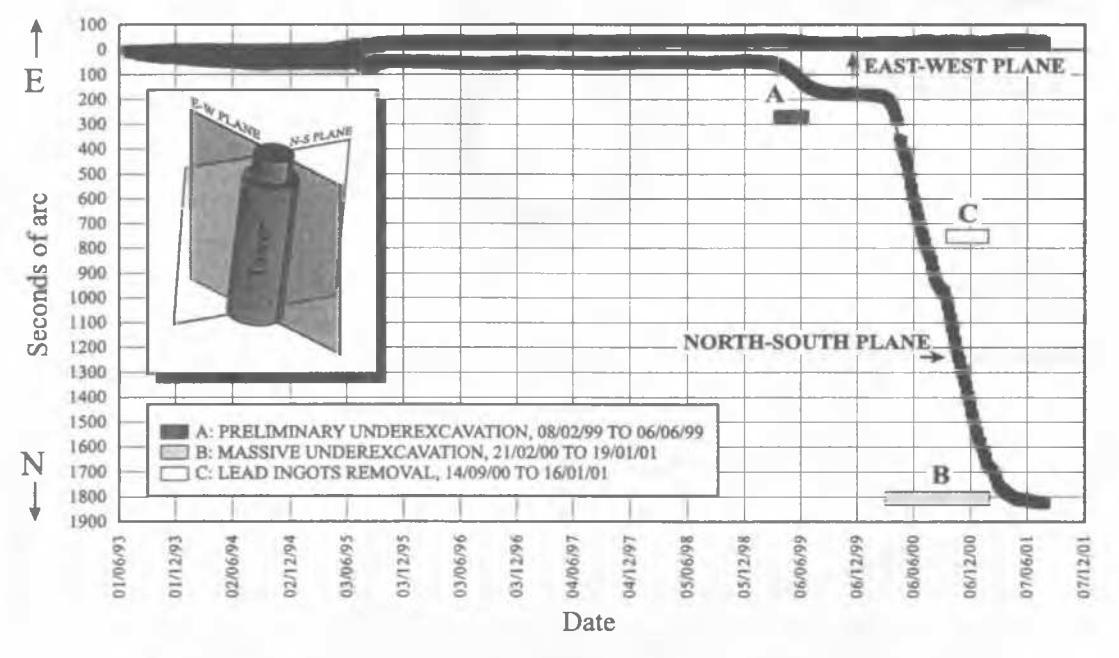
During the final underexcavation, the Tower was cleared from the lead ingots and all the other temporary interventions. Fig.37 summarises the overall reduction of the Tower inclination as result of all the intervention implemented by the Committee since 1993.

Fig. 37 - Rotation of Tower plinth during stabilization interventions.
