# Failure paths for levees

Final draft

December 2021

PREPARED BY  
Technical Committee on  
Geotechnical Aspects of Dikes and Levees  
(TC201)

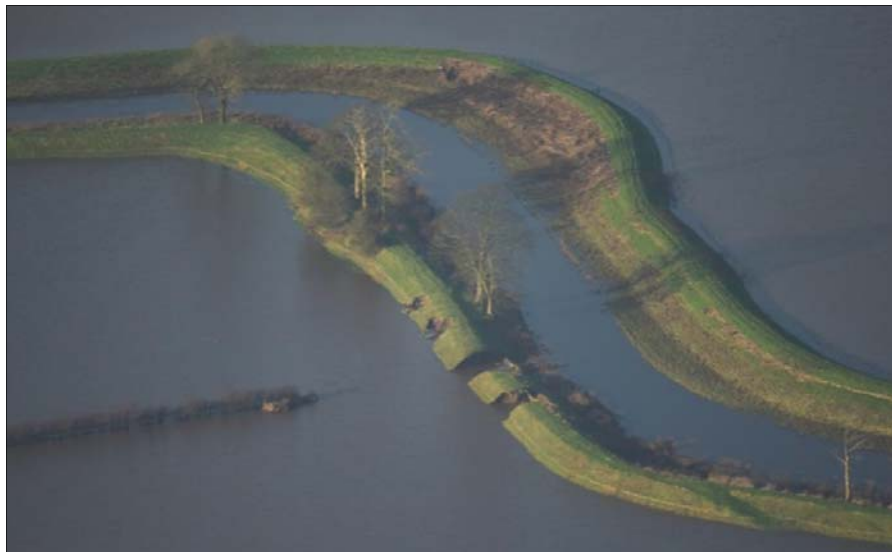
The breach occurred in the UK in 2015 following a period of heavy rain during a named storm event.

Figure 3.2 Photograph of the situation.

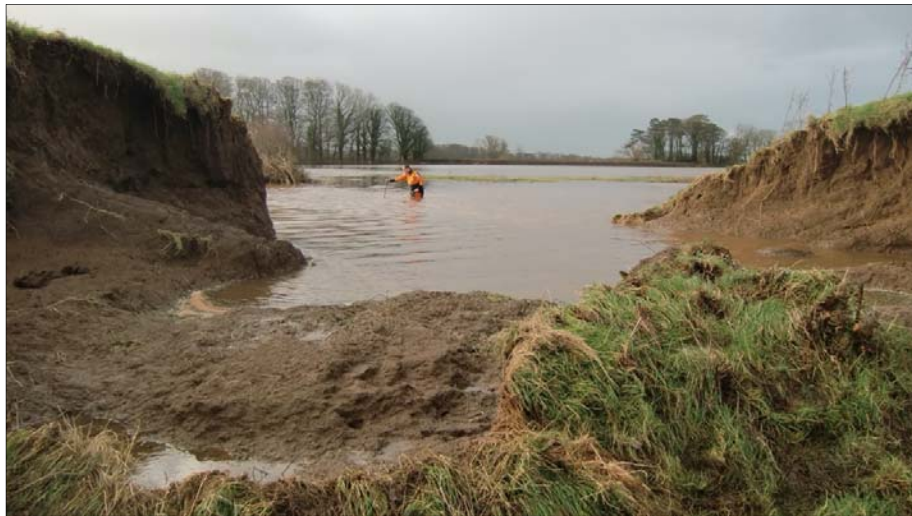
The flooding resulting from the breach, affected approximately sixteen properties and a large area of agricultural land. A scour hole of up to 10 m depth was caused by the flow through the breach.

Figure 3.3 Photograph of the breach.

A forensic review of recent LiDAR images showed that the original crest level at the location of the breach was up to 100 mm lower than at surrounding areas. Furthermore, the location of the breach was underlain by both an in-filled historical meander and an old field drain. It is likely that the localized settlement of the crest in the vicinity of the breach was originally caused by consolidation of the in-fill material in the old meander. This meant that the crest level at this location was lower than at surrounding areas; overflow at this location caused rapid external erosion of the levee because of the steepness of the landward slope, about 30 degrees, the quality of the levee fill material (erodibility) and the lack of a landward berm.

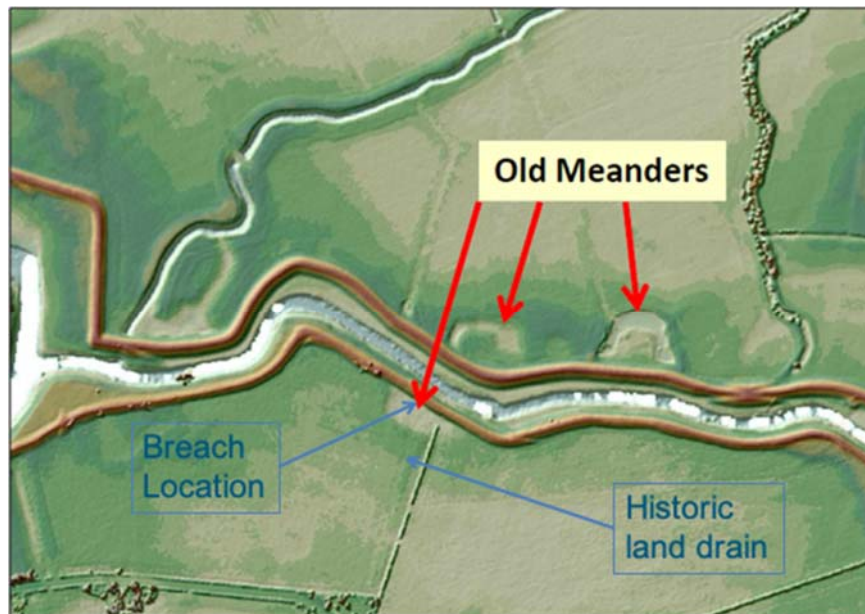
Figure 3.4 Overview of the situation.

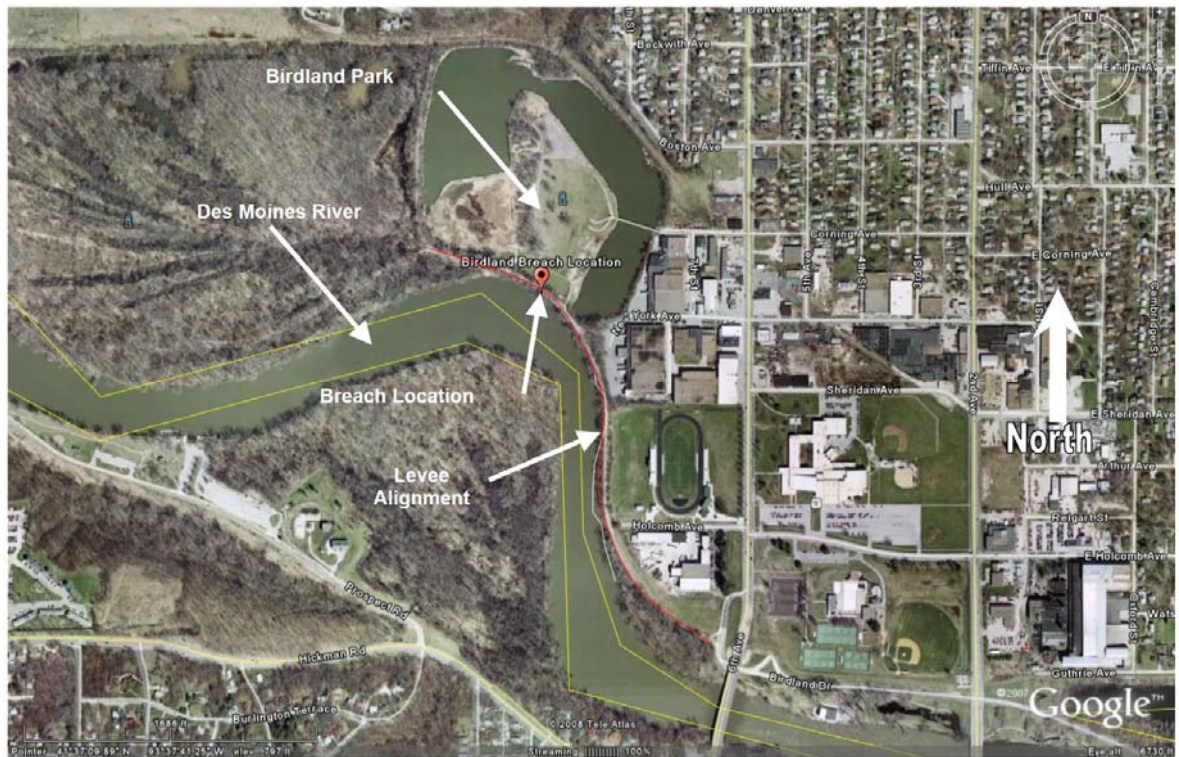
The report predicted that, in the levee's current state of disrepair, there was a 50% chance of failure for a 50-year flood event. By 2008, only a few minor improvements had been funded.

Figure 3.17 Location of the Birdland Levee breach (taken 2007).

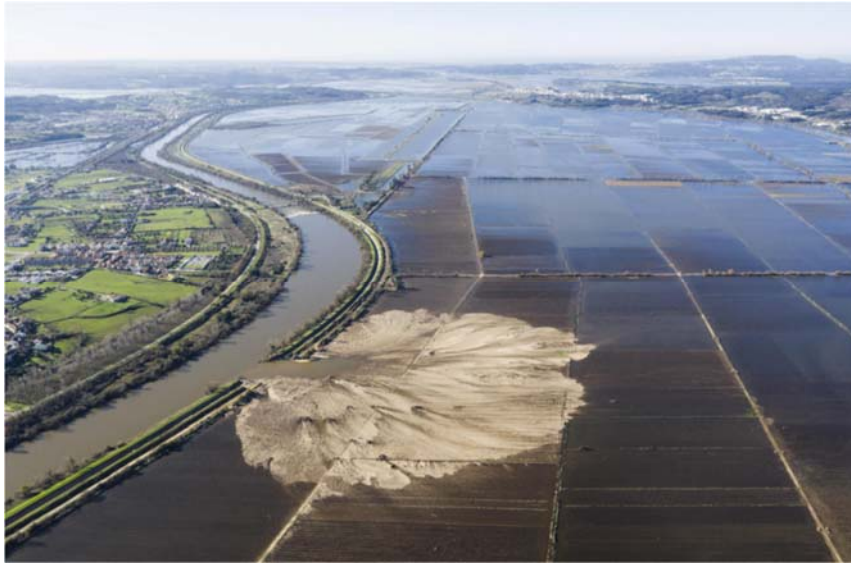
The collapse led to the flooding of the fields in the Central Valley of the Lower Mondego and the cutting of communication routes. Infrastructure was severely damaged, not only the embankment but also the road and the conducting channel at the right bank, for the water supply of agriculture and industries.

Figure 3.20 View of Santo Varão shortly after collapse of the embankment <sup>4</sup>.

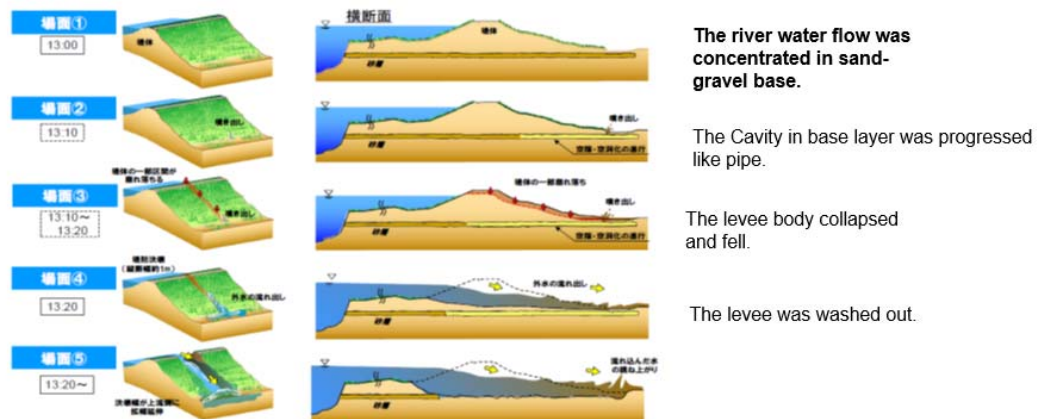
An example of levee failure due to piping erosion is illustrated below for a case on the Yabe river in 2012. In this example the high-water event caused erosion in a sand gravel layer at the base of the levee, which resulted in an eroded 'pipe' below the levee base. This resulted in collapse of the levee body and washing out of the levee, see Figure 3.27.

Figure 3.27 Example of piping erosion from the presentation 'Picture-Card Show Project' in JGS-JCES', contribution by K. Maeda, M. Ishihara and H. Mori, using materials from the Ministry of Land, Infrastructure, Transport and Tourism in Japan.

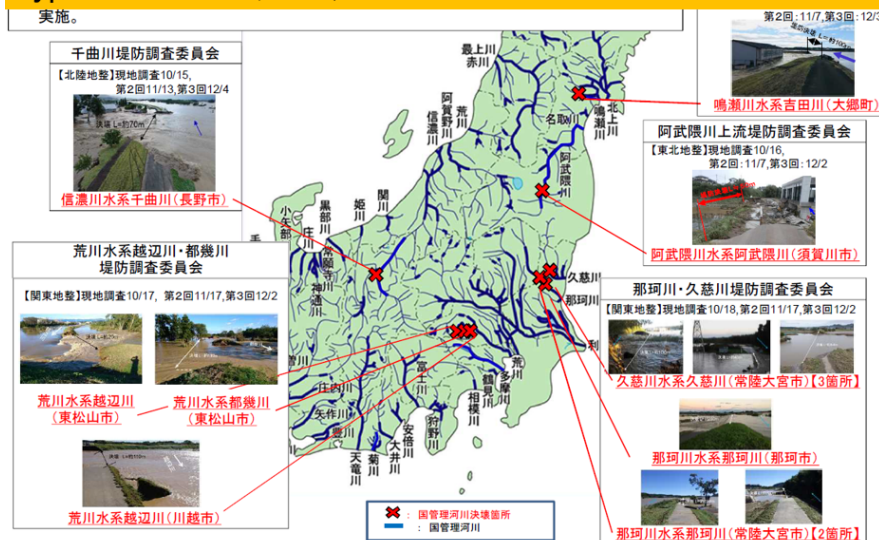
Figure 3.30 Location of overtopping from the presentation 'Picture-Card Show Project' in JGS-JCES, contribution by K. Maeda, M. Ishihara and H. Mori, using materials from the Ministry of Land, Infrastructure, Transport and Tourism in Japan.

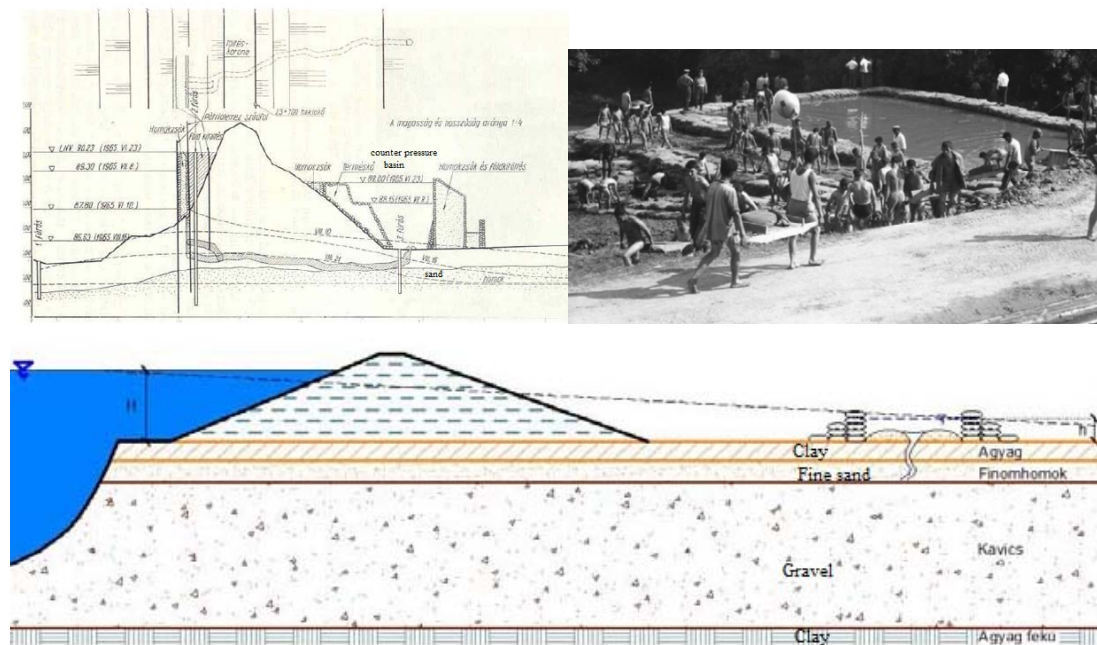
Figure 3.36 Danube, Margitta Island sand boil counter-pressure (top right) and diaphragm walls at the waterside (top left), the cause was the vicinity of an old meander (Garai, 2016). Water level of the counter-pressure basin (bottom).

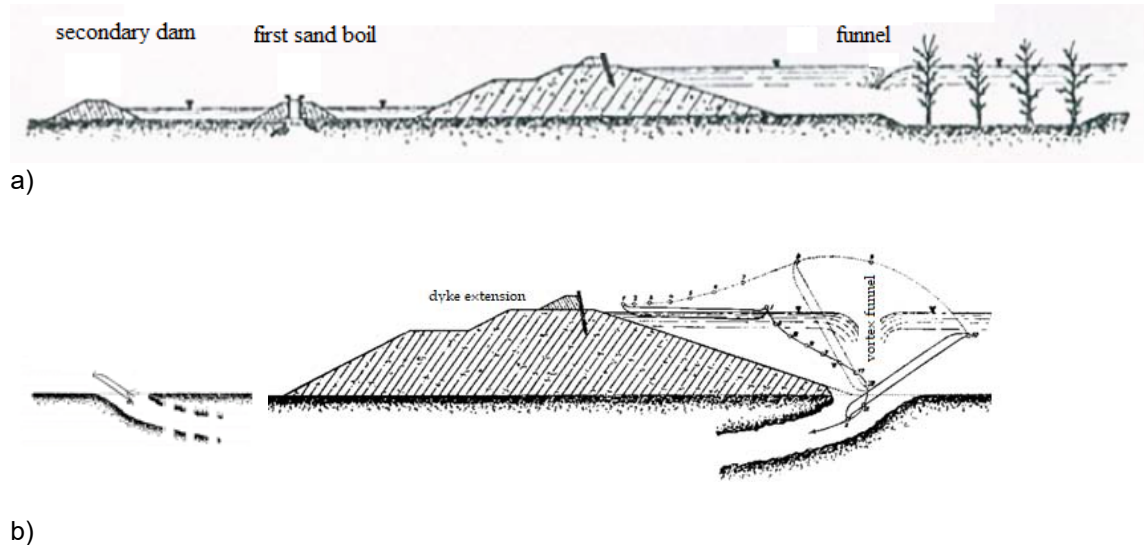
Figure 3.42 Illustration of the boat diving to the pipe, (a) condition some minutes before breach, (b) the path of the boat, which ended on the land side at around the first sand-boil spot.

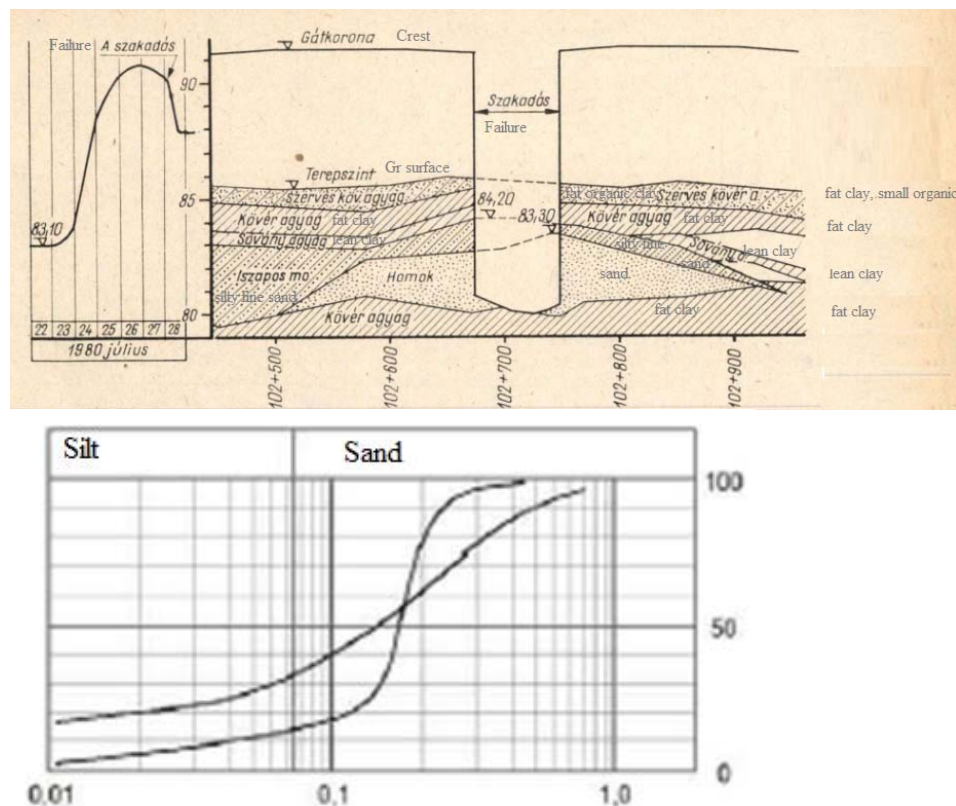
Figure 3.43 Kettős Körös, Hosszúfok in 1980, fast piping failure, failure location at top from (Szepessy, J.(1983)), with time history of flood. Bottom: grading curves, indicating the very loose sand inclusion with  $3 < C_u$  and  $e \sim 0.8$ .

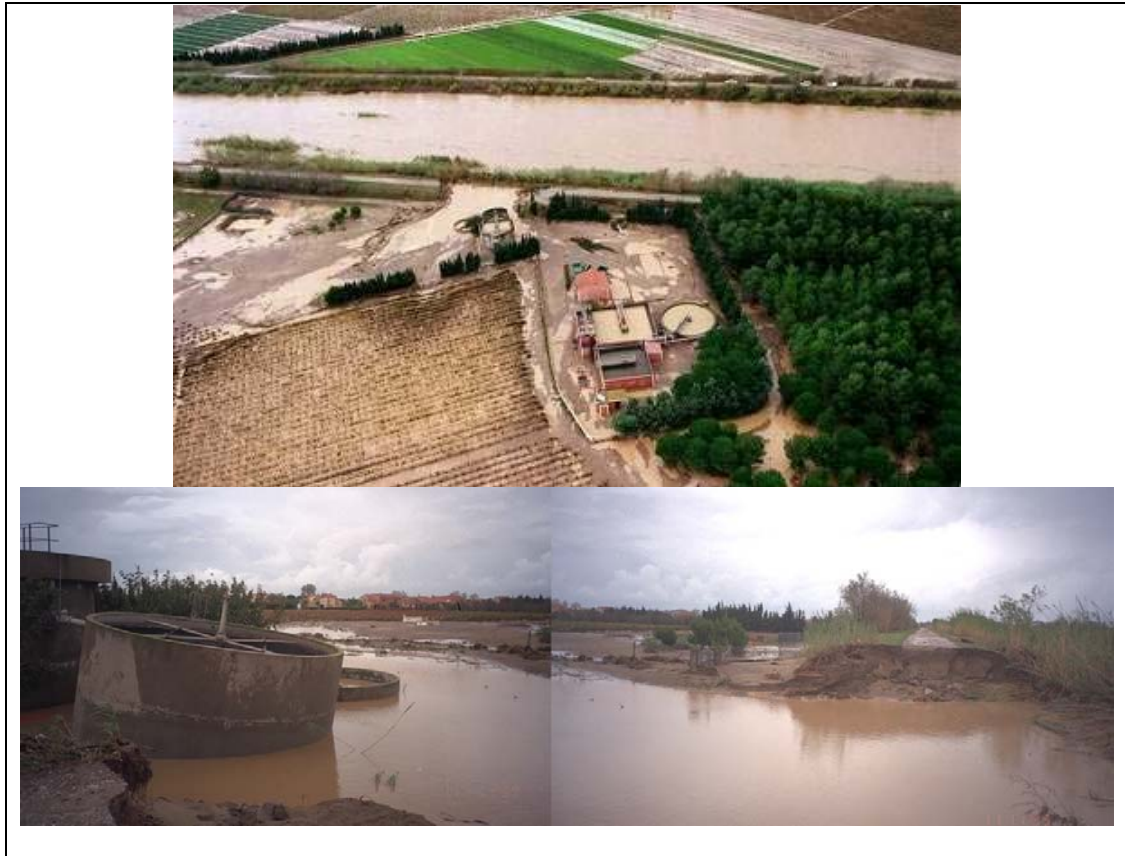
Figure 3.49 Breach in 1999 at St-Laurent-de-la-Salanque.

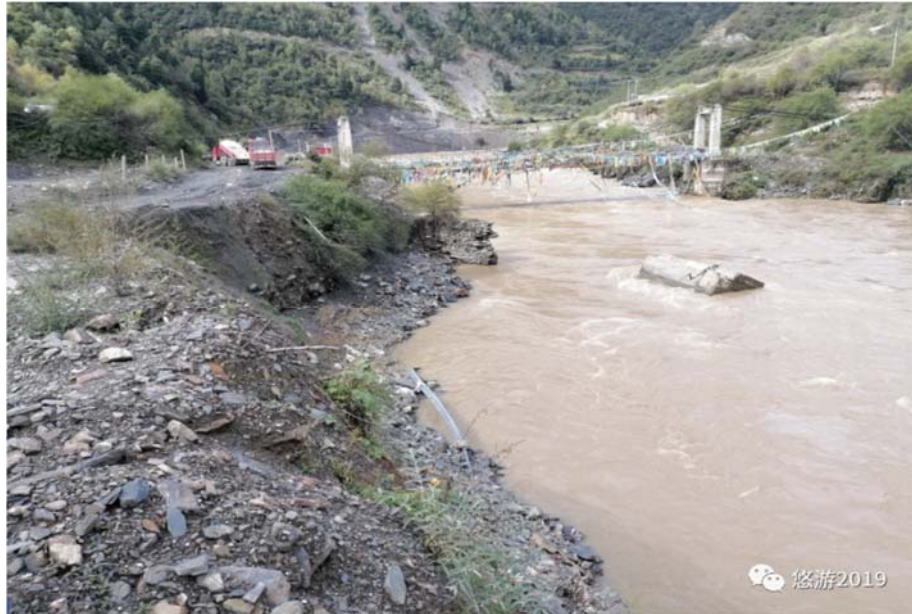
Figure 3.60 Riverbank morphology in the damaged section of retaining wall.

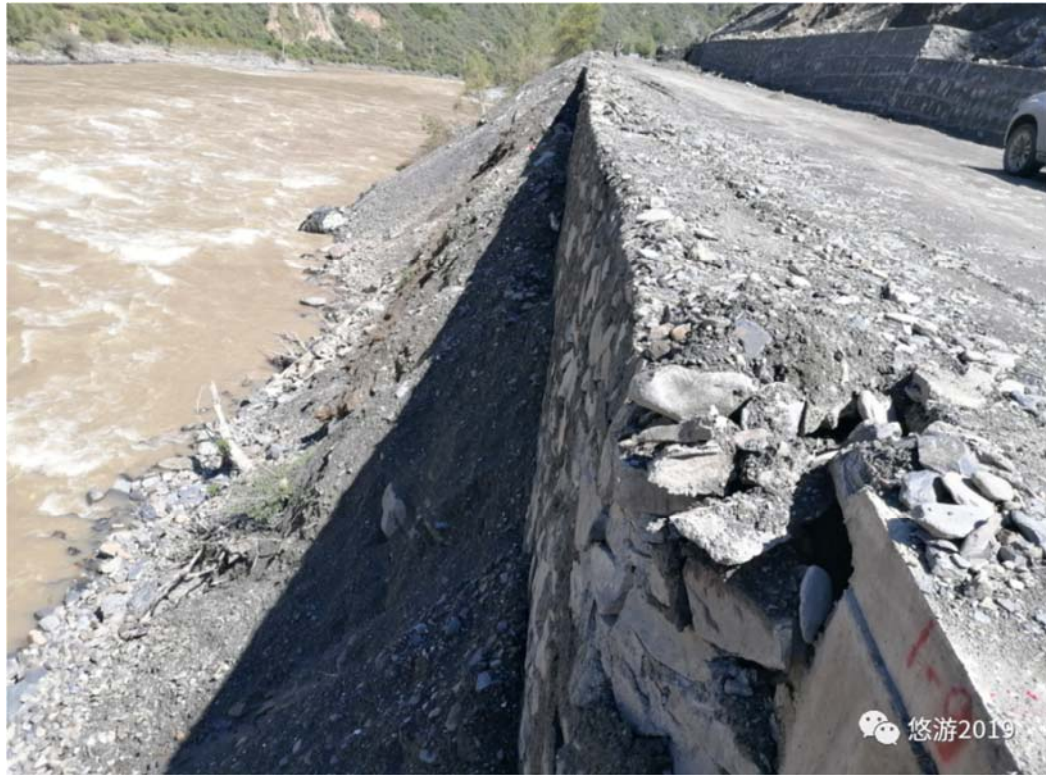
Figure 3.61 Outwards displacement of the bank slope and retaining wall.

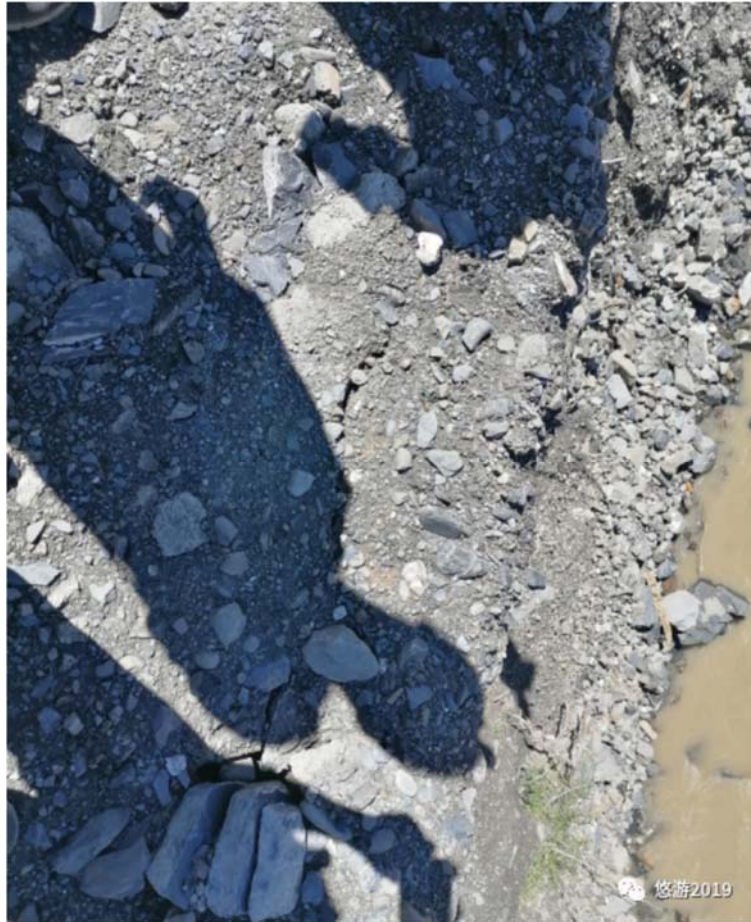
Figure 3.62 Cracking morphology of retaining wall body.

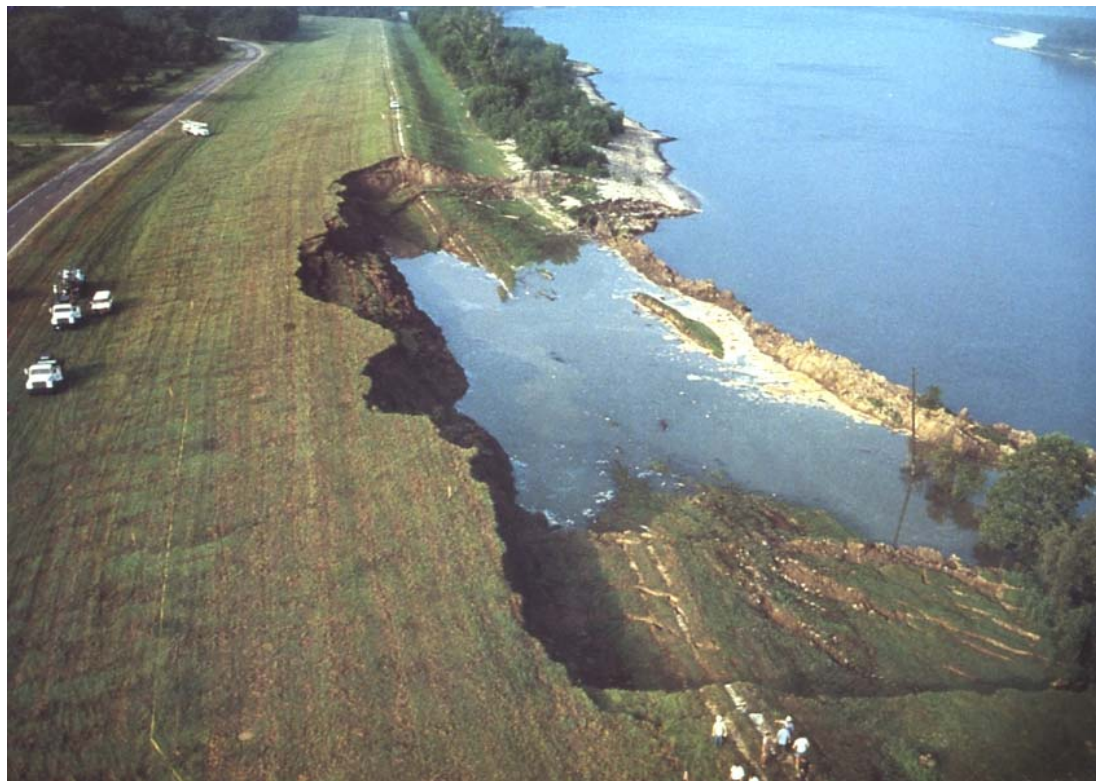
Figure 3.64 Photo: This 210 m section of levee slid into the east side of the Mississippi River on August 23, 1983 at Darrow, in Ascension Parish, Louisiana. The slide occurred shortly after a high-water stage had receded, suggesting that toe undercutting and rapid drawdown likely contributed to the failure.
