Behavior of a Sandy Uniform Soil During the Jaltipan Earthquake, Mexico

by R. J. MARSAL, Research Engineer, Instituto de Ingeniería, Ciudad Universitaria, U.N.A.M., México

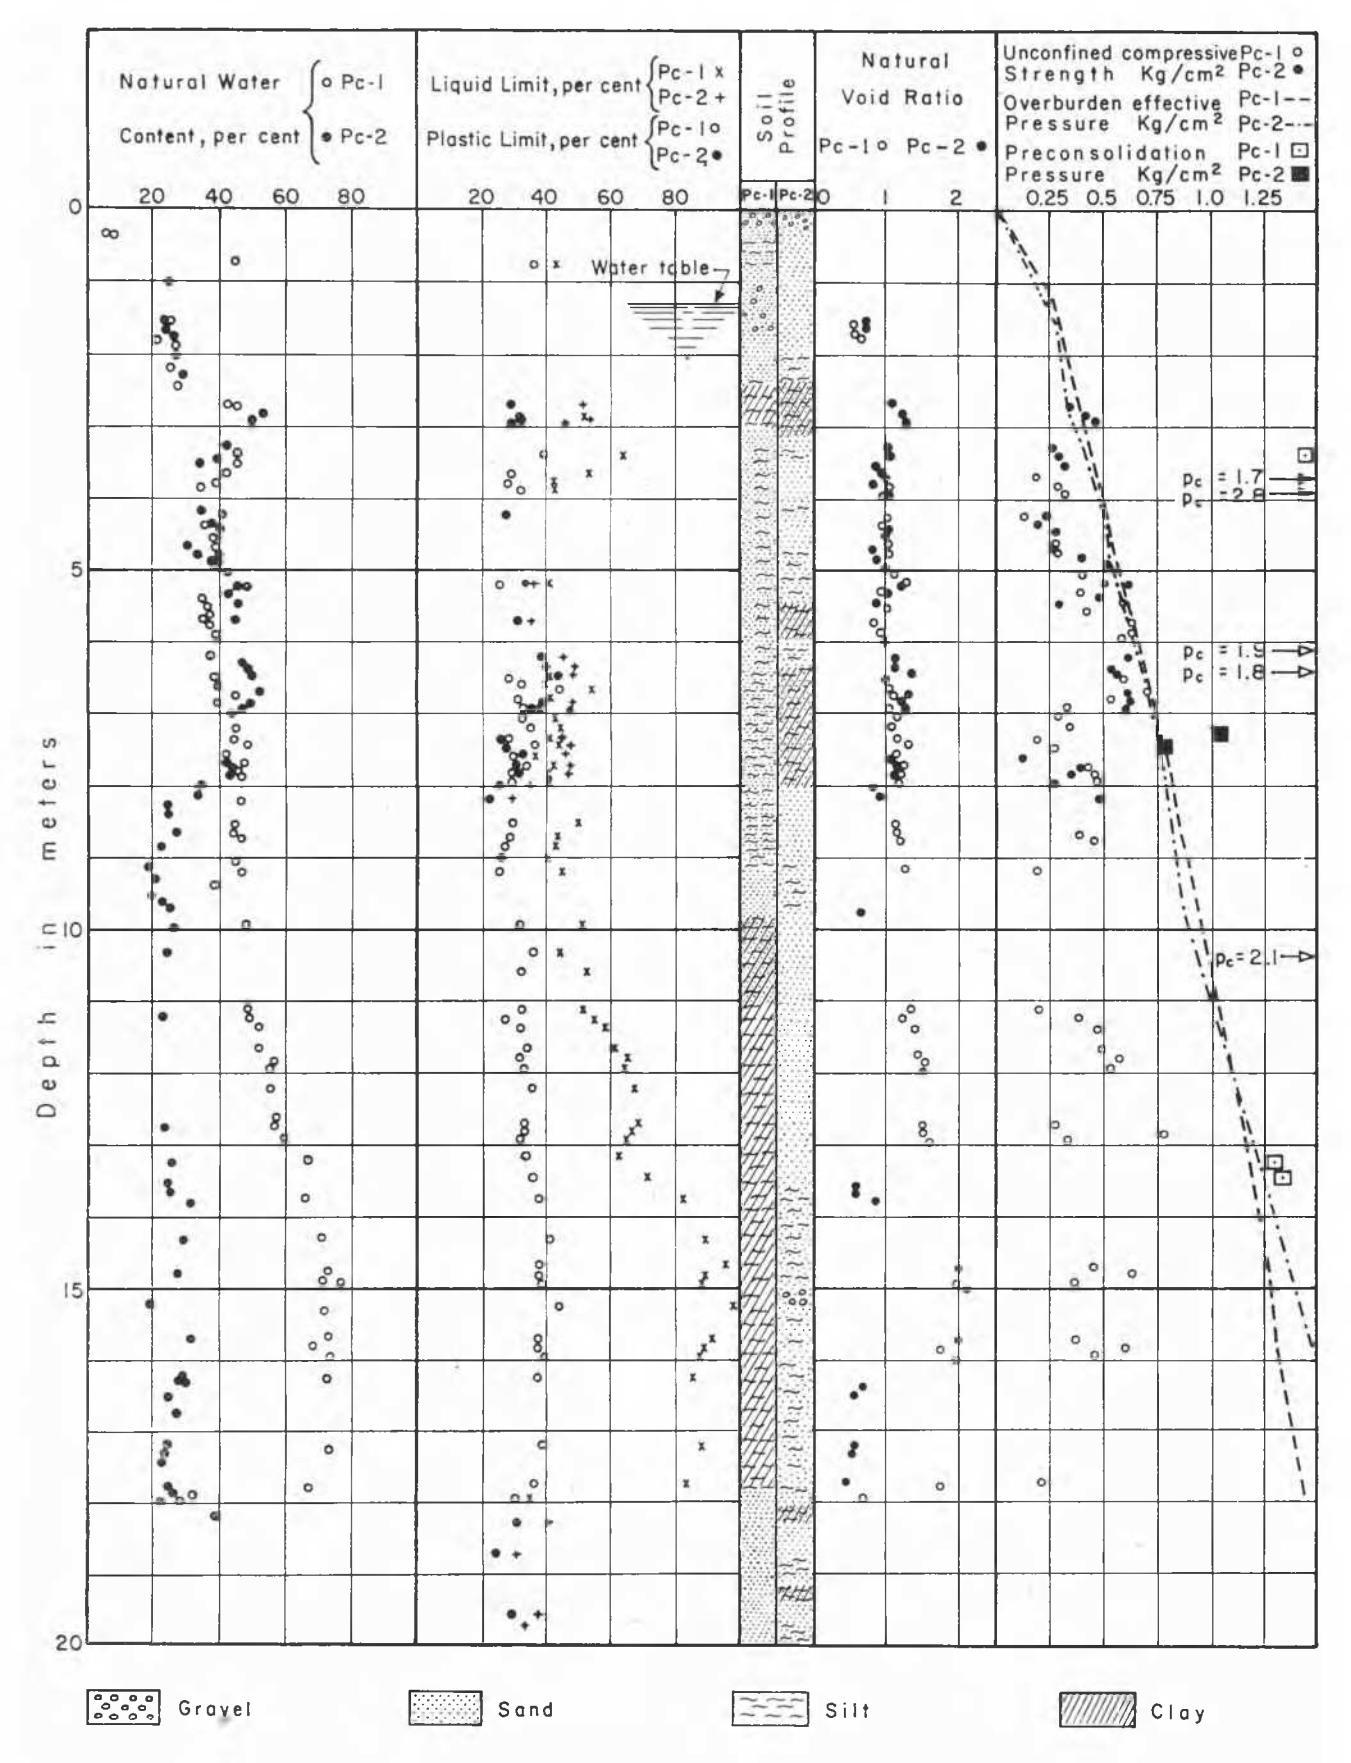
Fig. 2 Soil Profile, showing variation of mechanical properties with depth. Profil du sol, indiquant la variation des propriétés mécaniques avec la profondeur.

According to Fig. 2, the formations present in sample boring Pc-1 are as follows :

From the ground surface to El. -2.5 m, layers of medium to fine clean sand, with void ratios of about 0.6, moisture content varying from 20 to 25 per cent and specific gravities of 2.66 are found. These layers are interbedded with some silty ones. The ground water table was 1.3 m deep.

Between El. -2.5 and E. -6.7 m, there is a uniform layer of loose sand; void ratios are practically constant and equal to unity, water contents about 30 or 40 per cent. Except for a few specimens, these materials are not plastic. Unconfined compressive strengths range between 0.2 and 0.6 kg/cm², and specific gravity is of the order of 2.70.

From El. -6.7 to El. -9.0 m, sandy silts with void ratios of 1·1 to 1·2 are predominant. Water contents are of 45 per cent; liquid limits of about the same magnitude, and plastic limits of 30 per cent on the average. The unconfined compressive strength changes erratically between 0.2 and 0.7 kg per sq. cm. It has to be noted that these materials have an appreciable amount of biotite, organic matter, and some seashells.

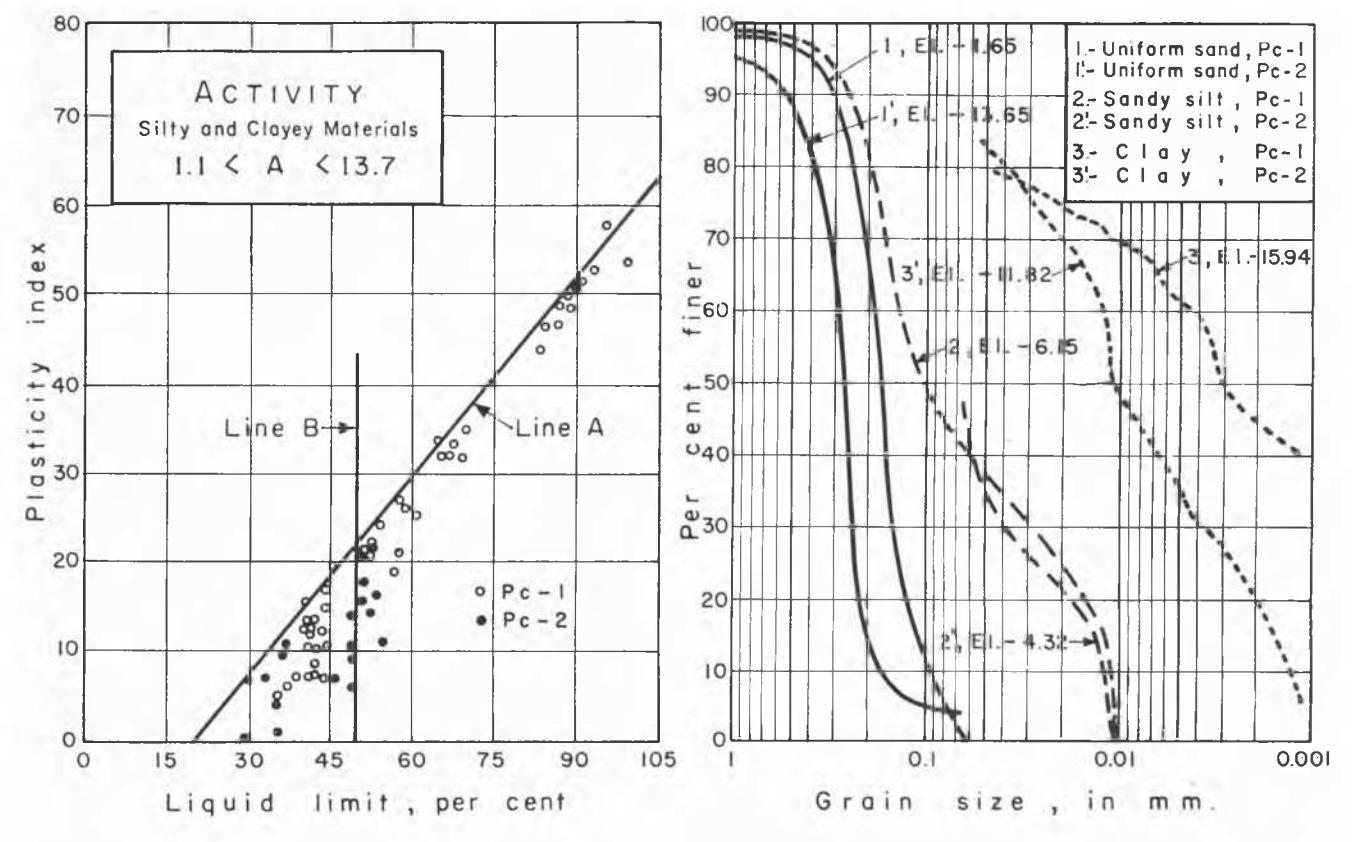
Fig. 3 Plasticity chart and activities of silty and clayey materials; grain-size curves. Diagramme de la plasticité et de l'activité des matériaux limoneux et argileux; courbes granulométriques.

These soils deserve special attention. They are non-plastic materials, and in a rather loose state, judging from their natural void ratios. Besides, as can be seen in Fig. 3, their grain sizes are quite uniform. These properties are characteristic of materials that, when subjected to a shock like that produced by an earthquake, are susceptible to structural collapse (2). A large mass of this type of soil can undergo rapid displacement, behaving as a liquid. In some cases, this phenomenon is local and limited to zones where maximum shear stresses occur.

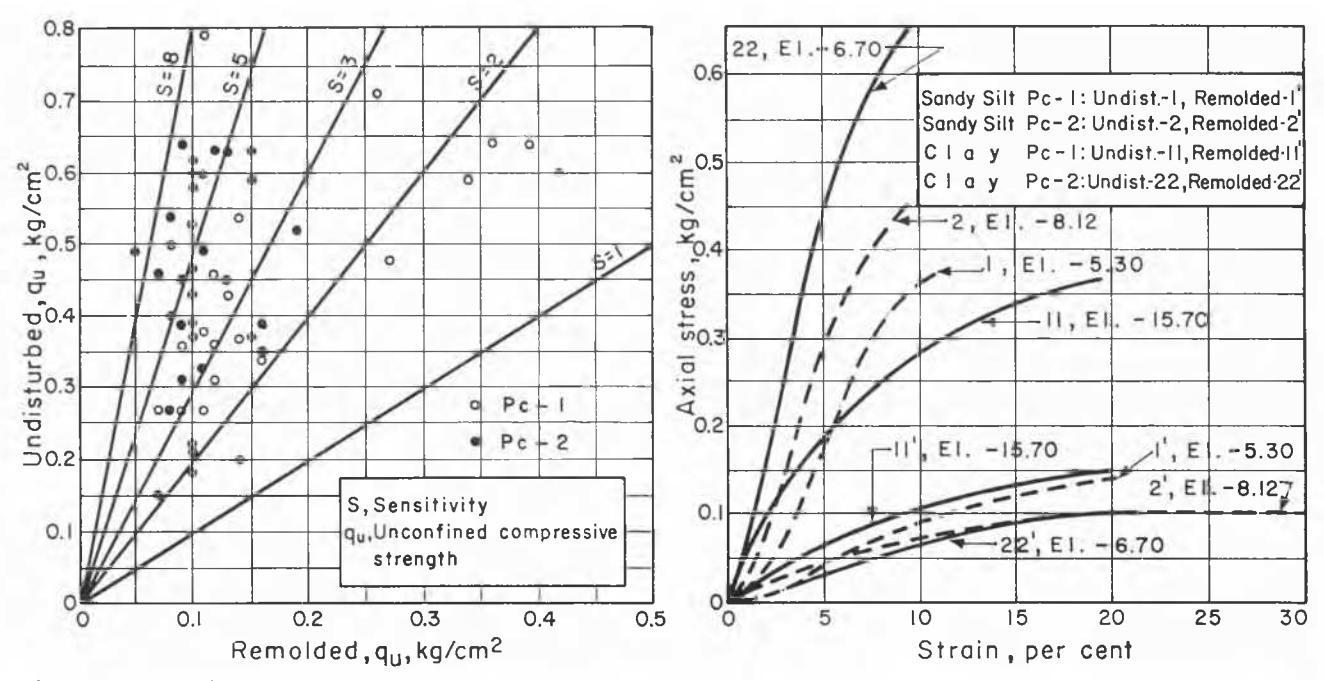
Fig. 4 Stress-Strain Curves of silty and clayey materials (unconfined compression test); sensitivities. Diagrammes contraintes-déformations des matériaux limoneux et argileux (essai de compression simple). Sensibilité.

Between El. -9.9 and -17.8 m, sandy silts and clays are found, their plasticity increasing with depth. Moisture contents vary from 50 to 75 per cent and liquid limits are much higher than the natural moisture content, reaching values of 90 per cent, while plastic limits are under 40. Unconfined compressive strengths range from 0.2 and to 0.8 kg/per sq. cm, the sensitivity varying from 2 to 8. Specific gravities are greater than 2.70. Activities fall between 1.1 and 13.7 (See Figs. 3 and 4).

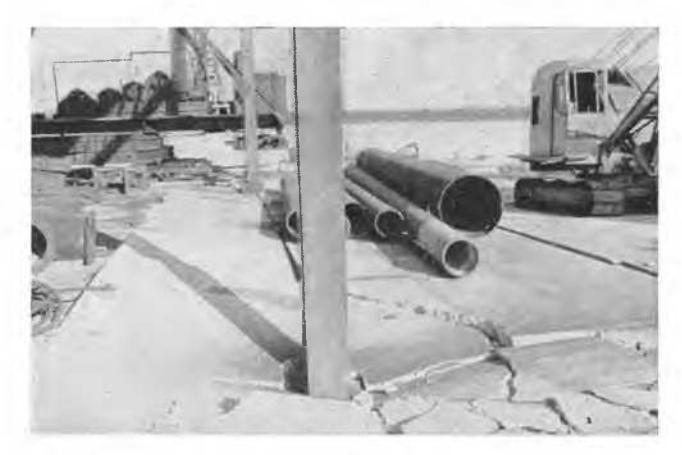
Two types of failure were observed in the Coatzacoalcos region next to the river; both of them are indicative of a partial liquefaction process taking place in the silty sand layers, particularly those between El. -2.5 and El. -6.7 m :

(a) A sudden settlement of the order of about one metre in the columns of the Naval Shipyard and the walls of the Machine Shop (Figs. 5 and 6).

Fig. 5 Collapse of column footings in the Naval Shipyard. Rupture de l'assise des colonnes dans l'arsenal.

The metal roof of the Naval Shipyard is supported on concrete columns which, in turn, rest on spread footings 1 metre square at a depth of 0.8 m.

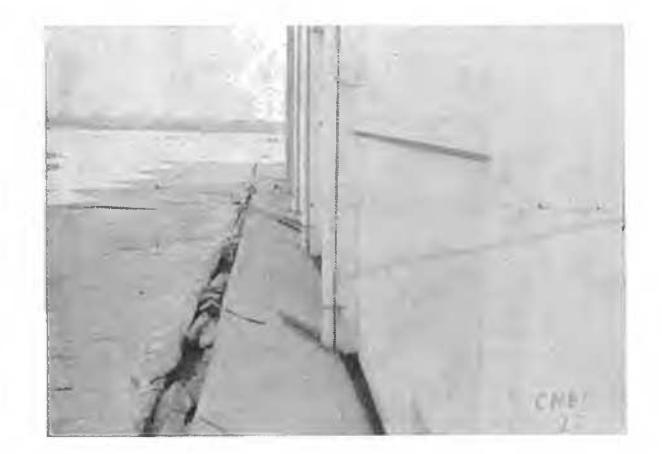
Fig. 6 Subsidence of a continuous wall footing, Naval Machine Shop.

The walls of the Machine Shop are founded on continuous footings 0.9 m wide at a depth of 0.8 m.

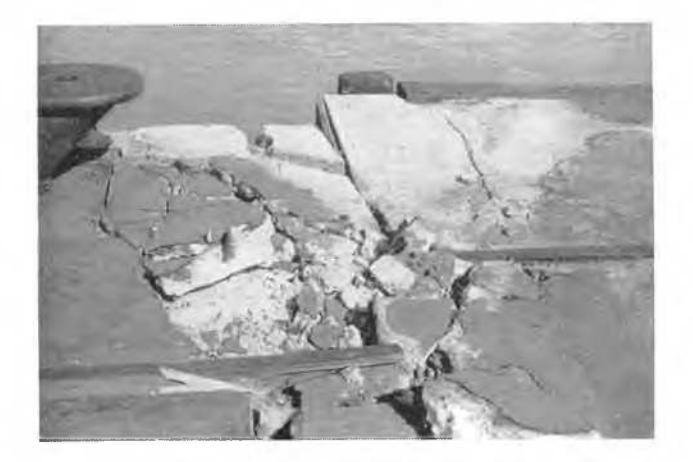
(b) Relative horizontal displacements between sections of the "Puertos Libres" quay (Fig. 7).

Fig. 7 Relative displacement of two sections of the Puertos Libres Quay.

The Puertos Libres quay sections are formed by a metallic

substructure resting on tubular steel piles, 20 cm in diameter, with an enlarged helical toe. The length of these piles is not exactly known, but it is greater than 10 m.
