Improving the Climate Resilience of Railway Earthworks: Case Studies from Southeast England

Burçin AVAR¹, Michael HALIBURTON², Simon SMITH³ and John-Paul INDOE³

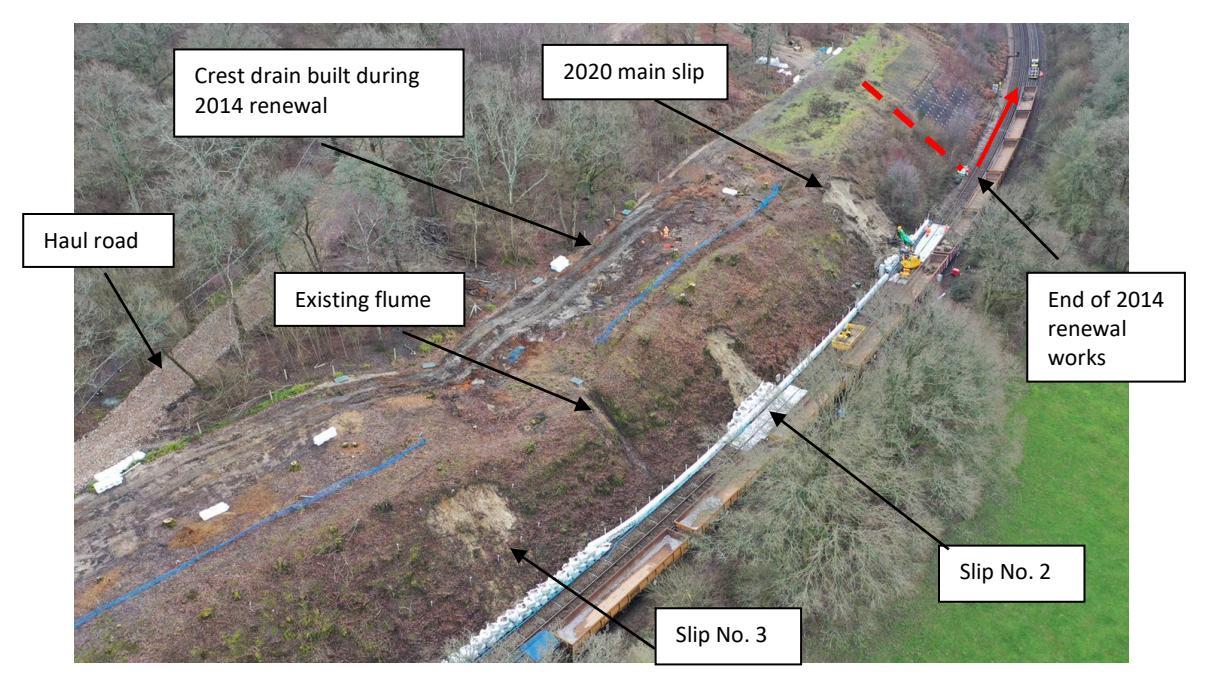
In February 2020, the slope failed at three locations following intense rainfall during 2019/2020 November to January, as shown in Figure 2. The main slip was approximately 15 m away from the end of 2014 repair works. The failures were translational first-time shallow slips.

The main slip extended to the mid-upper slope, but not as far up as the crest. It was approximately 8 m wide and less than 1 m deep. The slope height at the failed sections was approximately 12 m (including 2.7 m high sloping ground to the crest at 11.5° and 9.4 m high slope at 41°). The other two slips were narrower, but otherwise of similar dimension. NR immediately responded to protect the railway by placing ballast bags at the toe of the slope and installing monitoring survey points along the failed sections. The track speed limits were also lowered.

Figure 2: High Brooms cutting after February 2020 slips

Following the site visit by Tony Gee and a NR geotechnical asset engineer, it was decided to stabilise the Wadhurst Clay slope via regrading and soil nailing. Two rotary drilled boreholes encountered firm to stiff friable high plasticity clay overlying highly to completely weathered mudstone interbedded with siltstone and

Soil nails and the face plates were designed according to BSI (2017) and Phear *et al.* (2005). The top 1 m slice of the clay slope was considered to be in a "long-term" softened state, therefore it was modelled with the parameters given above. The slope was proposed to be graded to 31° prior to installation of soils nails. 9.5 m long Dywidag R32-280 nails in 100 mm diameter bores were proposed to be installed in a staggered diamond pattern with a minimum spacings of 1.2 m vertical and 2.0 m horizontal at 25° inclination. Structural flexible facing comprised 2 mm diameter steel wire mesh connected to the nail heads with a 15 mm thick 300 mm square galvanised S275 grade steel plate.

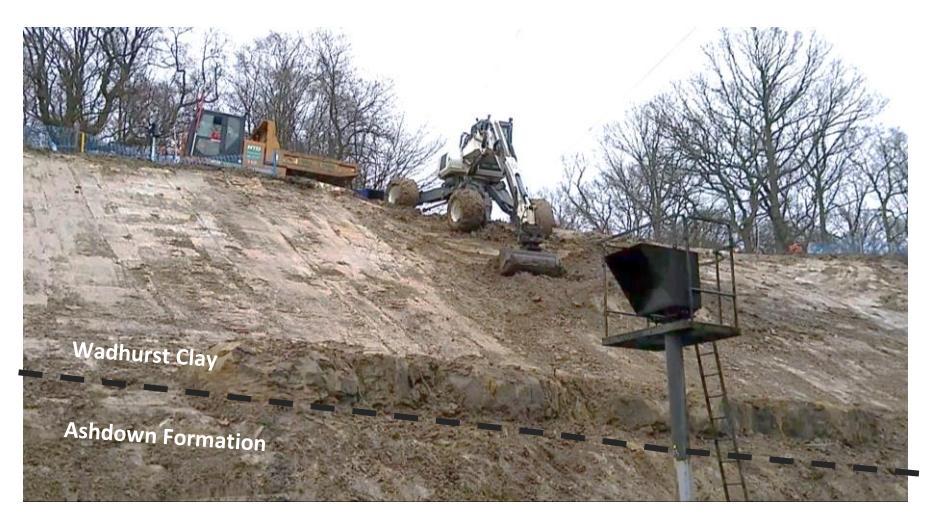
Figure 3: Regrading works at High Brooms Cutting

During a site meeting between the engineers from TGP and BAM and the NR geotechnical asset engineer, the rock exposure was inspected, and it was decided to terminate re-grading of the Ashdown Formation and instead to design a rock netting containment system. Re-grading works left the siltstone and the underlying sandstone exposed, resulting in locally very steep overhanging fractured rock. Figure 3 shows the boundary between two formations exposed during re-grading at the main slip location, and the spider excavator, with limited head room requirements, utilised to work under the high-voltage overhead electric power lines. Further discussions between the designer and the contractor optimised the netting solution considering the current stability of the Ashdown Formation slope. To mitigate likely future rock fall due to the more frequently occurring extreme weather events, a passive netting system was installed in the area of the Ashdown Formation slope that was not re-graded, and an active netting system was installed on the re-graded rock cutting.

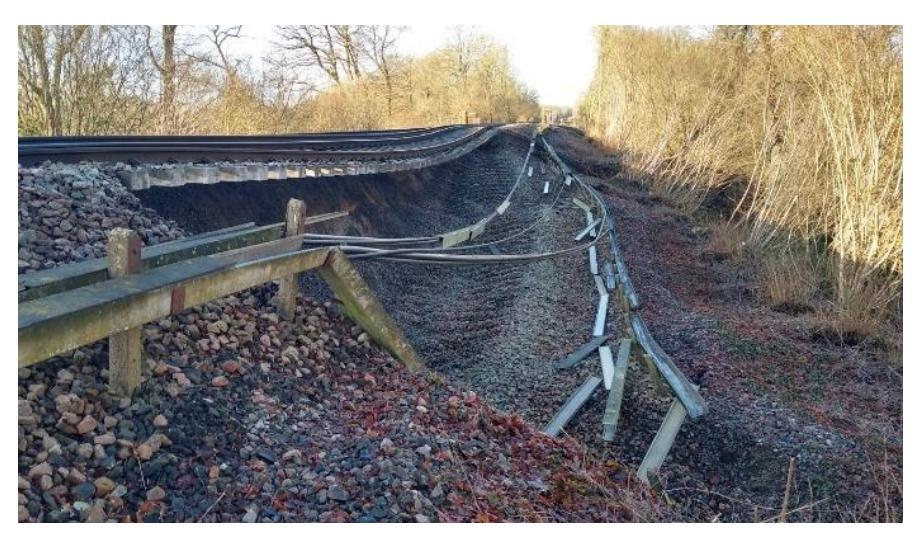
The rail embankment supporting the Redhill to Tonbridge Line between Godstone and Edenbridge suffered a catastrophic failure following an extended period of heavy rainfall during December 2019 which caused flooding at the embankment toe (Figure 4). The embankment was constructed in 1830s and is one of the earliest rail embankments in the UK. It is approximately 10.5 m high with average slope angles of 27°. The embankment is likely founded over Alluvium overlying the Weald Clay Formation ('Weald Clay'). The embankment was constructed from reworked Weald Clay from nearby railway cuttings. Ashy ballast was placed on the cohesive fill over time to compensate for ongoing settlement. The CPTs undertaken indicated approximately 2 m thick alluvial sand is located directly under the fill and overlying the Weald Clay.

There is also the poorly functioning culvert from the Downside to Upside (orange dashed line) that discharged into the river. It is probable that flooding related porewater pressure changes and softening at and above the embankment toe contributed to the failure of the embankment. Given the age of the embankment, it is likely that the mechanism behind the failure was due to non-recoverable plastic strains developing between dry and wet seasons in the slope coupled with strain-softening due to seasonal pore water pressure changes (Kovacevic et al., 2001; Take and Bolton, 2011).

Figure 4: Failed Edenbridge embankment

The remediation work included the rebuilding of the Downside of the embankment. BAM carried out the works 24/7. Due to the Downside (north) of the embankment being inaccessible, a section was cut into the existing embankment to allow construction plants to be mobilised at the failed slope. The failed embankment fill on the Down side was excavated and removed, and MCHW Class 1A granular fill was placed to rebuild to the slope. The slope was excavated and benched into the existing embankment core at a maximum average slope angle of 45°. The finished slope angle was 25° to ensure a similar slope profile to the original embankment. The base of the embankment reconstruction was formed by a 600 thick drainage layer tied to the refurbished toe drain

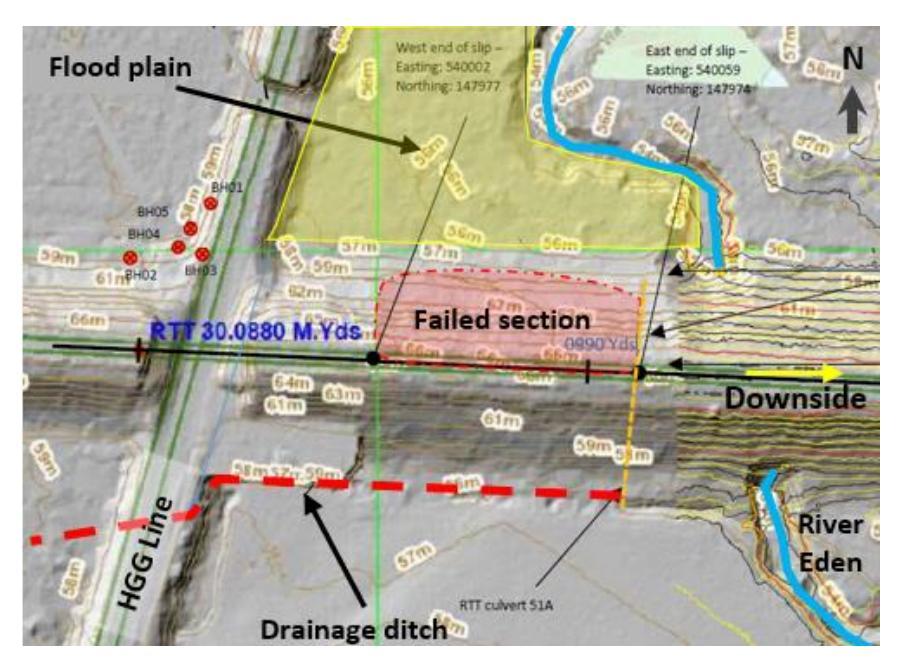
The current course of the River Eden crosses beneath the embankment via a culvert at the east boundary of the slip as shown in Figure 5. The river is the source of high flood probability at this location (yellow shaded area in Figure 5). In addition, the runoff collected into an overcapacity ditch passes under the railways via a NR culvert

then runs parallel with the embankment in an open ditch (red dashed line in Figure 5). The ditch originally discharged into the River Eden, but over time it eroded creating an open channel to the river that has been flooding the embankment toe at the Upside (south) as well.

Figure 5: Edenbridge embankment layout

The back-analysis indicated that despite the reduced embankment height at the Upside due to natural fall of the ground, there was also a reduced safety factor. To increase the resilience of the whole embankment, excavated original clay fill which was classified as MCHW Class 2A material was used to build a new slope at 14°. The new fill was also founded on drainage layer similar to that installed on the Downside. A new drainage system was design and installed on the Upside to provide further resilience by preventing the Upside toe flooding from the HGG line culvert stream.

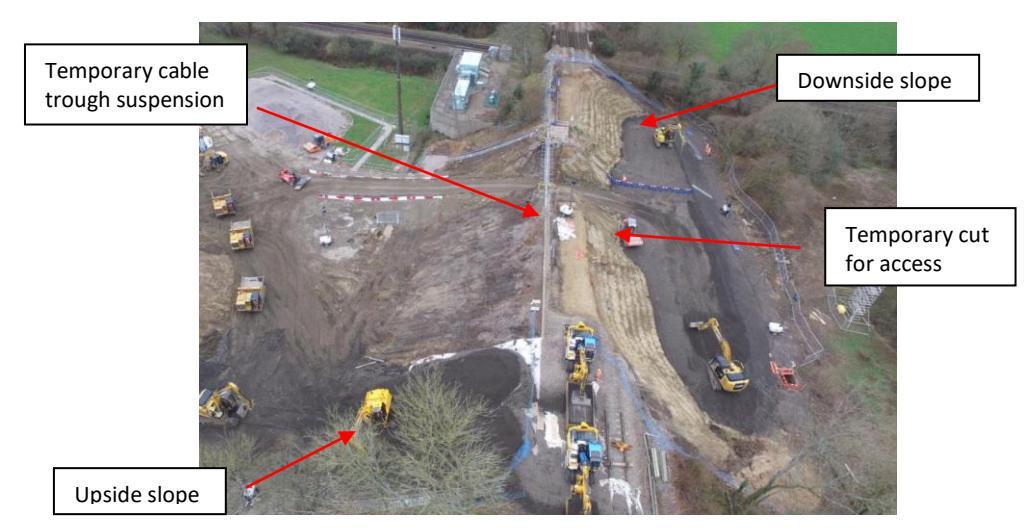
Figure 6: Edenbridge embankment during the works

draining to a NR culvert. The lower 2 m of the slope was protected by a rock mattress to reduce the impact of future flooding on the embankment. Figure 6 shows the site works.

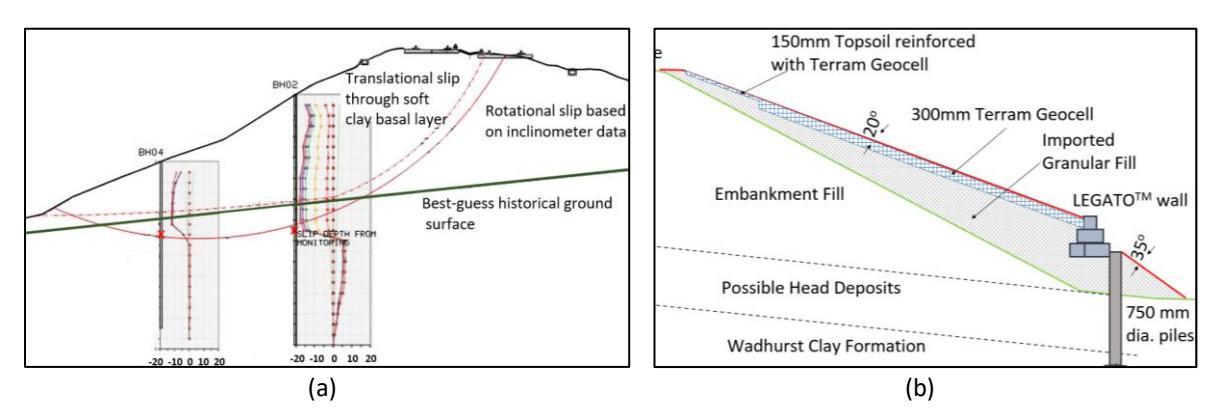
Figure 7(a) shows slip surfaces interpreted from the inclinometer data recorded from 2016 to 2021. Reviewing all the inclinometer data, a very similar rotational movement to that considered in the mid-1970s, and treated with grouting, appeared to have reactivated. Additional translational slip mechanism was also observed based on two inclinometers, which were likely occurring at the foundation level.

Figure 7: (a) Slip surfaces and inclinometer monitoring data at Balcombe embankment (b) Proposed design

It was considered likely that surface water runoff flowing down the sidelong ground which did not enter the culverted stream might have interacted with the failure surfaces by either percolating through the embankment from the slope side or moving immediately under the embankment along the original sloping ground interface. Rainwater was also locally ponded within the embankment as indicated by shallow water strikes in the boreholes. Such pockets of water might have also contributed to the sustained slope movement.

The geotechnical parameters used in the design were derived from the ground investigation data and the backanalysis. This analysis simulated deep-seated translational and rotational failure mechanisms similar to the inclinometer monitoring data. Together with the CPT results and ring shear tests carried out on the founding stratum, for the design of the mitigation solution embankment fill effective strength was determined as c'=4kPa and $\varphi'=19^{\circ}$. The strength of the soft interface between the fill and the underlying Head deposits were taken as c'=2 kPa and $\varphi'=17^{\circ}$. Piezometric level was taken at the natural ground level. Pore water pressures within the embankment was simulated using $r_u=0.2$. In order to arrest the embankment movement and prevent eventual failure, a piled retaining wall consisting of 750 mm diameter cast in-situ reinforced concrete piles with 1250 c/c spacing were proposed, as indicatively shown in Figure 7(b) for 13 m high section. The pile lengths were 13 m to 16 m long toed into the Wadhurst Clay mudstone. The existing slope was cleared and benched to allow placement of 'granular' fill to form a shallower 20° slope in order to prevent future shallow slips due to heavy and prolonged precipitation. The fill was retained by 3.2 m high gravity wall constructed using Legato[™] concrete blocks behind the piled wall. During the pile installation, the concrete blocks were also used to form the temporary piling platform. The piled retaining wall was buried completely as part of the granular fill placement to the existing embankment toe (Figure 8). A drainage channel was also built at the toe of the embankment to drain the water and prevent further erosion.

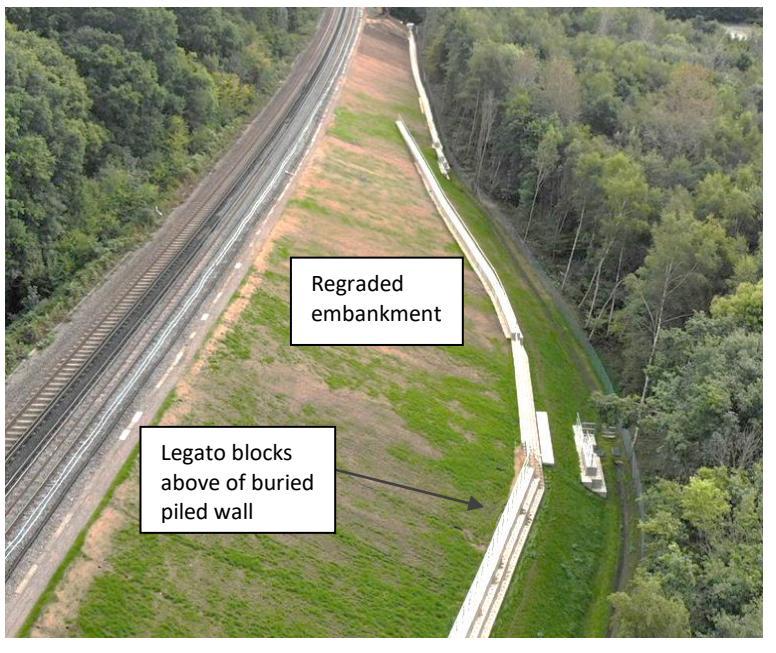
Figure 8: Balcombe embankment after completion

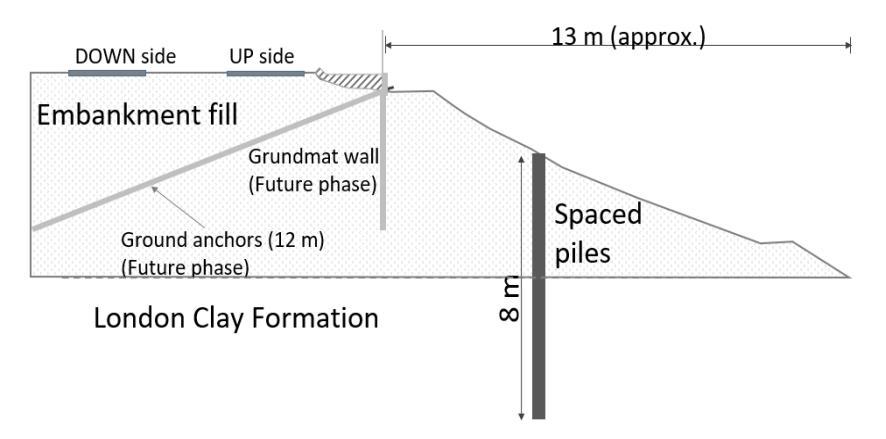
Peg monitoring was undertaken at the crest. There was a clear acceleration in movement following Storm Alex in October 2020 (see red arrow in the figure) indicating the stability of the embankment slope was vulnerable to heavy rainfall events. Peg monitoring also showed that at the soil nailed section of the slope the

Figure 8: Bracewell embankment proposed design

Cast-in-situ 450 mm diameter reinforced concrete CFA piles were constructed approximately 4.5 m from the slope crest at minimum centre to centre spacing of 1125 mm to maximize arching. The piles were 8 m long and embedded sufficiently below the calculated slip surface within the London Clay Formation. The piles were placed at approximately the mid-height of the embankment to ensure a "long pile" beneath the failure surface. Some pile locations had to be re-adjusted on site to avoid unforeseen obstructions. The section of the upper slope without existing soil nails was found not to be compliant with the standards, therefore soil nails were proposed to stabilise the upper slope during the next phase of works together with a Grundomat cess support wall to be anchored back into the embankment fill which will be constructed at a future date.
