Reconnaissance survey on earthquake-induced failures of ground composed of volcanic materials in Hokkaido, Japan, during the 2018 Hokkaido Eastern Iburi earthquake of Mw=6.6

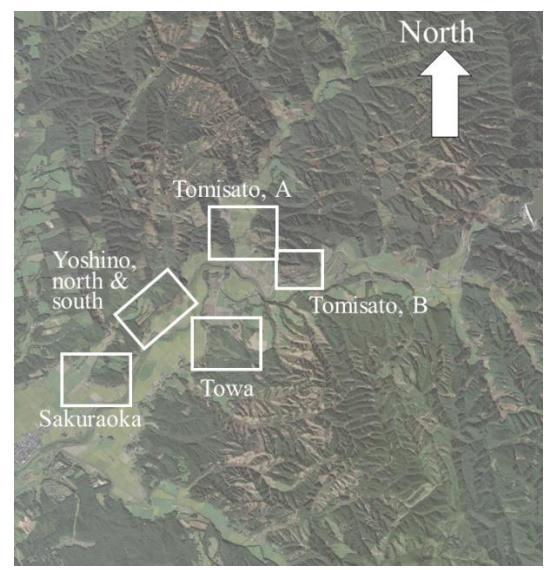
Figure 3. Areal view of Atsuma where many slope failure happened in volcanic deposits; brown color indicates the failed slopes (photograph provided by the Cabinet Office).

Fig. 3 revealed that volcanic ash slope failed at numerous places in Atsuma. More details of slope failure are addressed in what follows. First, Fig. 9 illustrates that the slope failed rather uniformly in the horizontal direction, implying uniform topographical and geological/mechanical properties of the slope. Another point is the long run-off of the failed soil mass over the wet rice paddy. Some parts of the head scarp with dark color suggest humid soil conditions. Fig. 10 was taken in Tomisato of Atsuma and shows that the failed soil mass traveled along the level surface of paddy. Because the paddy still held water near the time of Autumn harvest, the shear strength of clay in the paddy floor was low and allowed long-distance run-off. Fig. 10 indicates that the failed mass traveled over a long distance in the horizontal direction because the travel route was on wet and soft mud in rice paddy. The local practice of agriculture maintains water in the paddy in this season and reduced

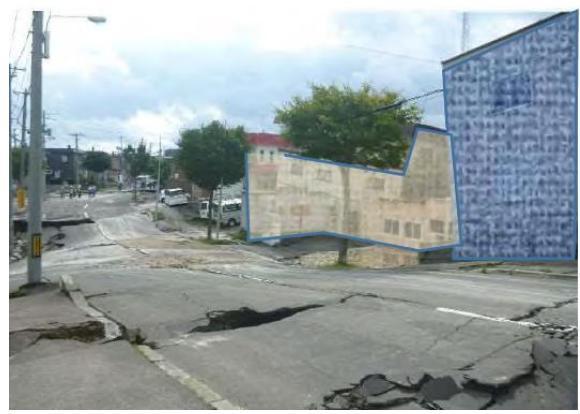
Figs. 5 and 6 illustrate the geotechnical damage in Satodzuka where residential land had been constructed in 1960s by filling former valleys with volcanic ash that was easily available in the vicinity. In the history of seismic damage, fills of volcanic ash have caused substantial damage; e.g., Sapporo [1] and Tsukidate in Miyagi [2]. During the present earthquake, a substantial amount of soil got fluidized and came out of the ground, leaving a big surface depression in the formerly level terrain. Fig. 7 shows an evidence of liquefaction of volcanic ash fill. Noteworthy is that liquefaction was repeated here, following the previous event during the 2003 Tokachioki earthquake that had magnitude of Mw=8.0 but registered the JMA seismic intensity scale of only 4 in Sapporo City.

Figure 5. Profound depression in fill part in Satodzuka, Kiyota, Sapporo.

The ongoing discussion concerns the cause of the profound flow failure in Satodzuka (Figs. 5 and 6). Although liquefaction played some role in the disaster, additional discussion addresses possible deterioration of the earth fill structure, including walls and drainage channels. Much is not yet clear about these issues.

After this disaster, Sapporo Municipal Government initiated a quick response within 2018 towards restoration. The national governmnt had introduced a scheme for stabilization of disaster-prone slopes and the unstable ground in Satodzuka was decided to be restored from summer of 2019 by means of colloidal silica injection. The good point of this financial scheme is that all the expenditures are paid by the national government and the residents do not have to pay, although the affected land is their private property.

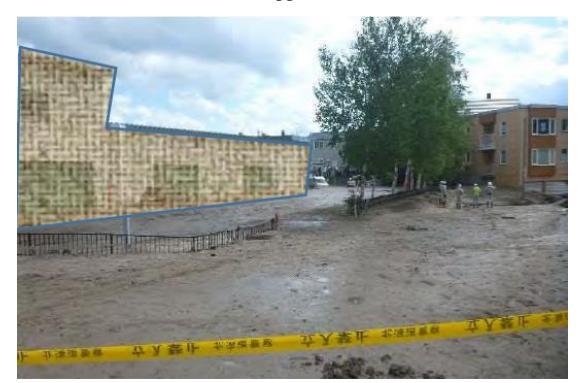
Figure 6. Deposit of volcanic ash materials that flowed out of the fill (Satodzuka).

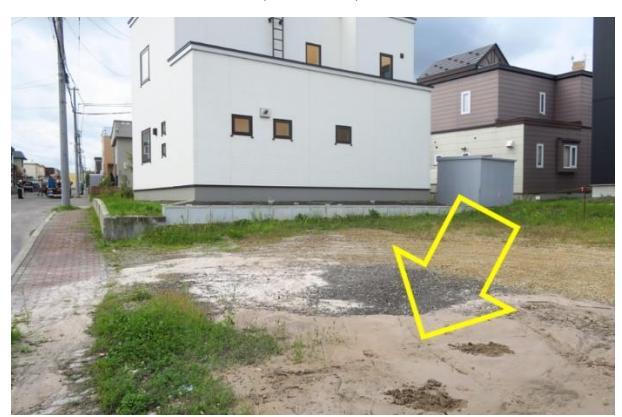
Figure 7. Sand ejecta in Utsukushigaoka area of Kiyota, showing repeated liquefaction after the previous event during the 2003 Tokachi-oki earthquake.

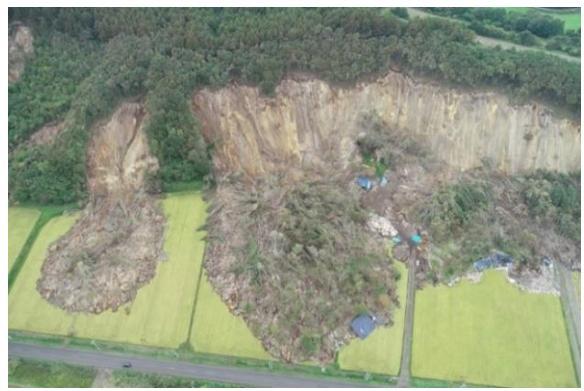
Figure 9. Drone photograph of slope failure in Yoshino District of Atsuma Town.

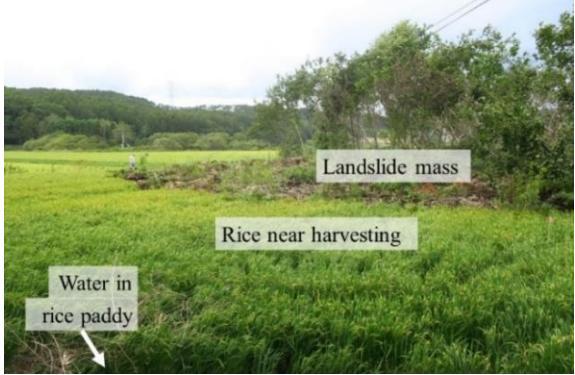
the shear strength of the soil, making sliding easy above it. Fig. 11 shows the appearance of one of the head scarps where ground water was still coming out two days after the disaster. This water probably corresponds to the perched water (Table 1) that was produced by antecedent rainfalls (Fig. 12).

Figure 10. Landslide mass on soft rice paddy soil (Tomisato A District).

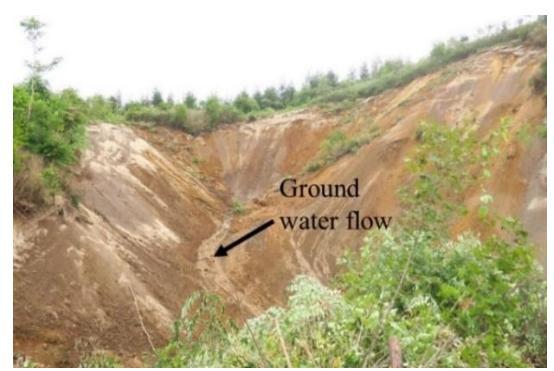
Figure 11. Head scarp in Towa District (this photograph was taken on September 8th, 2018; two days after the disaster).

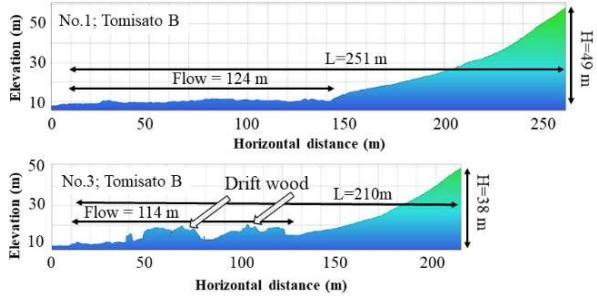
Figure 13. Cross sections of landslide mass in Tomisato B District.

The geometric information on the landslide soil mass is discussed in what follows. The geometry was investigated by using drone photographs that were taken in Tomisato B and Yoshino Districts (Fig. 3). Fig. 13 shows two examples in Tomisato B District. The right ends of the figure are the place of top scarp. It is interesting that the distance of lateral flow exceeded the length of the source slope. This ease of flow was facilitated by soft paddy soil as stated above. Moreover, the shorter flow distance in No.3 of Tomisato is possibly the consequence of drift wood that increased the frictional resistance over the paddy soil. Similar discussion is possible on Fig. 14 on failure in Yoshino District.

Table 2 summarizes the geometry of three studied failures. The ratio of flow distance vs. source length is nearly 1.0 or greater and implies the ease of flow on paddies. Another ratio was evaluated on the fall height (*H*) over the horizontal size (*L*); for their definisions, see Figs. 13 or 14. *H/L* is equal to $\tan\varphi_t$ where the friction angle [10] in terms of "total" stress is designated by φ_t . It is interesting that the obtained total-stress friction angle is uniformly equal to 10-11 degrees, irrespective of the different sizes and sites of slopes.

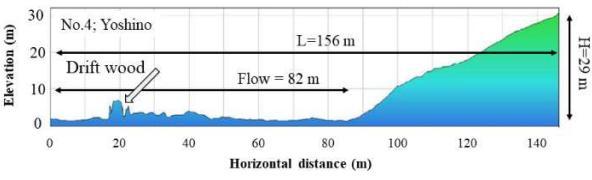
Figure 14. Cross section of landslide mass in Yoshino District.

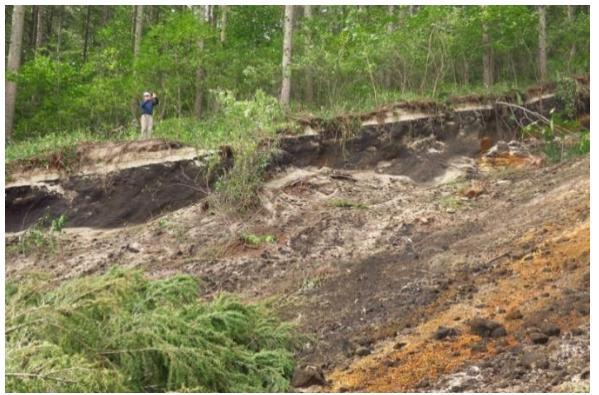
Soil hardness was measured in several failed slopes. At each point of measurement, data was taken 3 times and the mean value was kept in record. First set of data was obtained in Sakuraoka District. Fig. 17 clearly shows layers of volcanic materials parallel to the slope surface. The depth of the slide was approximately 2m here. Fig. 18 illustrates the distribution of P value in the lower part of the side wall. Generally, the P value decreases as going downwards possibly because of inundation in perched ground water. In particular, the lower part of the Tarumae-d₂ pumice layer exhibits very low strength. Under this layer, a slip plane was encountered above the upper face of the underlying Tarumae loam layer (Ta-Lm) in which the P value was 79.5 kN/m² (Fig. 19). Thus, slip happened at the interface between the overlying weaker and underlying stiffer layers.

Figure 17. Overall view of a landslide site in Sakuraoka.

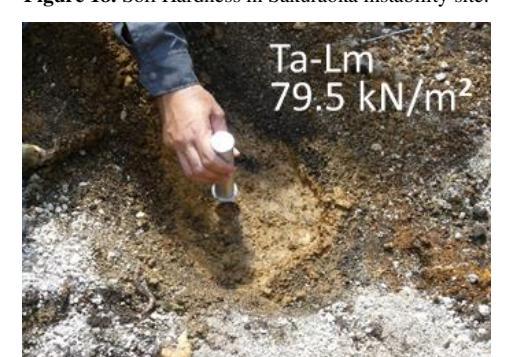
Figure 19. Yamanaka Soil Hardness Test immediately below the slip plane in Sakuraoka instability site.

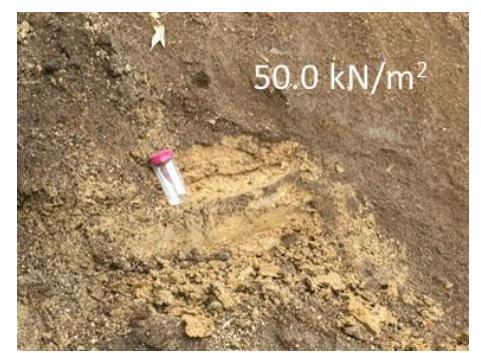
Fig. 20 illustrates the hardness test in the slip plane in Towa District where *P* value was found to be 50.0 kN/m^2 . Noteworthy is that the *P* value above this position was 96.1-137.3 kN/m² that was greater than at the slip plane. This suggests again that slip happened at the bottom of a softer stratum resting on harder layer. Furthermore, the *P* value in the slip plane is within the range of 8 (Ta_{d2A}) -50 (Fig. 20) kN/m², although the variation of material properties is substantial. Table 3 shows physical properties of materials in Sakuraoka slope in which the loam at the bottom (Ta-Lm) is shown to be fine grained cohesive soil. It is, hence, reasonable to consider this layer impervious and capable of producing perched water above its level.

Figure 20. Yamanaka Soil Hardness Test immediately below the slip plane in Towa instability site.
