CPTU crossing existing boreholes in the soil

K. Kåsin

Norwegian Geotechnical Institute, Oslo, Norway

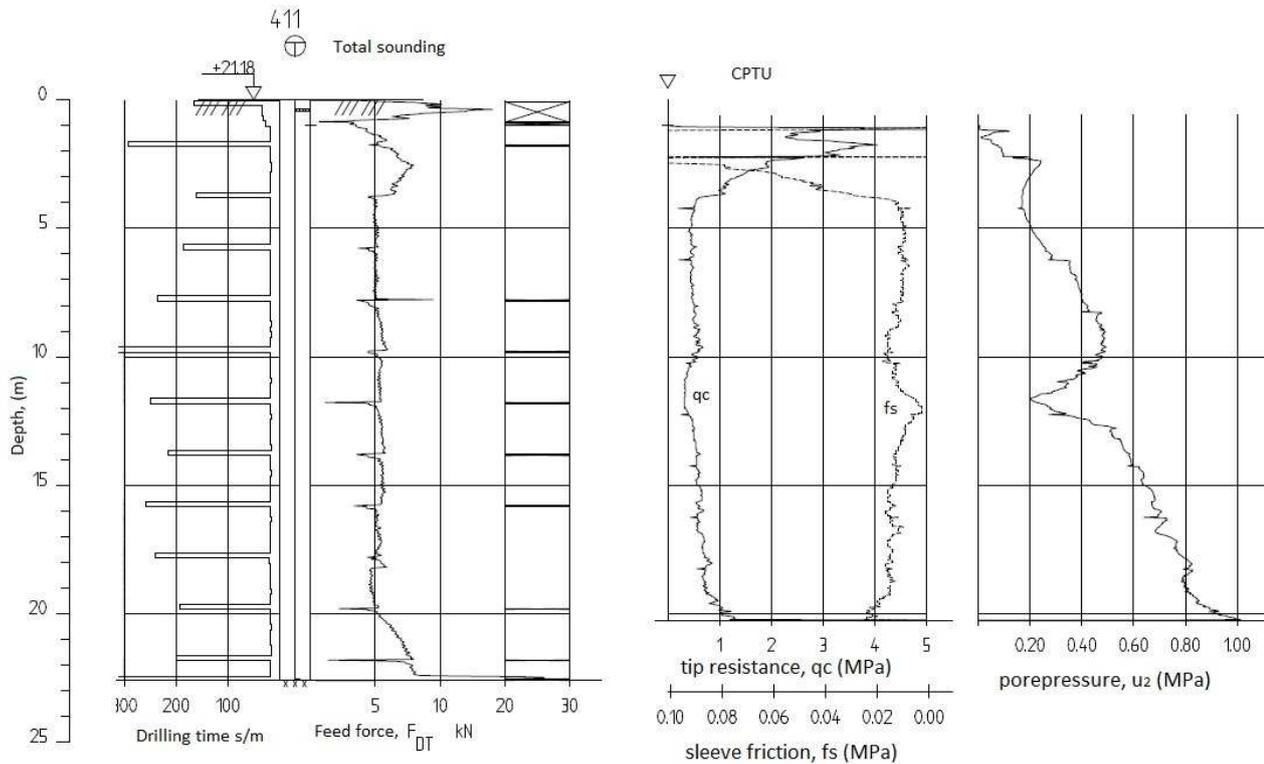
Figure 1 shows a typical example of this type of anomaly, with both a total sounding, and the CPT with the anomaly present in the depth interval between ca. 9.7 m and ca. 12.7 m. The total sounding does not show any indication that the clay is weaker in the same layer. The total sounding and CPT were performed in central parts of Oslo, just east of Gamlebyen gravlund, at a borehole location 411. The tests were performed by Rambøll in 2009 with a Geotech CPTu type Nova. Figure 2 shows the same CPTu sounding where the undrained shear strength is interpreted using the correlations presented in Karlsrud (2005). Between 9.7 m and 12.7 m the strength of the soil is below the trend at the site, and between 10.5 m and 12.4 m the interpreted strength is below $0.3 \times P_0'$, that can be used as an estimate of the shear strength for a normally consolidated clay in the area. Both the total sounding and the CPT indicate homogeneous, sensitive clay, with an interpreted over-consolidations ratio, OCR, between OCR=3 just below the dry crust at 5 m, and reducing with depth down to around OCR=1.8 at 20 m. The anomaly can be seen between 10 m and 12.9 m where the measured values in both the tip resistance, q_c , side friction, f_s , and the excess pore pressure, u_2 , are lower than the rest of the profile.

Figure 1: Plot of total sounding and CPT sounding in borehole 411, Oslo

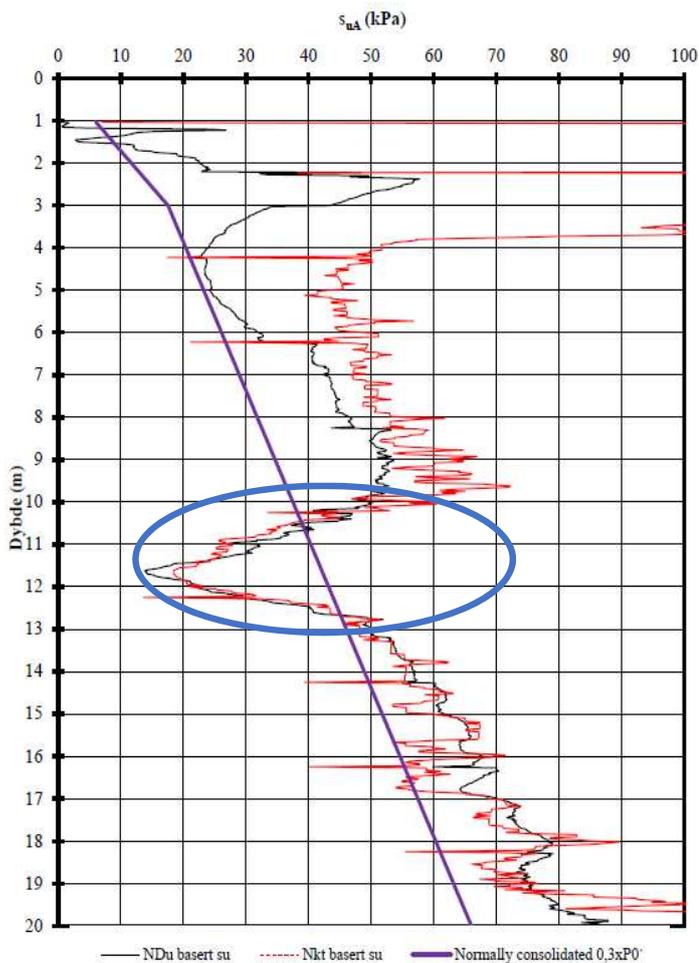
Figure 2. Interpreted shear strength

Looking back to Figure 2, the interpreted shear strength is falling between 9.7 m and 11.6 m where the interpreted strength is at the lowest. From 11.6 m the strength increases strongly with depth to 12.7 m. This points to the CPT seeking the path of least resistance as it is passing through the less disturbed soil furthest away from the previous sounding, and then passing through or close to the center of the borehole at 11.6 m. From the center of the previous borehole the probe goes through less and less disturbed soil until it reaches undisturbed soil at around 12.7 m. This fits well with an assumption that the disturbance or remoulding effect of the previously drilled sounding is greatest near the center of the drilled, and reducing with distance from the center.

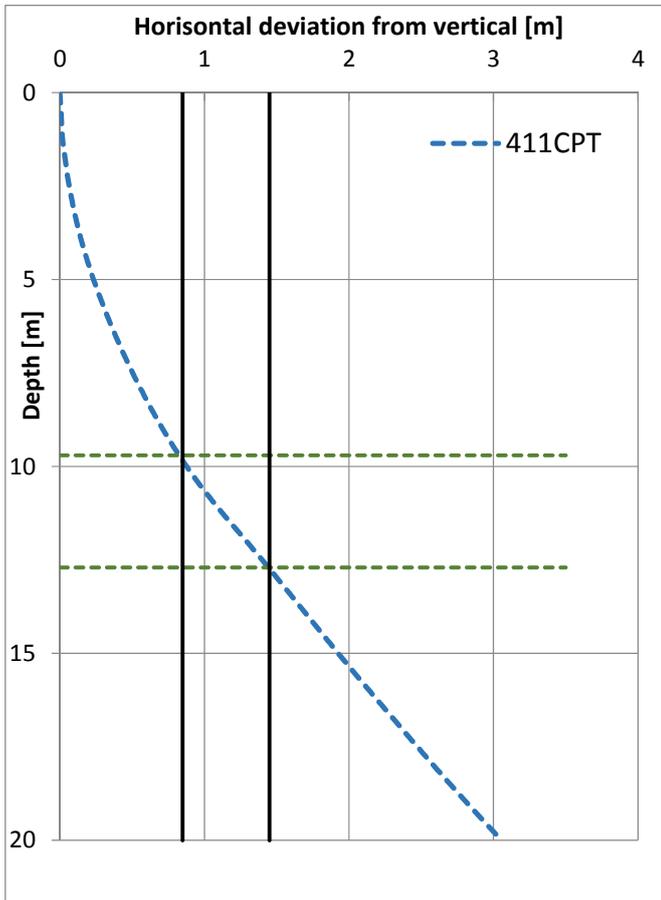
As shown in Figure 3, which shows the horizontal deviation vs the true depth for CPT 411, the horizontal deviation of the CPT can be significant, and certainly more than the 1 – 2 m that is common practice to move the drill rig in between different tests at the same location. The horizontal and vertical deviations in each depth increment is calculated using the following equations:

Going back to the sounding at location 411CPT and applying this, one can see that at 9.7 m depth, where the start of the layer with apparently lower shear strength, the CPT has moved a horizontal distance of 0.85 m, at 12.7 m the distance is 1.45 m, and at 20 m the horizontal distance travelled is over 3 m. The CPT travels around 60 cm horizontally within the 3 m thickness of the layer with lower shear strength, indicating that the width of a disturbed zone that is at least this wide.

Figure 3. Calculated horizontal deviation of 411CPT using measured inclination data.

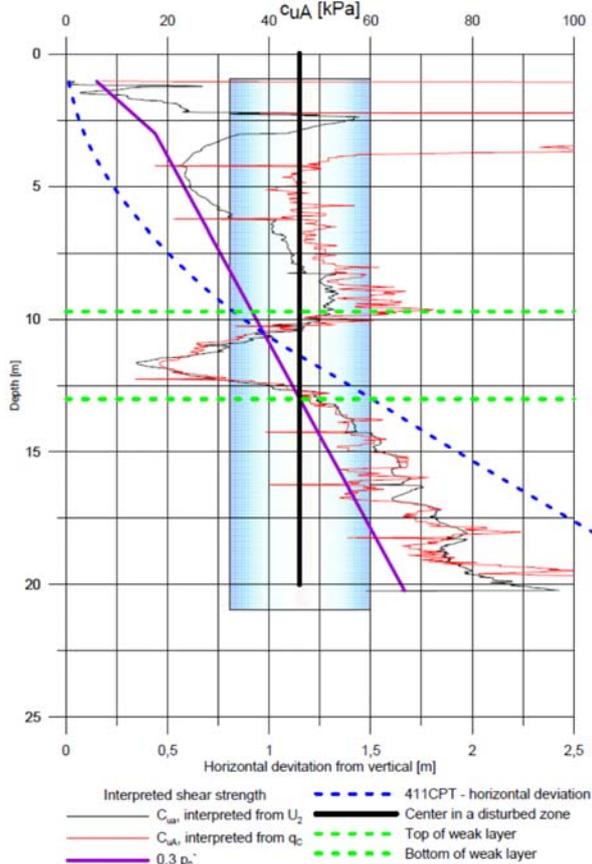
To estimate the width of the disturbed zone around the previous sounding one look at the horizontal distance that the CPT travels within the disturbed layer. In sounding 411, the CPT travelled 60 cm horizontally within the disturbed layer. This suggest that the disturbed zone is close to this width, and this indicates a disturbed zone of 8 – 12 times the diameter of the sounding that was done before the CPT.

Figure 4. Interpreted shear strength, weak layer and the path of the CPT in the ground, from borehole 411CPT

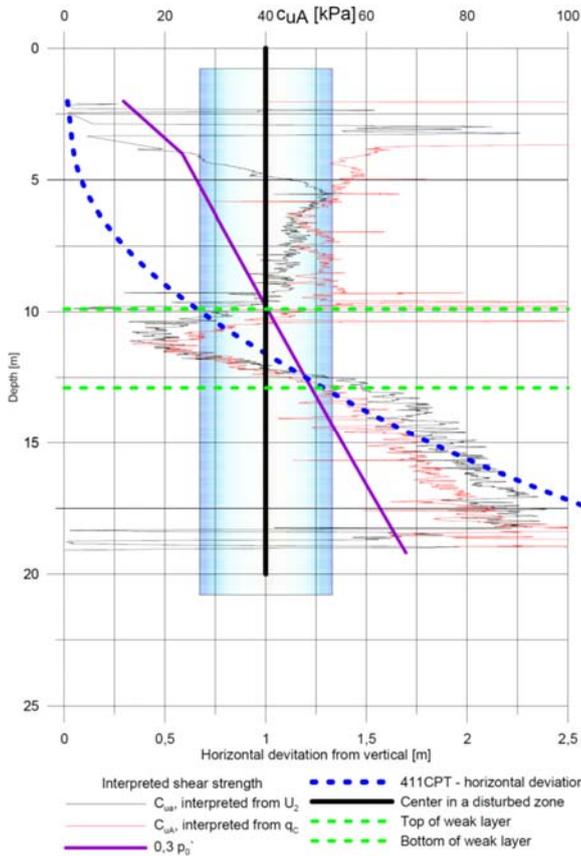
Figure 5. Interpreted shear strength, weak layer and the path of the CPT in the ground, from borehole 5 Stasjonsveien in Oslo

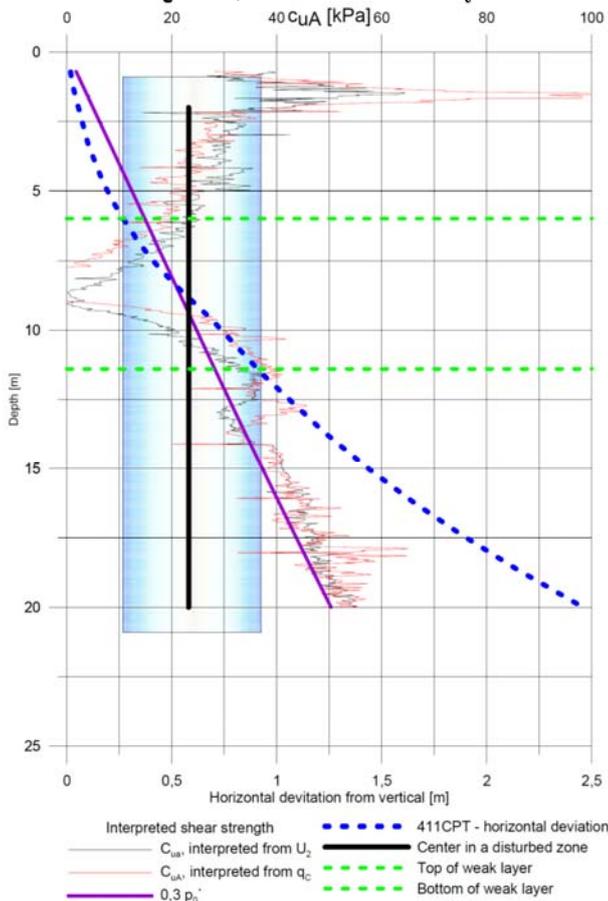
Figure 6. Interpreted shear strength, weak layer and the path of the CPT in the ground, from borehole V-NB-018 in Nykirke in Norway
