Deep excavations for Amsterdam Metro North-South line: An update and lessons learned

A.F. van Tol

M. Korff

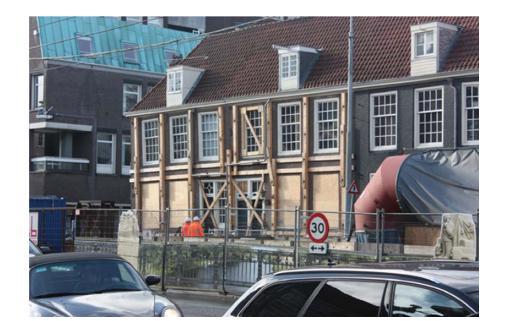
There was severe inflow of water and soil through a panel joint for the first time on the 19th of June 2008 in the west wall of Vijzelgracht Station. The excavation depth was approximately NAP -12 m at that time. The leak was attributed to a steel stop end which could not be removed at this location and the failure of the jet grouting repair method. This leak of water and soil resulted in substantial settlement-up to 140 mm-and damage in the adjacent buildings. To stabilise the historic buildings a timber framework was installed, see Figure 2. More details of the damage to the adjacent buildings are described in Korff et al. (2009). The settlement was mainly the result of ground loss into the excavation causing a strong reduction of the coneresistance of the first sand layer, the bearing strata of the wooden pile foundations; consolidation

Figure 2. A timber framework was installed to stabilise the historical buildings after severe settlements.

effects due to pore pressure reduction were minor. It was possible to stop the inflow only after substantial backfill and polyurethane injection.

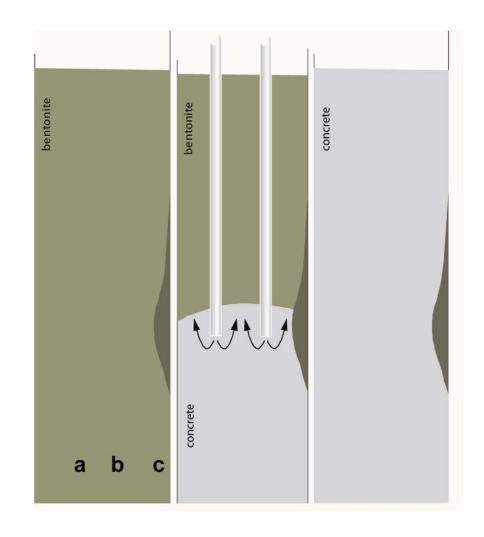
The bentonite inclusions are most likely caused by a combination of suboptimal circumstances during the installation of the walls, such as delays after removing the steel stop ends, after cleaning the bentonite slurry, the inclination of the stop ends and very thick reinforcement bars relative to the aggregate size of the concrete. Moreover the bentonite slurry had to be replaced entirely in several panels when it became too viscous probably because of an unfavourable interaction with the soft mix, used to stabilise the very soft top-layers and to replace bored obstacles. In addition, cleaning the bentoniet in the trench with the 5.2 m-wide panels from just one pump position and concreting with only one tremie pipe could have contributed to the development of a large bentonite inclusion. All the causes listed here attributed to the trench being not fully cleaned with fresh bentonite just before concreting (Figure 3a). During concreting, the thick bentonite was therefore not removed by the concrete, as seen in Figure 3b. The result is a bentonite inclusion in the concrete, as shown in Figure 3c.

Figure 3. Forming of a bentonite inclusion during the concreting of a panel in three subsequent stages.

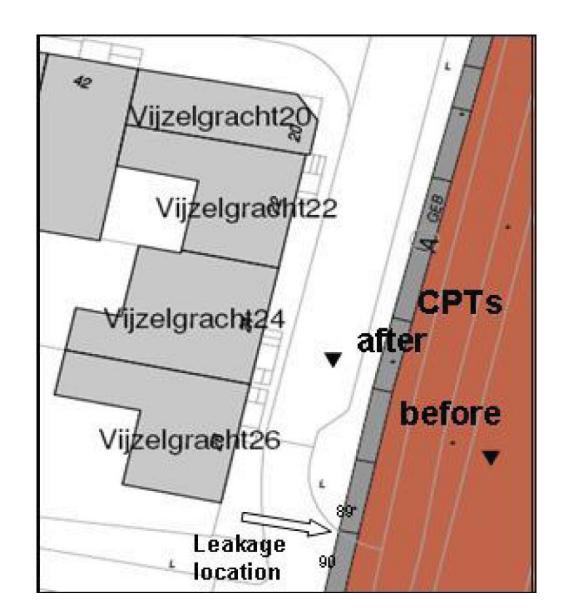
Investigations were undertaken, including Cone Penetration Tests (CPTs) to determine the amount of soil disturbance, which reached about 20 m away from the joint where the soil inflow occurred, see Figure 4. Examination of CPTs performed immediately after the first incident (see Figure 5) indicates that there is clear evidence of the 1st sand layer (between NAP -12 and -14) having been disturbed in the region of the panel joint 89/90. The second sand layer also shows disturbance.

Figure 4. Situation of CPT's at first incident.

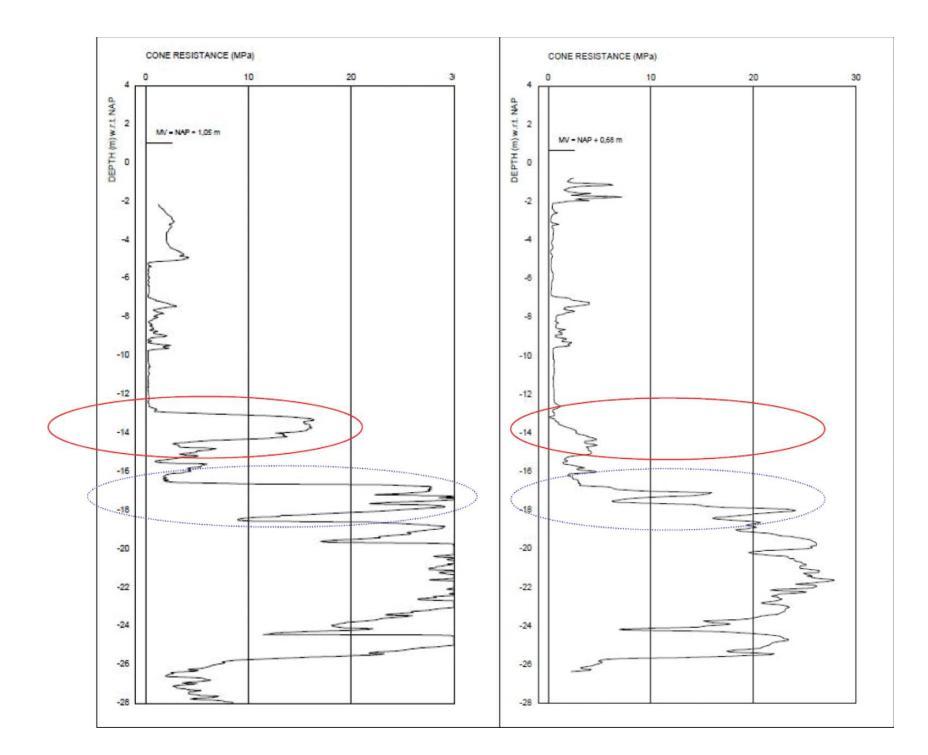
The CPT's show cone resistance, q_c , values of the 1st sand layer to have reduced significantly adjacent to houses 4 to 8 Vijzelgracht. The largest reduction to 6–7 MPa was found at the location of the houses 4 and 6 Vijzelgracht. Other CPTs at greater distance from this region show q_c values in excess of 20 MPa.

The reduced q_c values of the 1st sand layer are consistent with considerable loosening caused by a significant volume of sand being washed through the leaking panel joint. During the second incident, some disturbance of the second sand layer was also evident from the CPTs.

Figure 5. CPT's before (left) and after (right) first incident.

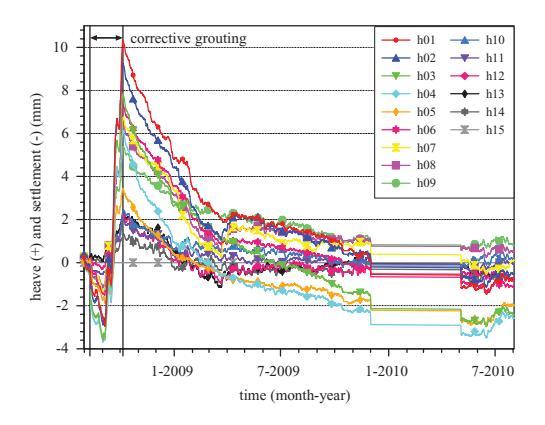
Figure 6. Results of corrective grouting underneath Block VZG 20–26, from Bezuijen et al. (2011).

due to ground loss) the efficiency of the corrective grouting process was very low. Ongoing settlements were found up to at least 5 months after finishing the grouting, see Figure 6. The buildings responded to the grouting in a relatively stiff manner, probably due to the temporary stabilizing timber cross beams, which made analysis of the grouting process difficult. Details of the corrective grouting can be found in Bezuijen et al. (2011).

After bracing the buildings, it was decided to apply corrective grouting to increase the bearing capacity of the sand and to lift the buildings. For the final restoration of the buildings a new foundation will be installed. It was implicitly demonstrated that the end bearing capacity of the pile foundations had been restored, when lifting of the buildings proved possible and stability of the building had been assured. Moreover, it showed that it was possible to apply further grouting to compensate for future settlements from ongoing construction of the station.

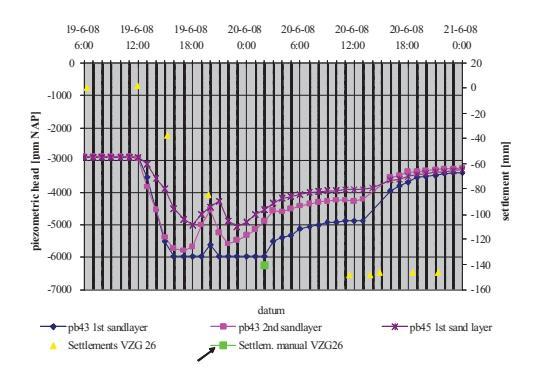
Another possible early warning could be the readings from the piezometers installed in the different aquifers. These data were recorded every hour. Figure 7 shows the pore pressure readings (left axis) in the first and second sand layer during the first events as well as the total station reading as the manual levelling system (right axis). These measurements can be compared to the data from the diaries of the supervisors during the first incident:

At 13.00 the pore pressures first show signs of leakage by a draw down of nearly 1 m in the closest observation wells. Ten minutes later (13.10) the first inflow was recorded. So in this case neither the prism's nor the pore pressure transducers showed any early sign of the coming event.

Figure 7. Monitoring data during first event.

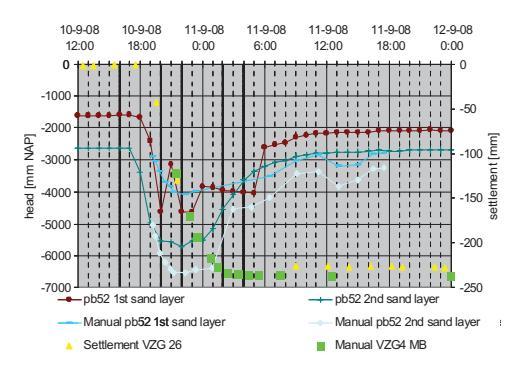
Figure 8. Monitoring data during second event.

Figure 8 shows the monitoring data during the second event.

During the second incident, the pore pressure transducers in the second sand layer show a first draw down of nearly 1 m at 18.00 hours, while the first inflow of water was observed at 18.45 h. This could have been a signal for immediate back filling instead of going on with mounting plates.

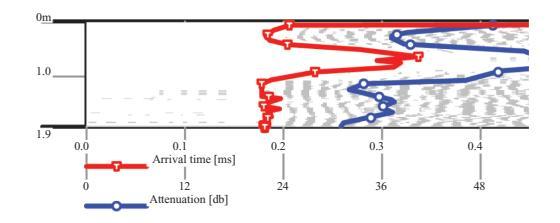
Figure 10. The response of Cross-Hole-Sonic-Logging over a D-wall joint, partly filled with an inclusion (Spruit, 2011).

Figure 9 shows the layout of different monitoring systems at the joint between two D-wall panels as recently applied in a test in a D-wall project in Rotterdam and on a regular base at a D-wall project in Delft, Netherlands. The cross-hole seismic logging method was validated using a D-wall test block with a height of 2 m with a known inclusion. The measurements, see Figure 10, showed a clear increase of arrival time and of attenuation of the sonic waves (Spruit, 2011).
