Comparison of monitoring techniques for measuring deformations in an excavation

De Vos L., Van Alboom G., Haelterman K.
Geotechnics Division, Flemish Government, Ghent, Belgium

Maekelberg W.
TUC RAIL, Brussels, Belgium

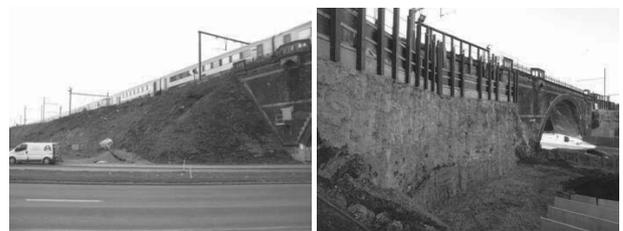
Figure 1. Picture of initial situation (left) and picture of the jet grout wall after excavation (right).

The monitoring site is located in Belgium, Anderlecht (Brussels), where an extra railway track will be constructed alongside the existing tracks. For the foundation of the new bridge, a nailed jet grout wall was installed next to the existing railway. By doing so, the soil could be excavated vertically and

the foundation could be realised in an open construction pit. The excavation depth is 12.5m starting from the railways. The jet grout wall starts 4m below the railway level and has a total length of 21m. HEB profiles with a length of 21m are inserted in the jet grout wall. Five rows of nails are installed over the excavated depth. Figure 1 shows pictures before excavation and after excavation. The excavation is executed in different phases. Each time 2m is excavated and consecutively, a row of nails is installed. After installation of the nails, the contractor waits at least 2 weeks before excavating the consecutive part. More information on the site can be found in Van Alboom et al. 2012 and Verstraelen et al. 2013.

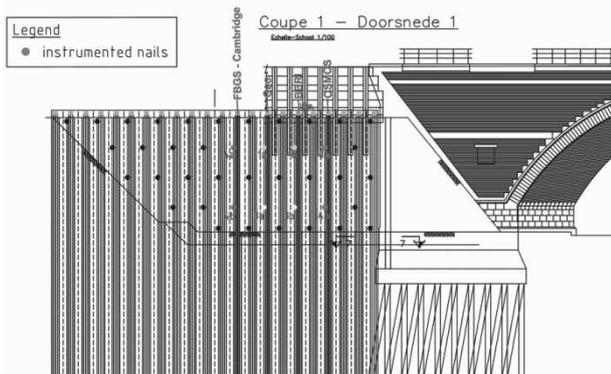
Figure 2. Front view of excavation with indication of instrumented HEB profiles.

The equipment for measuring the deformation of the wall or stresses in the wall, is placed on 4 HEB profiles which are lowered over their full length in the jet grout wall. Figure 2 shows a front view of the excavation site and the location of the instrumented profiles is indicated in red. Figure 3 shows a drawing and some pictures of the FBG and BOTDR fibers which are fixed to the HEB profile. The FBG fibers are fixed in small anchor blocks which are welded to the HEB profile (size of the anchor blocks is 18mm x 18mm). Those anchors are placed every 0.5m in the upper 8m of the profile and every 2m for the lower part. The BOTDR fibers measure the strain continuously, but are locally glued to the HEB-profile (every 0.5m and 2m) for better comparison with the FBG data. To measure deformations and moments perpendicular to the wall, fibers are placed on the top and bottom flange. To measure possible deformations parallel to the wall, two extra fibers are placed at the sides of the bottom flange. Extra L-profiles, placed above all fibers, are used as a protection during installation.

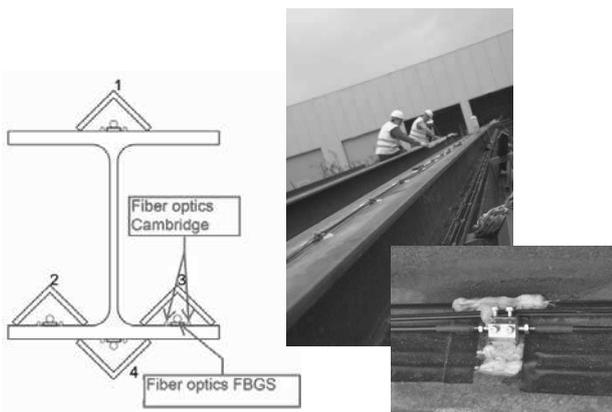
Figure 3. Sketch and pictures of a HEB profile which was instrumented with two optical fiber systems.

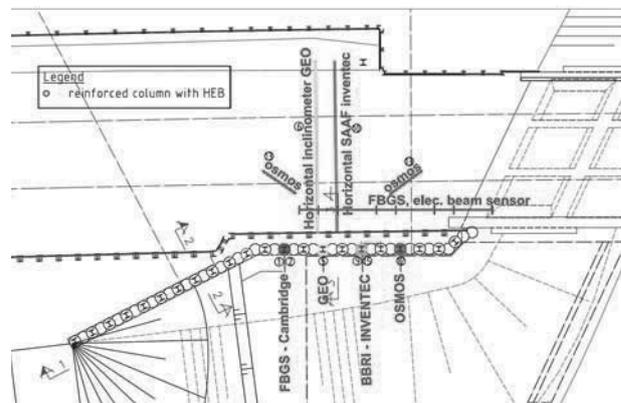
Figure 4. Top view of installed equipment.

Figure 4 gives a top view of the instrumentation which is placed on or underneath the railway tracks. It also shows the different HEB profiles which were instrumented.

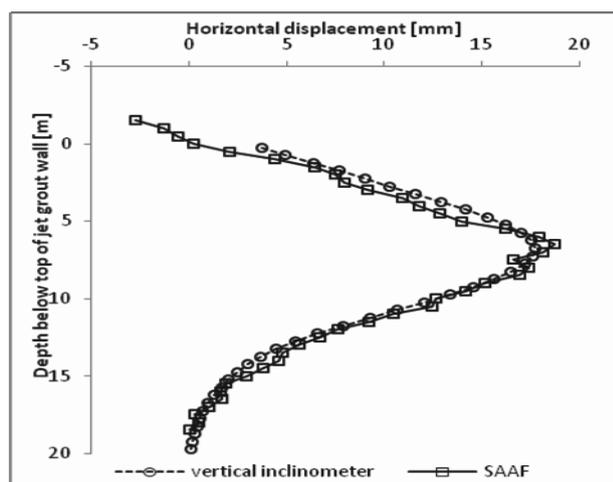
Figure 5. Horizontal deformation of the HEB profile on 07-03-2012.

Figure 5 shows the horizontal deformation of the HEB profiles, measured with the traditional inclinometer and the SAAF. These measurements are both made on the same date and are taken after the installation of the fourth row of nails. The excavation depth at that time is 7m. The data fit very well together. The data from the SAAF start above the reference zero level (which is the top of the grout wall), as the HEB profile did not reach full depth and protruded about 1.7m above the top of the grout wall.

The maximum horizontal displacement, measured after full excavation, amounts to 21 mm (26/04/2012) at a depth of 6.5m below the top of the grout wall for the inclinometer and 21.6mm for the SAAF. This lies very close to the calculated value of 22mm. It is found however that the direction at which the maximum deformation is found for the SAAF deviates slightly from the expected angle (perpendicular to the wall). This is probably due to a very small twist in between the different elements of the SAAF.

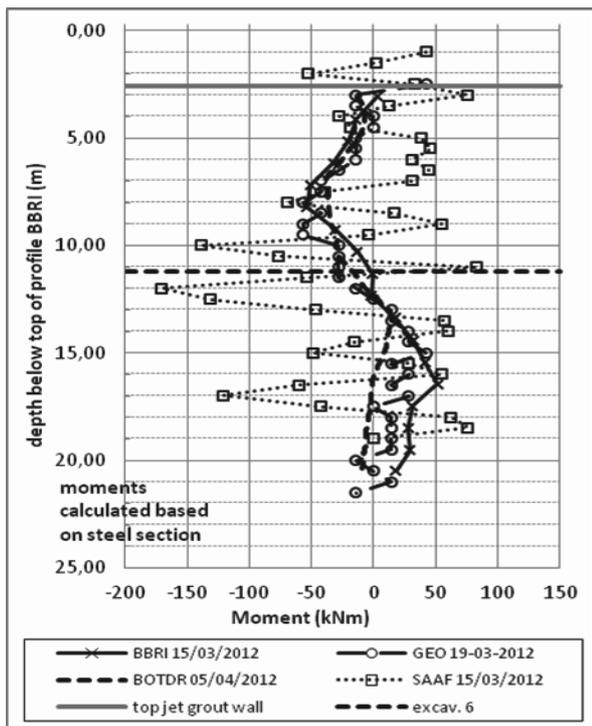
Figure 6. Bending moment HEB profile after the last excavation.

Figure 6 shows the bending moments derived according to Eq. 1 and Eq. 2 for the different measuring techniques (except for the optical strand, as this does not result in a bending moment as a function of depth). Unfortunately, a lot of the FBG sensors placed by FBGS failed during the first weeks after installation. For this reason, they are not included in the graph. For the stiffness of the wall, the stiffness of the HEB profiles was used, as the instrumentation is placed on these profiles.

Figure 6 shows that all derived bending moments give comparable values, except for the SAAF. This can be explained by the fact that the deformation measurements of the SAAF are less "smooth". As the bending moment is a result of the derivative of the measured inclination, this results in unexpected peak values.

A maximum bending moment of about 55 kNm is derived from the measurements. This is again in the same order of magnitude as the calculations (maximum calculated bending moment of 65 kNm). For the optical strand, the derived bending moment is about 35kNm, which is considerably lower than the other measurements. Due to the smoothing which is used for the BOTDR measurements, the peak bending moment is also reduced and has a value of 39kNm, which is also less than the value obtained by the inclinometer and the FBG technique from the BBRI. The shape of the bending moment curve however, is comparable to the other results.

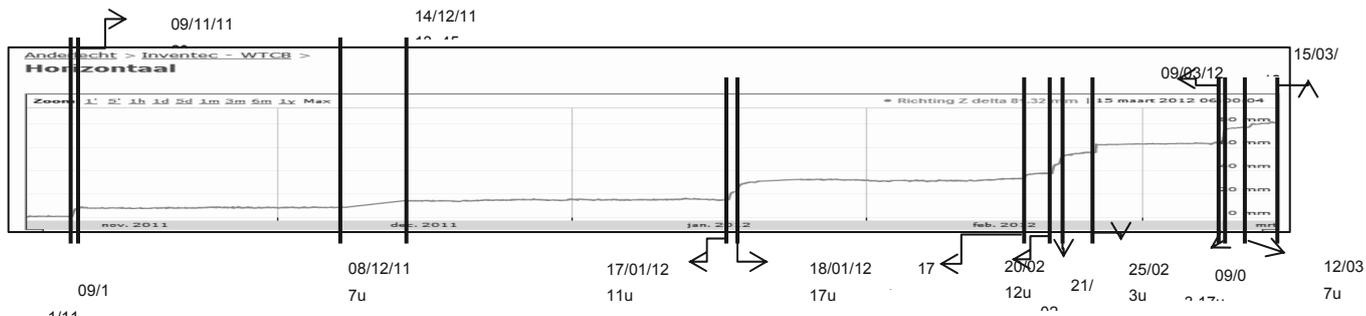
Figure 7. Maximum settlement as a function of time for the horizontal SAAF.

The calculated settlement prior to installation is 5mm. The measurements indicate a maximum settlement varying between 50 mm and 70mm for the different measuring techniques, which is much larger than the calculated value. Figure 7 shows the evolution in time of the maximum settlement value as measured by the SAAF. It demonstrates the great advantage of measuring continuously.

When comparing Table 1 with Figure 7, it can be seen that the discontinuities in the settlement curve correspond each time with the installation of the nails. In Verstraelen et al. 2013, it is explained that this is due to the execution of the jet grout nails. The settlement on 25/02/2012 is caused by lifting the tracks, due to which the inclinometer was locally displaced.

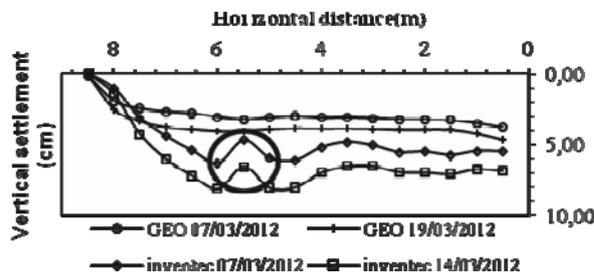
Figure 8. Settlements measured with hor. SAAF and hor. inclinometer.

Figure 8 shows the settlement measured by the horizontal inclinometer and the SAAF on two different dates. The zero settlement point corresponds with the fixed point on the Berliner wall. A significant difference between the settlements measured with the two techniques can be observed (approx. 30%). When comparing with the topographical levelling, it can be concluded that the measurements made with the horizontal SAAF are closest to the real settlements. This can be explained by the limited length of the inclinometer tubes (8m) and the fact that the stiffness of a traditional inclinometer tube is quite high for such a short distance (and large settlements).

The “bump” in the measurements of the SAAF (circled in Figure 8) is caused by the lifting of the tracks on 25/02/2012, as explained above. This “bump” has no influence on the settlement which is measured at the end of the railway tracks.
