Preservation of slope stability along the by-pass Vlora

Bozo L.
POLIS University

Allkja S.
ALTEA& GEOSTODIO 2000 Shpk

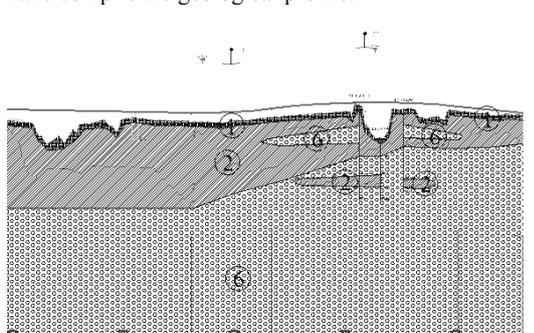
From BH we have discover some different layers and we have compile the geological profile.

Fig. 1 Geological Profile

4.1.1 By description of layers and SPT-tests we have evidence six layers (Table 1)

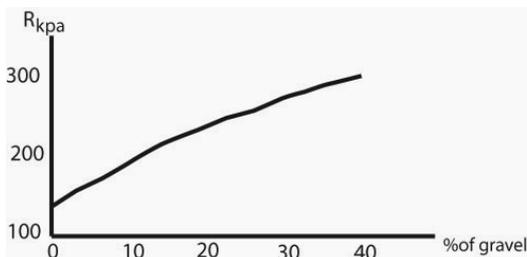
After elaboration of the results from laboratory tests and in situ tests we have take the following correlations :
 Correlation between bearing capacity of each layer “R” and percentage of gravel.

Fig.2 Correlation between R and percentage of gravel

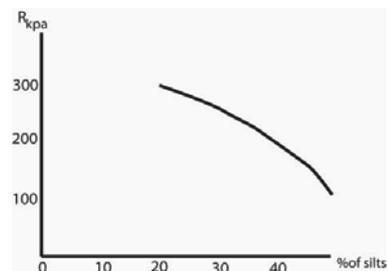
Correlation between bearing capacity “R” and percentage of silty grains

Fig.3 Correlation between R and percentage of silty grains

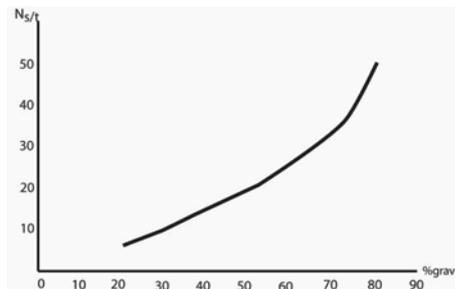
Correlation between N_{SPT} and percentage of gravel grains

Fig.6 Correlation N_{SPT} and percentage of gravel grains
