Stability of underwater slopes realized by means of a suction dredger

ABSTRACT

In Flanders (Belgium) large amounts of sands, to be used in the construction and glass industry, are excavated by means of suction dredgers. It showed that for deep excavations the dredging process cannot be modelled by conventional methods. In order to comprehend the process of breaching a laboratory test set up was elaborated and a full scale breaching test was performed.

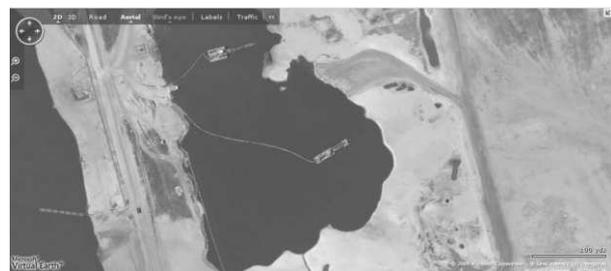
The full scale breaching test was performed at a typical sand extraction site in Flanders, as shown on aerial view – figure 4.

Figure 4: Aerial view of test site

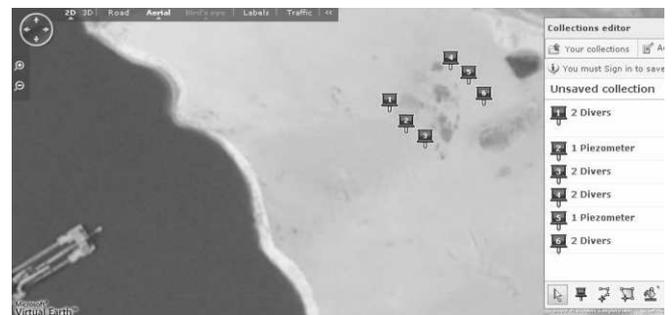
The emplacement of the piezometers is also shown on the aerial view figure 9.

Figure 9. Emplacement of piezometers

The piezometers have a filter element of 2m, placed of depths of resp. 3m and 15m and are equipped with divers (ceramic pressure sensors in stainless steel housing with a memory capacity of 24000 measurements)

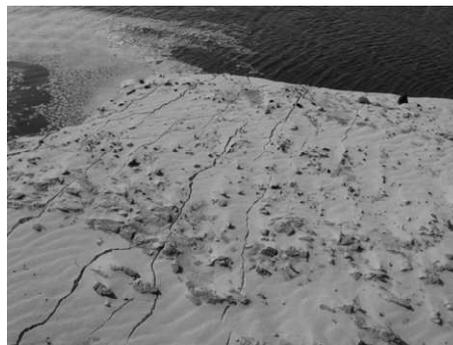
Figure 12: Fissuring at surface level.

Figure 12 shows a picture of fissuring observed at surface level.

The video recordings confirm these findings, and show a steadily progressing instability front during breaching. With regular time intervals soil layers with a thickness of some decimeter come apart and then gently slide away.
