Improvement of transition zones for an old embankment

V. Cuéllar & J. Valerio

J.A. Rivas & M. Rodríguez

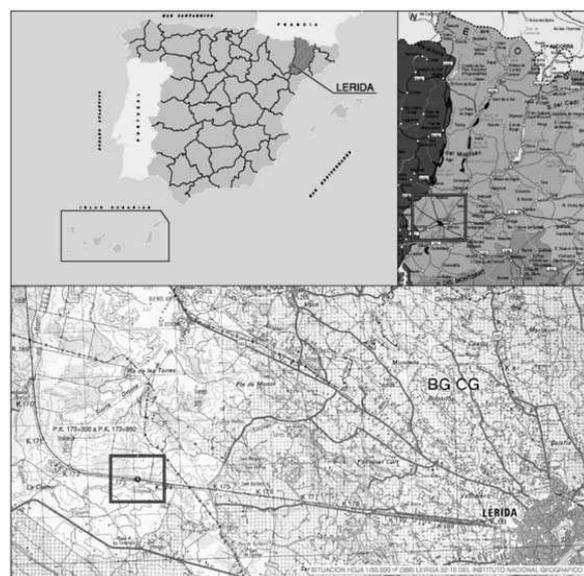
Fig 1. Montagut site in the conventional line Zaragoza-Lerida

To carry out the work assigned to the Spanish partners within that task, ADIF selected, at the beginning of the year 2007, the transition zones between an underpass concrete block and an old embankment 8 m high at Montagut, near Lérida, in the conventional railway line Zaragoza-Barcelona (see fig. 1).

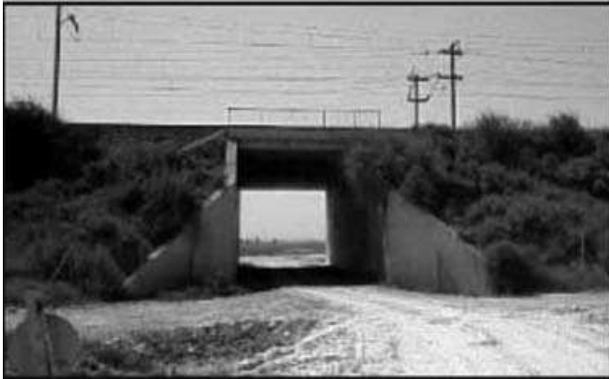
Fig 2. Reinforced concrete block at Montagut

The underpass structure consists of a reinforced concrete frame 8 m high and wide (see fig. 2), that in order to provide a safe passage under the track was pushed against the embankment by the time the high speed line Madrid-Zaragoza-Barcelona, running parallel to the conventional line, was constructed (see fig. 3).

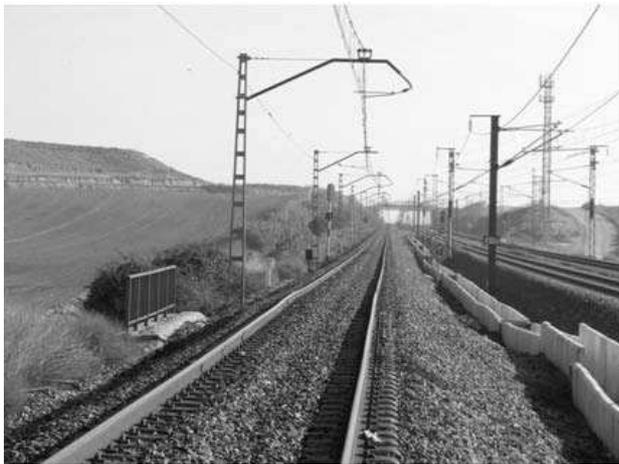
Fig 3. Conventional line at Montagut

At the time at which Montagut was selected to carry out the study, there was in that point of the conventional railway line a strong limitation of speed (10 km/h) for the operation of both conventional and passenger trains due to the bad state of the track, requiring frequent tamping (see fig. 3). To overcome that problem ADIF had prepared a project to improve the core of the embankment at both sides of the concrete block based on the methodology described by Cuéllar (1999) and Santos & Cuéllar

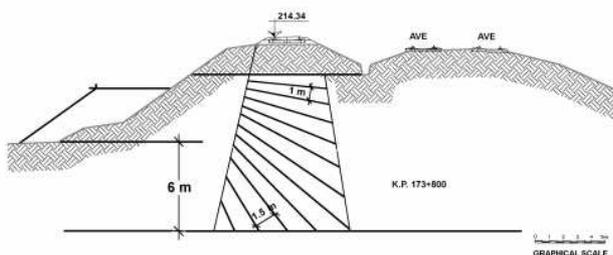
Fig. 4. Initial retrofitting procedure designed

(2000) for repairing railway embankments without interrupting the traffic of trains by injecting stable mixtures of cement from a side berm previously placed against the embankment (see fig. 4). That technique had been proved to be highly efficient in the improvement of a transition zone of the Amposta viaduct over the Ebro river, as related in a final report for the SUPERTRACK (2005) project, carried out within the 5th Framework Programme of the European Commission.

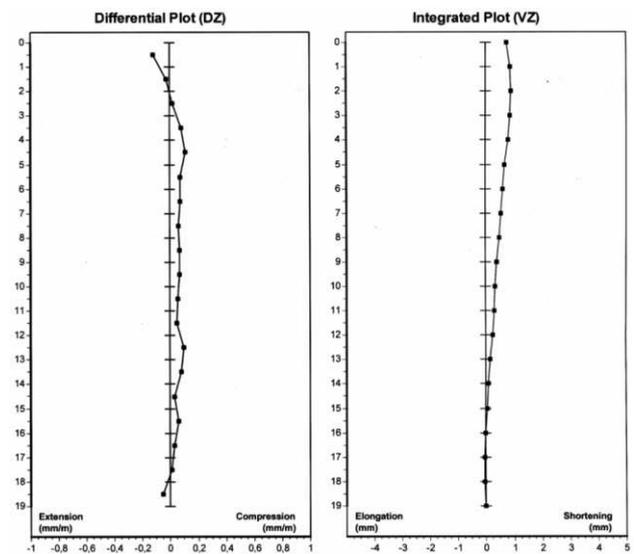
Fig. 5. Relative and accumulated settlements at Montagut

In those figures, the measurements recorded along the three reference axes of the equipment: axle "z" for settlements and axles "x" and "y" for horizontal displacements have been plotted against depth, every one meter. In each figure, two graphs can be observed: the first, on the left side represents the strains (mm/m) at each depth relative to the reference measurements carried out on May 17th, and the second, on the right side, stands for the accumulated movements (mm) from the bottom of the borehole obtained at each depth. Concerning the behaviour of both, the core and the foundation of the embankment, no significant deformations can be observed in those figures.

After the borehole was drilled, a PVC tube provided with metallic reference marks, at about 1 m of separation each other, was installed inside and attached to the borehole walls by means of a stable cement mixture that was injected between the borehole wall and the tube. After the mixture had set up, a reference measurement of the "x", "y" and "z" coordinates of the metallic marks inside the tube was achieved inserting the TRIVEC probe between two consecutive marks along the tube on May 17th 2007. A second lecture was made on June 12th 2007, after some heavy rains fell on the site. The results obtained are provided in fig. 5 to fig. 7.

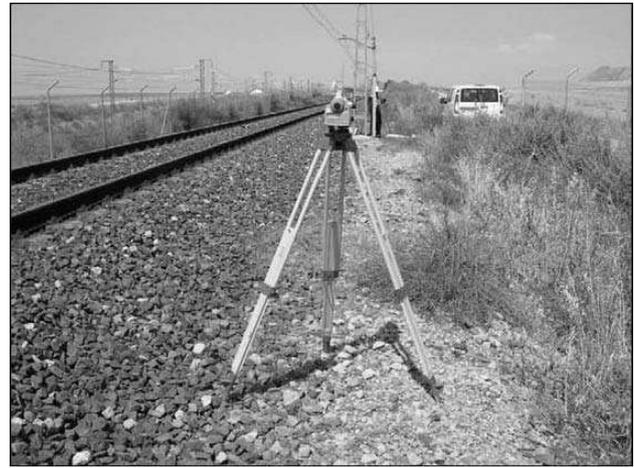
Fig. 8. High precision instruments used in the levelling surveys

The levelling surveys were performed with a high precision digital level of the ZEISS DINI 12 type and invar sights 3 m long (see fig. 8). To carry out the surveys a double geometric levelling procedure, forward and backward, was adopted. The error committed in each level measurement made has been less than 0.01 mm.

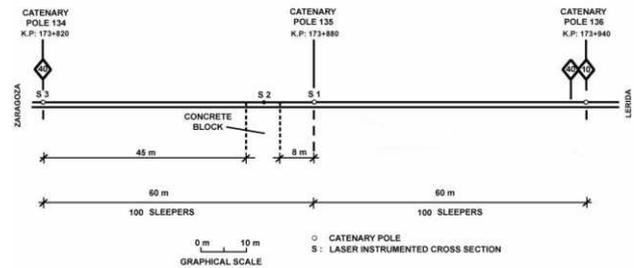
Fig. 9. Track cross sections instrumented on July 2007

conditions, at some representative points of the conventional railway line near the concrete structure. Accordingly, the three cross sections indicated in fig. 9. were chosen.

Cross section S1 was located at K.P. 173+880 in front of catenary pole n° 135 at 8 m from the concrete structure in the Lerida direction. Cross section S2 at K.P. 173+869 in the middle of the concrete structure and cross section S3 at K.P. 173+820 in front of catenary pole n° 134 at 45 m, from the concrete structure in the Zaragoza direction.

In each one of those cross sections, a reference base to monitor the external rail deflection of the track was built: attached to the catenary poles in cross sections S1 and S3 and fixed to the concrete structure in cross section S2.

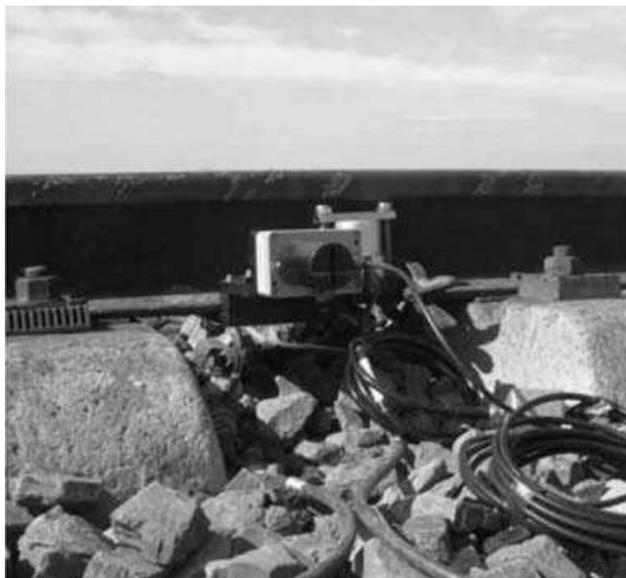
Fig.10. Laser receiver clamped to the base of the exterior rail

- One laser beam receiver, to measure the vertical deflections of the rail with an estimated error of 0.01 mm (see fig. 10)
- Two extensometer shear bands $2.12 \mu\text{V}/\mu\text{e}$ sensitive, to determine the loads induced by the traffic operating the line (see fig. 11)

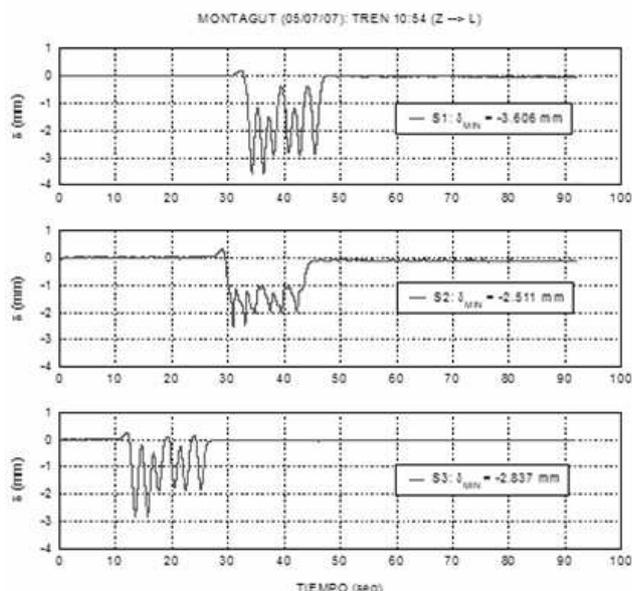
Fig. 12. Locotractor rail deflection time histories on 05-07-07

Fig. 12 shows the rail deflection time histories obtained in the three cross sections under the passage of the locomotive convoy at 10 km/h in the Zaragoza-Lerida direction on the 5th of July. Slightly different values were obtained for the convoy travelling in the opposite direction.

On the 5th of July 2007, when monitoring the pass of the locotractor convoy over the concrete block, the laser system was moved by mistake to cross section S2(4T) located four sleepers more in the Lleida direction, at 2.4 m from cross section S2, so data concerning the rail deflection in cross section S2 were not collected that day. The track stiffness value for cross section S2(4T) given above was estimated assuming for cross section S2(4T) the same load time history as the one recorded in cross section S2 when the locotractor convoy passed over the concrete block that day. Due to that error, the rail deflection time history assigned to cross section S2 in fig.12 really corresponds to cross section S2(4T).

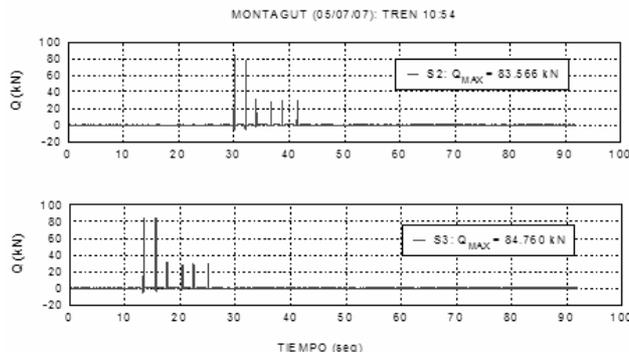
Fig. 13. Locotractor load time histories on 05-07-07

Converting the shear band micro-strains into shear forces and adding the shear forces provided by two consecutive shear bands, the load time histories induced by any moving car in any one of the three cross sections instrumented can be obtained. Unfortunately shear band Q1 installed in cross section S1 in the Lerida side failed on the last day (5th of July). Fig. 13 shows the load time histories induced in the remaining cross sections, S2 and S3, by the locotractor unit that day. It can be seen that they are almost the same.

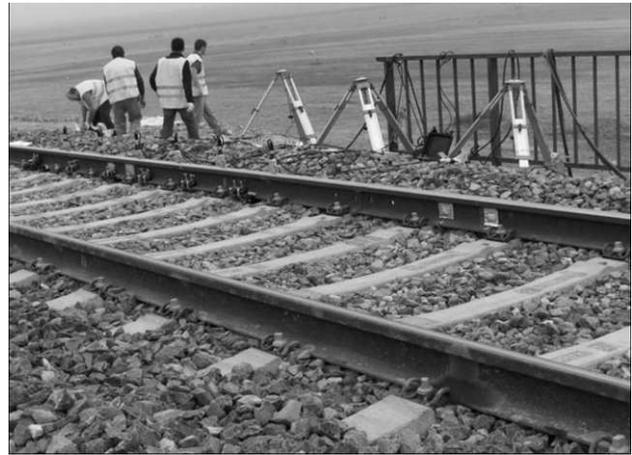
Fig. 22. Laser systems at cross section S1N on October 2008

On October 16th, three laser systems were installed in cross section S1N, which for that purpose was subdivided in other three cross sections denominated S1N1, S1N2 and S1N3. To identify each one of them, sleepers over the concrete block were given an integer number: starting with 0 at the center of the structure and increasing continuously in the Zaragoza direction. Accordingly, laser system in cross section S1N1 was located between sleepers 3 and 4, and those corresponding to cross sections S1N2 and S1N3 between sleepers 6 and 7 and sleepers 8 and 9 respectively. It was also checked that sleepers 6 and 7 were still in the concrete block with sleeper 7 just at its edge, in the Zaragoza direction, while sleepers 8 and 9 clearly laid on the transition zone very close to the concrete block (see fig. 22).

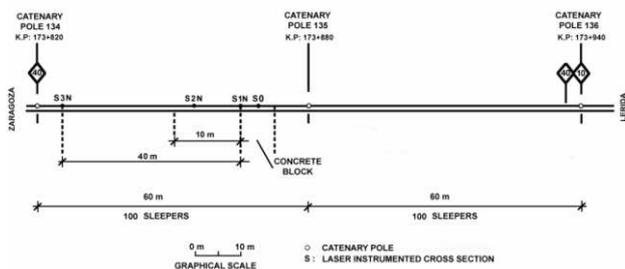
Fig. 21. Track cross sections instrumented on October 2008

In order to assess the efficiency of the final solution adopted, a last in situ campaign was undertaken on the 16th and 17th of October 2008 aimed to determine the improvement achieved in the track stiffness values over the concrete block and the adjacent transition zones. During those days cross sections S0 S1N, S2N and S3N indicated in fig. 21 were monitored with the same type of sensors as those used when instrumenting cross sections S1, S2 and S3 on July 2007, the only significant difference resting on the use in this time of movable tripods (validated in other measurement campaigns) as reference bases for the laser systems.

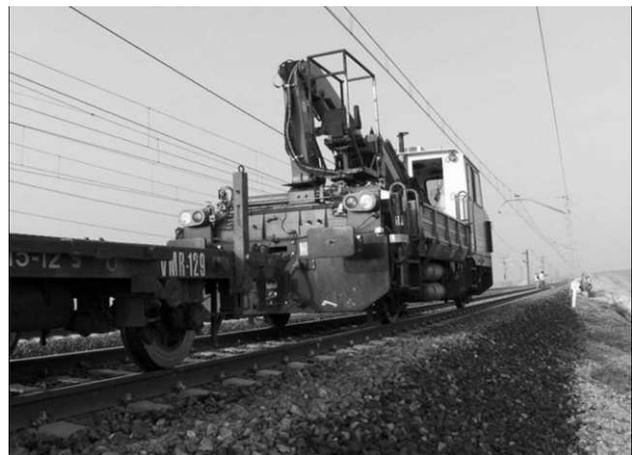
Fig.23. Locotractor convoy provided by ADIF on October 2008

The locotractor convoy provided by ADIF during those days consisted of a locomotive with 6 T wheel loads and two platform wagons providing 1 T per wheel each, see fig. 23.

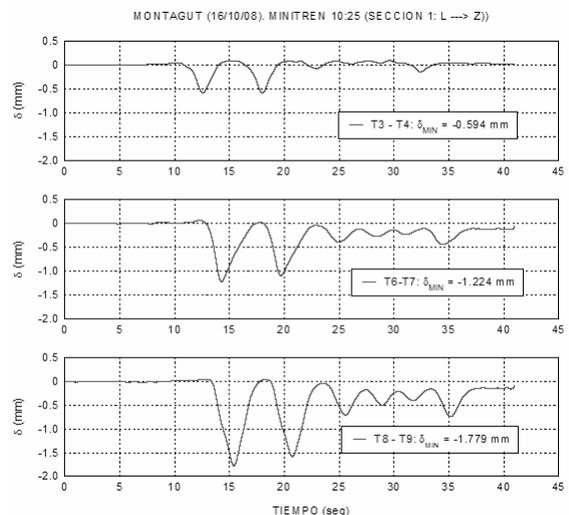
Fig. 24. Locotractor convoy data provided on 16-10-08

Fig. 24 shows the rail deflection time histories induced in cross sections S1N1, S1N2 and S1N3 by the locotractor convoy travelling at 4 km/h in the Lerida-Zaragoza direction on the 16th of October. The same type of information obtained in cross sections S0, S2 and S3 on the 17th of October is provided in fig. 25.

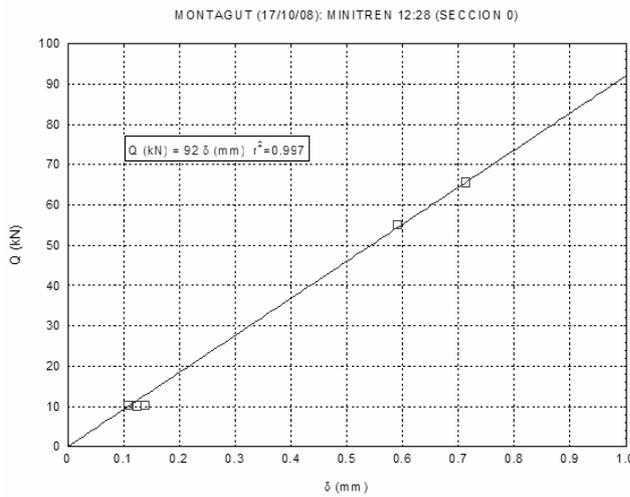
Fig. 26. None seating load detected in cross section S0

Plotting locotractor wheel loads against rail deflections, graphs similar to the one presented in fig. 26, for cross section S0, were obtained in all the other cross sections on the 16th and 17th of October. They all reflect the non-existence of seating loads associated to a poor mechanical behaviour of the ballast.

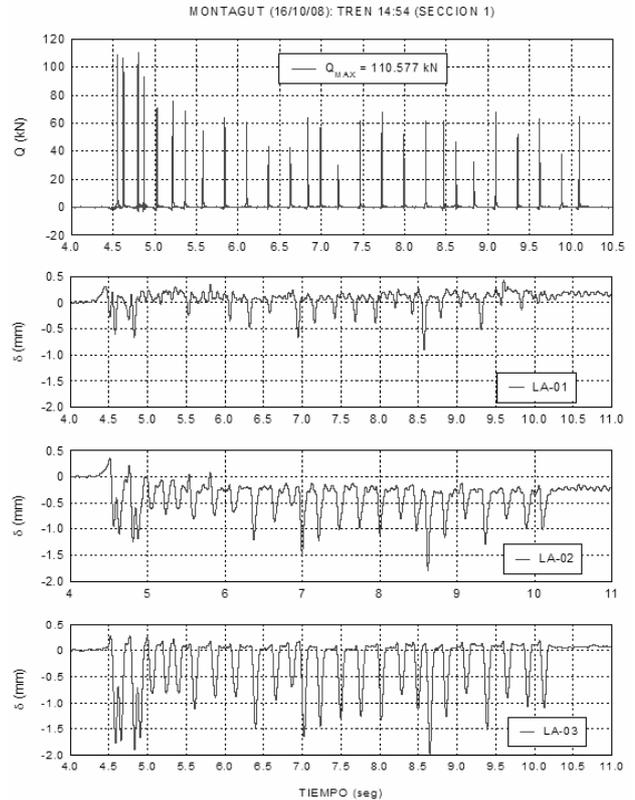
Fig. 27. Talgo train time history data in cross section S1N on 16-10-08

The effect on the different cross sections of commercial trains operating the line at speeds higher than 150 km/h is presented in fig. 27 and fig. 28. In those figures the load time histories induced by Talgo trains on the two groups of cross sections analysed on the 16th and 17th of October are also given. From the wheel loads in both figure the following mean values can be derived:

- For cross section S1N: 64 kN
 - For cross sections S0, S2N and S3N: 55 kN
- Dividing those loads by the mean values of the deflections induced in the different cross sections, the following track stiffness values have been evaluated:
- On 16-6-08:
 - o Cross section S1N1: $K = 120 \text{ kN/mm}$
 - o Cross section S1N2: $K = 81 \text{ kN/mm}$
 - o Cross section S1N3: $K = 58 \text{ kN/mm}$
 - On 17-10-08:
 - o Cross section S0: 86 kN/mm
 - o Cross section S2N: 95 kN/mm
 - o Cross section S3N: 85 kN/mm
