# Influence of the rate of construction and of rock mass strength reduction on the stability of deep cuts in marl

K. Štern

### ABSTRACT

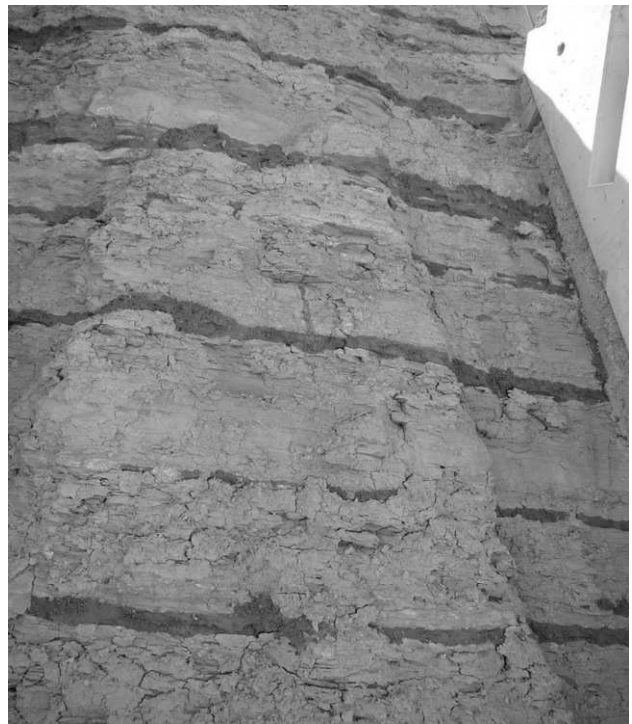
Figure 1. Bedding of the excavation with visible sandstone aquifer layers.

The basic rock mass of the area in question is formed by miocene sediments, sandy marls, sandstones and siltstones. They alternate, with prevailing marl layers. According to the mineralogical petrographical data the rock mass is carbonate clayey siltstone and calcite muscovite quartz marly claystone. Sheet minerals of claystones and siltstones are predominantly oriented along the bedding, which results in strong hygroscopicity of the rock mass. Between the marl and sandstone layers there are layers of fine grained mica quartz sandstone and grey sandy siltstone of different thicknesses.

From the hydrogeological aspect the area belongs to areas with poor permeability. The first type of water is represented by water in the weathered cover layer and appears locally. The second type is water in the rock mass. It appears in sandstone with double porosity. It flows in from open cracks, and partially also from intergranular porosity, and it leaches in the form of dripping. The water in the cracks is located in hydrologically closed system under hydrostatic pressure of 5 bars.

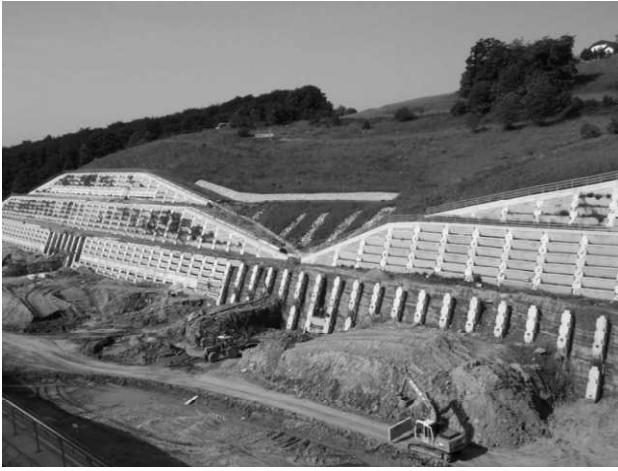
Figure 2. View to retaining wall OZ-05 during construction

Slopes of a 520 m long and 30 m deep cut are protected by retaining structures. On the left side there is structure OZ-05 along the whole length of the cut, while on the right side there are two shorter separated structures. The supporting measures are designed using unified system of anchored prefabricated structures, distributed long the slopes with intermediate berms. The protection of slopes is foreseen at all sections of the cut, where the cut height reaches the height of the lower 9.0 m high level. The concrete columns, geotechnical anchors, binding beams and fills between columns are installed gradually, adapted to the final heights of individual levels. From the aspect of time and logistics, such construction is slow and time consuming.

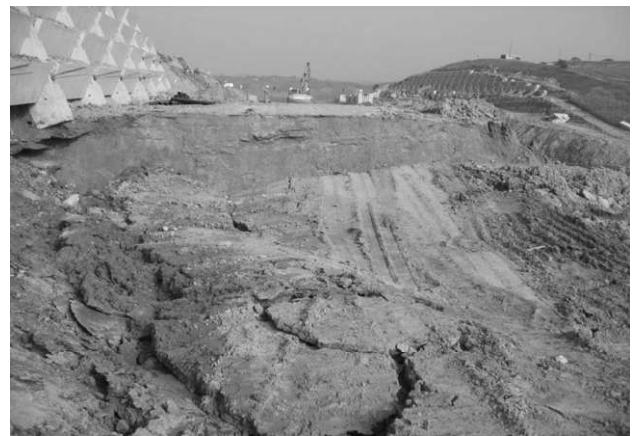
Figure 3. Slide in marl at the medium berm

front of the structure did not ensure adequate resistance, nor was it stable in the locally performed excavation, which resulted in a minor local failure of marl at the middle berm.

All the above stated observations required immediate action to prevent further deformations. The first measures related to the interruption of the excavation works, convey of ballast material in front of the failed slope, immediate anchoring of all the constructed columns and installing additional anchors at the foreseen points.

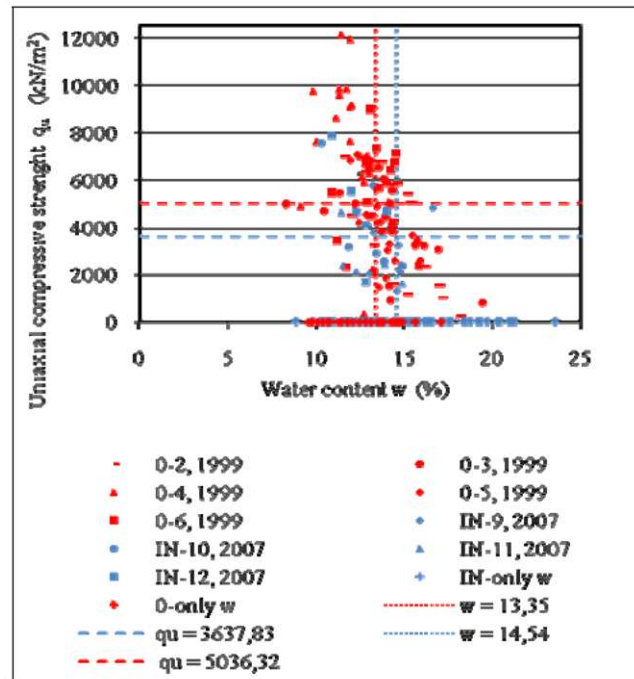
Figure 5. Relationship between natural water content and uniaxial compressive strength from the investigation phase (red) and from the construction phase (blue)

The data analysis of uniaxial compressive strengths shows that material strengths in slopes of active cut are lower than strengths recorded in the time of natural condition. The decrease of average compressive strength, measured for the total depth and for all samples, is on average 28%, from the average value of  $q_u = 5036$  kPa to  $q_u = 3637$  kPa. In individual adjoining boreholes this ratio may even be higher.

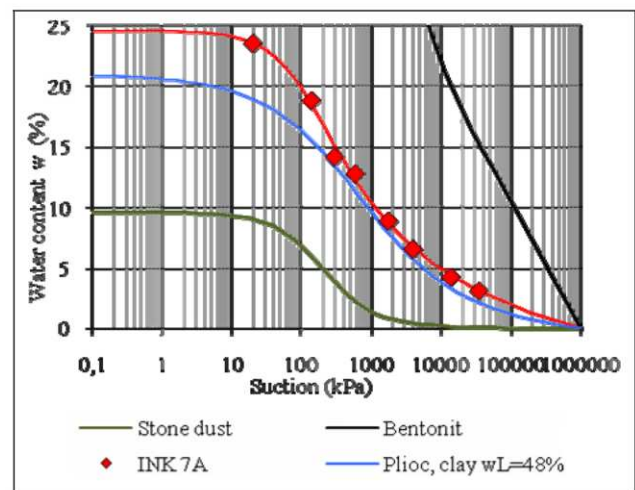
Figure 6. Relationship between suction and water content

Natural water contents of marls from the time of investigations were between  $w = 8.3$  and  $19.4\%$ , on average  $13.35\%$ , while during construction they reached the values between  $w = 7.52$  and  $25.25\%$ , on average  $14.46\%$ . The transition of the soil from the zone of residual water content to desaturation zone was at the water content between 8 and  $10\%$ .

Based on the above data the investigated marl is outside the critical area of residual water content, where no major volume deformations can be expected.

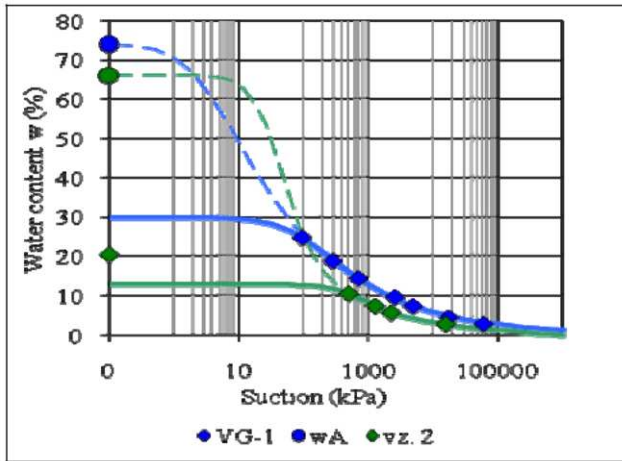
Figure 7. Retention curves defined for marls from the cut

The soil constantly referred to as marl is clayey in character. According to the Atterberg plasticity limits it belongs to the group of low plasticity (CL) clays. According to its retention curve (Petkovšek 2007) its behaviour in contact with water is very similar to medium plasticity clays. According to some data (Petkovšek 2006), the mentioned marls also show properties of high plasticity clays.
