Forensic study of the Ohio SHRP Test Road U.S. 23 flexible test pavement

S. M. Sargand & S.-S. Kim
 Department of Civil Engineering, Ohio University, Athens Ohio, USA

ABSTRACT

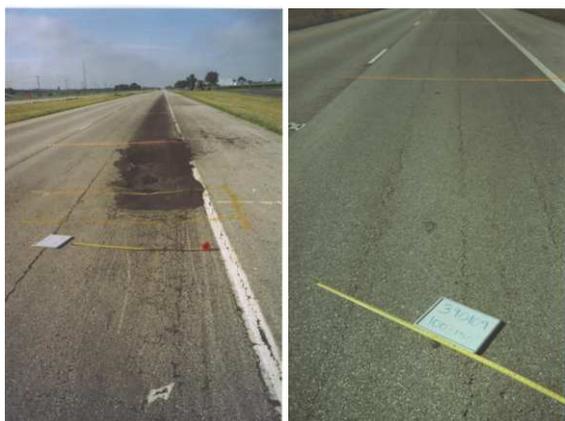
Section 390103 showed the worst overall distress. High levels of rutting and longitudinal cracking were the most prevalent in this section. The longitudinal cracking was present in the center of the lane for the entire length of section 390103, with a mean crack width of about $\frac{1}{2}$ inch. Also, longitudinal cracking of the same magnitude was noted along the inside edge of both wheel paths. Cold patch had been used to repair some of this area (Figure 1). The patching was classified as high severity patch. Extreme distress was indicated at this location. Fatigue cracking was present in approximately 25% of the right and left wheel paths, mostly concentrated at a short section. This fatigue cracking was classified as moderate in severity. Some fatigue cracking was also noticed on the shoulder throughout the length of the section.

Figure 1. Distress photograph of Section 390103 (left) and typical longitudinal cracks (right)

The longitudinal cracking observed in all four sections during trench excavation, was initiated on the pavement surface and was considered to be top-down with low to moderate severity as shown in Figure 2. Unlike the conventional longitudinal cracks which develop at the bottom of asphalt layers under excessive tensile stresses, the top-down cracks initiate from the surface of pavement and seldom reach the bottom of the asphalt layers. Holewinski et al. (2003) summarized several mechanisms and causes of the top-down crack. For each section, the longitudinal crack consistently occurred in the center of the lane in all four sections and did not stray from a straight line path. The longitudinal wheel path cracking occurred on the edge of the wheel path and also was consistent in forming a straight line. The wheel path cracks were shallower than the center line cracks. None of the longitudinal cracks extended all the way to the bottom of the base, most were within the first four inches of the surface. Very similar observations were made during the recent Colorado top-down crack study (Harmelink and Aschenbrener, 2003). Of twenty-five longitudinal crack sites in Colorado, 72% were top-down cracking and 67% of the top-down cracking associated with visual segregation at the bottom of the surface layer. Figure 2 shows the segregation, i.e., a relatively large portion of coarse aggregates are distributed at the bottom half of the surface layer. The Colorado study further identified the source of the segregation. Certain models of pavers caused the early longitudinal cracking at the pavement locations corresponding to the edges of the slat conveyors and the center point of the paver. This explains the straight line longitudinal cracks shown in Figure 1.

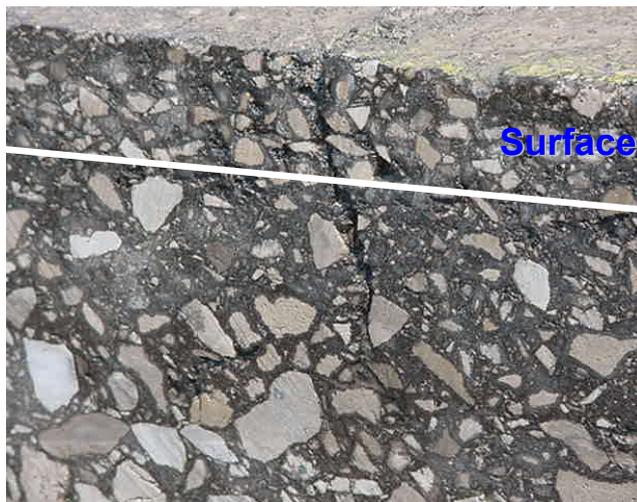
Figure 2. Top-down longitudinal crack and segregation of surface layer

Lateral trenches roughly five feet wide and four feet deep were excavated at locations in each section representing various levels of distress. Three trenches were excavated in Sections 390103 and 390110, and two trenches in Sections 390108 and 390109. The longitudinal cracks were visually inspected as previously shown in Figure 2.

taken from the test sections had a much higher air void content after 4.5 years of heavy traffic loading. This is believed to be due to segregation as previously shown in Figure 2. Asphalt mixes with high air voids generally lead to a high permeability which will allow moisture infiltration.

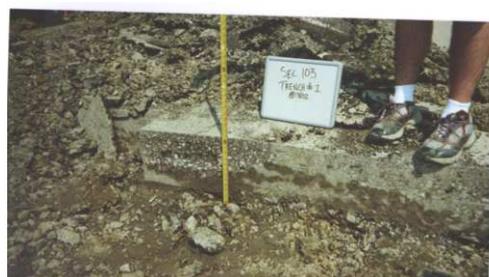
The thickness of individual pavement and base lifts were also measured at three foot intervals with a standard tape measure along the length of each trench and estimated to the nearest

Figure 4. Measurement of lift layers at a trench

¼ inch (Figure 4). In some locations it was difficult to see the layer interfaces. While the extent of rutting was very apparent in some sections, the thickness of the pavement layers remained consistent with their design thickness throughout the transverse length of all the trenches, indicating minimal, if any rutting in the asphaltic material. Some consolidation of the base layers was noted.
