## The restoration of San Pedro cliff at La Alhambra La restauration de la falaise de San Pedro à La Alhambra

J.L. Justo, J. Saura, N. Vázquez, P. Durand & E. Justo  
*Department of Continuum Mechanics, E. T. S. Arquitectura, University of Seville, Spain*

### ABSTRACT

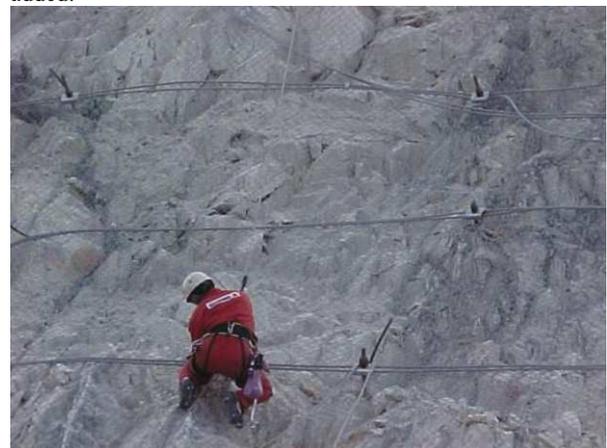
Figure 4. Tecco mesh reinforced by cables (courtesy of Geobruigg)

### 7.2 High yield stress wire mesh (Fig. 4)

It is a rhomboidal mesh, with yield stress 1770 to 2020 MPa and 3-4 mm wire thickness, lying directly on the slope with opening 65 mm. The pressure on the slope (10 to 30 kPa) is applied by post-tensioned anchorages isolated or reinforced by cables. The anchorages may be GEWI bars 25 to 40 mm thick. Anchored cables 20 to 24 mm thick surround the treated zone.

The 65 mm mesh opening is small enough to avoid erosion of the conglomerate and to provide an acceptable visual impact, especially if the present vegetation is maintained (at least the trees and shrubs) and new autochthonous plants are added.
