Protecting the Environment with Geosynthetics

R. K. Rowe

GeoEngineering Centre at Queen's-RMC, Department of Civil Engineering, Queen's University, Kingston, Canada

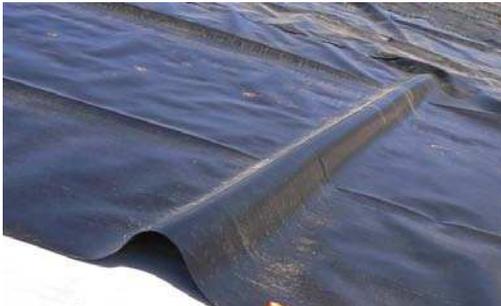
Fig. 1 HDPE geomembrane with a wrinkle

For the applications considered in this paper the geomembrane is invariably ≥ 1 mm -thick and in cases involving a bottom liner it generally will be 1.5-2.5 mm thick. One important characteristic of HDPE and, to a lesser extent, LLDPE geomembranes is that, after being placed, heating by solar radiation can induce wrinkles (Fig. 1) in both black and white geomembranes (although the effect is the most pronounced for black geomembranes). The implications of this will be discussed later.

When exposed to solar radiation a black geomembrane can heat to 40°C (or more in some cases) above ambient temperature. This causes wrinkling of the geomembrane (Fig. 1), as discussed earlier. On a hot day these wrinkles can represent a third of the lined area and have connected lengths (L in Eq. 2) of up to 5000 to 10000 m/ha (Chappel et al. 2012a,b; Rowe et al. 2012). Thus, it is essential that the geomembrane be covered at a time of day when there are relatively few wrinkles (e.g., less than 5% of area) and that leakage calculations have taken account of some wrinkles at the

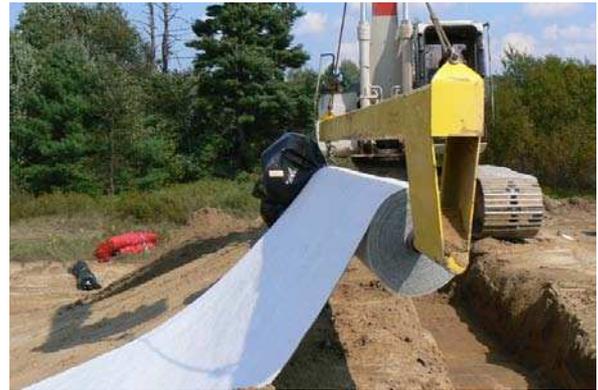
Fig. 2 GCL being unrolled on site as it is installed

A GCL is a manufactured product comprised of relatively low permeability clay (usually bentonite) and one or more geosynthetics. They are delivered to site on rolls (Fig. 2) that are laid down with adjacent panels overlapped to provide a continuous layer of GCL.

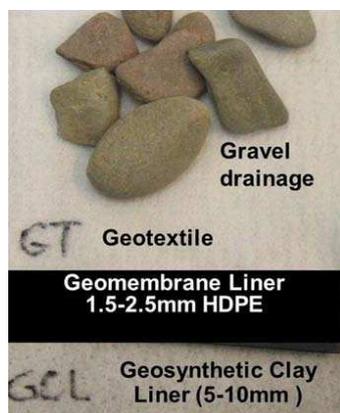
Fig. 3 Typical barrier with gravel drainage layer, geotextile protection layer, HDPE geomembrane, and GCL

Geomembranes and GCLs may be used alone in some applications but most commonly are used together as a composite liner (Fig. 3). As discussed

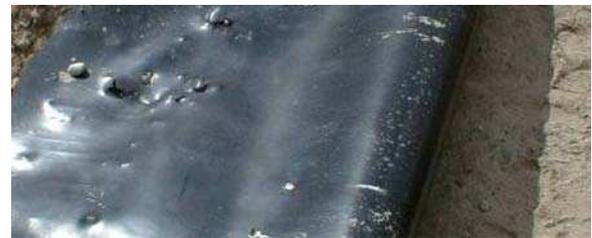
Fig. 4 Geomembrane damaged by stones in an unsuitable foundation (Photo: courtesy of R. Thiel)

GCL and geomembrane panels are rolled out with an overlap to the adjacent panel to allow seaming. This is simple enough. However the foundation should be smooth (no protruding stone, rocks or other objects, and no rutting) and firm (unyielding). A geomembrane can be damaged by isolated angular gravel in the foundation layer both during construction (Fig. 4) and subsequently (Brachman and Sabir 2010). The performance of both a GCL and geomembrane can be badly affected if they are placed on a badly rutted surface (Fig. 5)

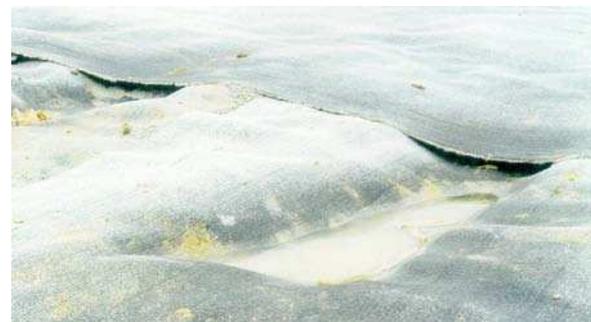
Fig. 5 GCL installed on an irregular/rutted (poor) foundation and not covered before heavy rainfall

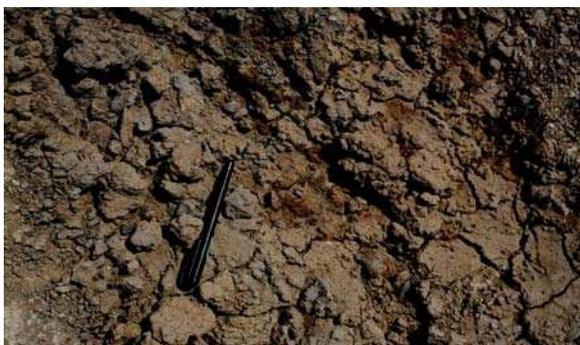
Fig. 6 Eroded foundation layer due to heavy rainfall

Problems can arise during installation even if the foundation was initially satisfactory but is damaged by rainfall events making it wet, soft or

eroding it where liner material has not yet been placed (Fig. 6). In these situations, the foundation needs to be adequately dried and repaired to be smooth and firm before more geosynthetics are placed. If the foundation for a geomembrane is a compacted clay liner, considerable care is required to avoid liner desiccation before the geomembrane is placed. For a GCL, the foundation also needs to be without sharp changes in grade and the GCL should be covered quickly so that the GCL is not exposed to heavy rainfall (i.e., avoid situations as shown in Fig. 5). Placing a geomembrane on a poor underlying foundation or liner (e.g., as shown in Figs 4-6) can substantially increase both short and long-term leakage.

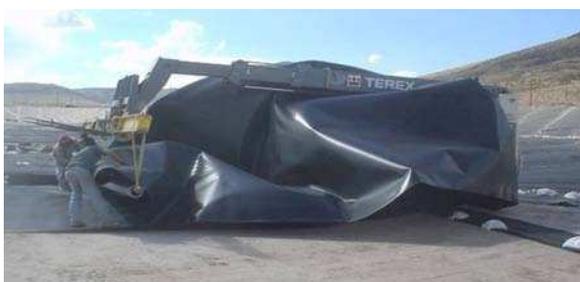
Fig. 7 Geomembrane panel picked up by wind (Photo: courtesy of R. Thiel)

Once the geomembrane has been laid it must be adequately ballasted against wind up-lift or what seemed like a heavy geomembrane soon becomes a very large and expensive waste ball of plastic (Fig. 7) with risks of damage to people and/or equipment.

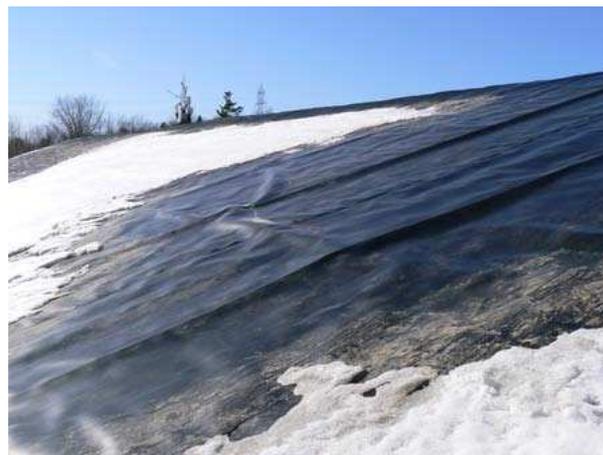
Fig. 8 Geomembrane partially covered by snow but with significant wrinkles in snow free areas on south facing slope

Construction in cold regions can be complicated by the fact that the geomembrane can be at very different temperatures depending on the level of solar exposure/heating. For example, on a day with a cold ambient temperature and snow on parts of the geomembrane, the geomembrane may be hot enough where exposed to direct sun (e.g., a south facing slope in a Canadian winter) to have significant wrinkles (Fig. 8). Thus, as discussed by Rowe et al. (2014b), there is potential for evaporation of moisture and down-slope erosion even on chilly spring days such as that on which Fig. 8 was taken.

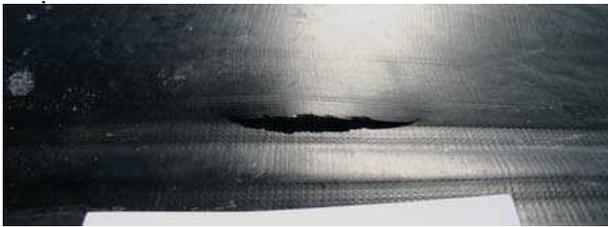
Fig. 9 Defect on underside of a geomembrane weld that would not be detected by an air channel test or casual visual inspection from the top of the geomembrane

Testing of seams (e.g., air channel testing of dual wedge welded seams) is useful for detecting and correcting some problems with seams but it will not detect all problems. For example, the defect apparent in Fig. 9 is on the underside of a white faced geomembrane adjacent to the weld and visually hidden by the geomembrane above. This was not detected by air channel testing, and would not have been detected by a visual inspection unless one looked between the two welded geomembranes. It should be detectable by a suitable leak detection survey, provided the design allows reasonable detection sensitivity (e.g. see ASTM 7007; § 6).

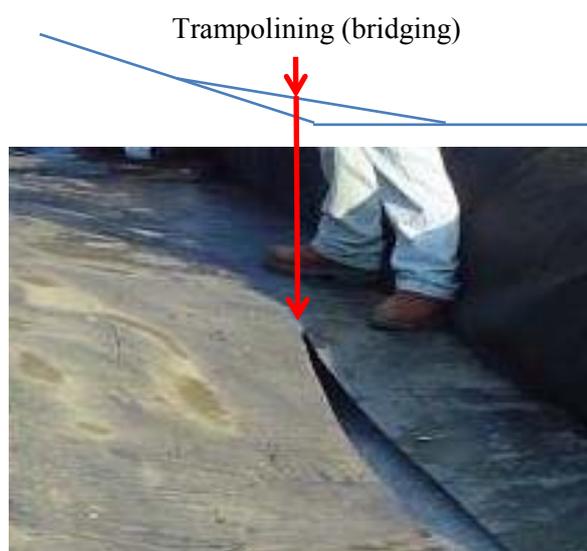
Fig. 10 Geomembrane trampoline (bridging) due to thermal contraction on cooling of the geomembrane if welded at a temperature significantly above the current temperature (Photo: courtesy of R. Thiel)

When the geomembrane is much colder than at the time it was welded and if adequate allowance has not been made for contraction from the as-welded dimensions, thermal contraction caused by cooling of the geomembrane causes the geomembrane to rise up (trampoline or bridge) over changes in slope (e.g., at intersection of side slope and base; Fig. 10) and go into tension both here and elsewhere. These tensions can be “locked” in if the geomembrane were covered in this state. This could cause an immediate tear/hole (especially at a change in slope as shown in Fig. 10) but even if not, the tensions may contribute to long term stress cracking in these locations. Just as the geomembrane should not be covered with too many wrinkles, it should not be covered when
