## A field case study on construction of underground passageway with non-open excavation method

**ABSTRACT:** In this study, the construction process of non-open excavation cases using DSM and TRCM and the field monitoring during construction stage are introduced and the applicability and the stability of the applied method are reviewed. The problems occurred in the fields are drawn out and the settlement profiles of the tunnels during the construction stages are analyzed using the field monitoring results. Although both methods are applied successfully in the site, it was recognized that some complementary measures are necessary to prevent the settlement in soft clay layers. In the future, the usage of non-open methods will be more expanded at the urban areas. The findings in this study would be a good reference for underground passage way installation.

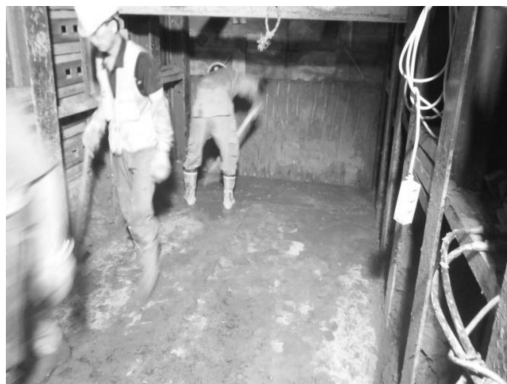
Figure 3. Influx of tunnel groundwater and soils during excavation.

gave difficulties in construction. Figure 3 shows the situation of trouble for arranging the bottom of the tunnel due to large influx of the soft soil and water.

The measures for solving this problem is to increase the number of the multiple steel pipe grouting from 8 layers to 13 layers to protect the tunnel face and the grouting work was extended from starting point to whole length of the tunnel. The depth of the tunnel depth is down to 18.4~19.1 m from the surface and laid down to residual soil layer. This way of counter measure has a disadvantage of the utilization of the passage way since the tunnel location becomes deeper than that of the original plan and the decision was made for the safety of the construction.

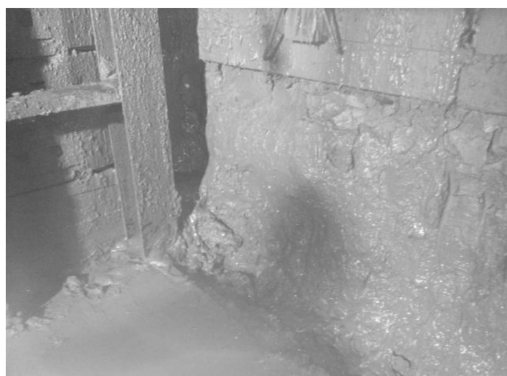
Figure 4. Relaxation of protection board at the bottom of tunnel face.

Figure 4 shows the situation that the protection board is released at the bottom of the tunnel face due to fluidized soil inflow.

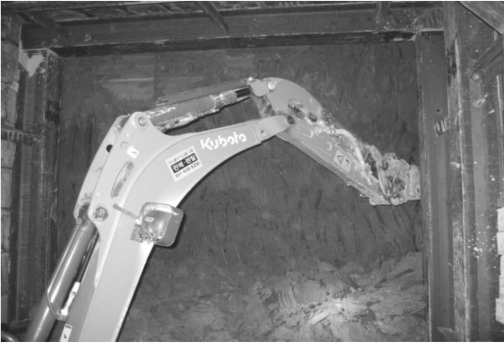
Figure 5. Status of excavation at tunnel face after counter measure.

Figure 5 shows the dried soil conditions during excavation since the soil layer become better as mentioned by Boscardin & Cording (1989). Figure 6 also shows the condition of the tunnel face during excavation after increase of tunnel depth and the change of the soil reinforcement. The advance rate was increase from 0.9~1.8 m/day before the countermeasure to 1.8~2.7 m/day.

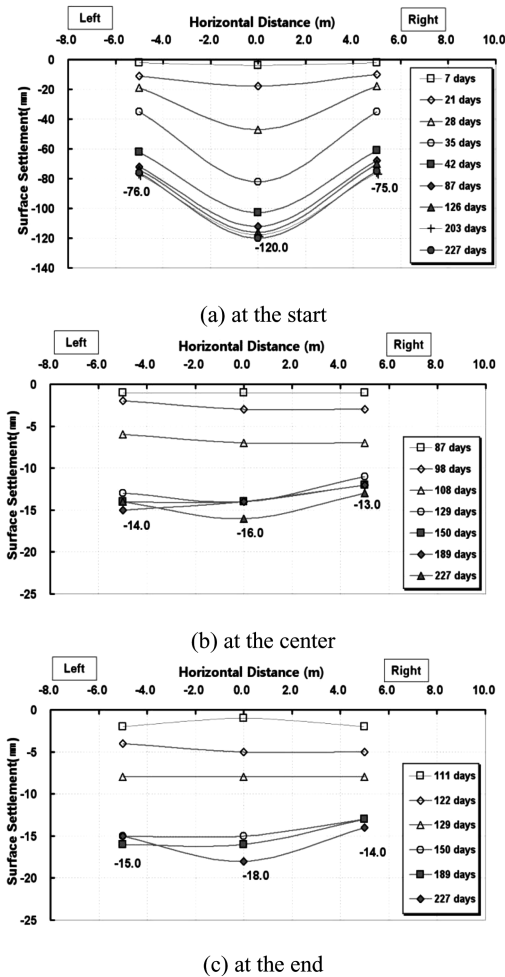
Figure 8. Transverse profile of settlement for various locations in DSM site.

Figure 8(a), (b) & (c) show the trend of surface settlements to transverse direction at three locations. In Fig. 8(a), settlements increase significantly from the initial period up to 120 mm in the center line within 7 weeks. The settlements are stabilized thereafter. According to Figure 8(b) and (c), initial settlements are still high. But the settlements occurred within 16~18 mm and showed a favorable behavior after protective measurements are launched.

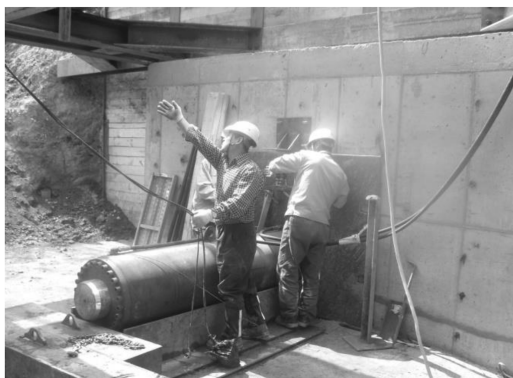
Figure 11. Hydraulic pressure device and the reaction wall.

device with reaction wall to push in the gallery pipe for TRCM method. In Figure 12 air is blown into the pie for manual excavation after the pipe is pushed in. Slab pipe is constructed to transverse direction in the gallery pipe in Figure 13.

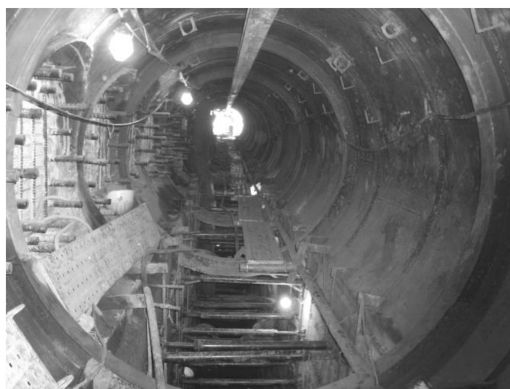
Figure 14. Concrete pouring in slab pipe.

In Figure 14, trench is excavated to form the exterior wall after placing the steel bar reinforcement and pouring concrete in slab pipe. Figure 15 shows the supports with PC panel during the excavation of the trench.

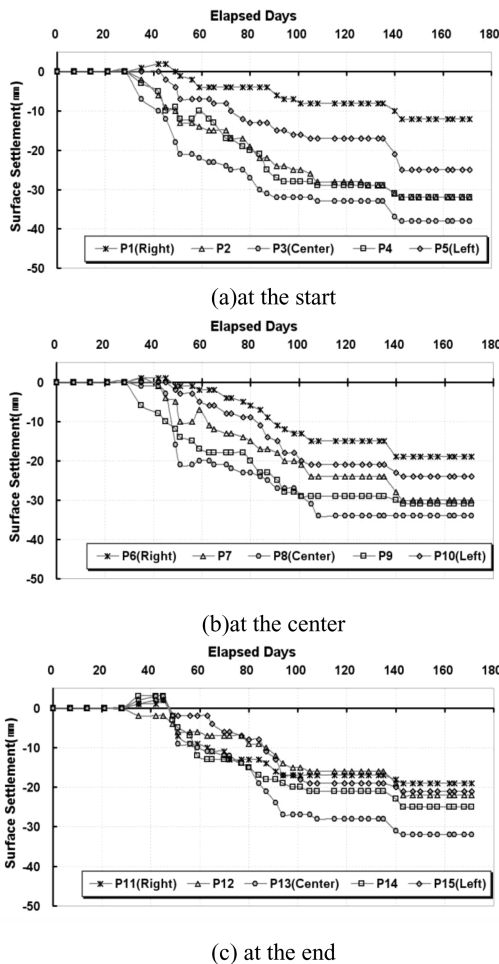
Figure 16. Longitudinal profile of settlement for various locations in TRCM site.

The settlement trends to longitudinal direction in Figure 16 shows the changes in soil behavior around 20 days after the start of construction. This is the time, when the construction of slab steel pipe is started. Continuous increase of the surface settlements are recognized until the construction is completed regardless of the interior excavation of TRCM. It seems that the pushed in construction of the slab pipe disturbed the surrounding soil and the subsequent settlements are occurred due to traffic loads on the road. It tends that usual settlements are caused by the overcutting of soils between the slab pipes during the interior excavation of TRCM.
