Introduction

The failure of the Derna dams, Libya, September 2023

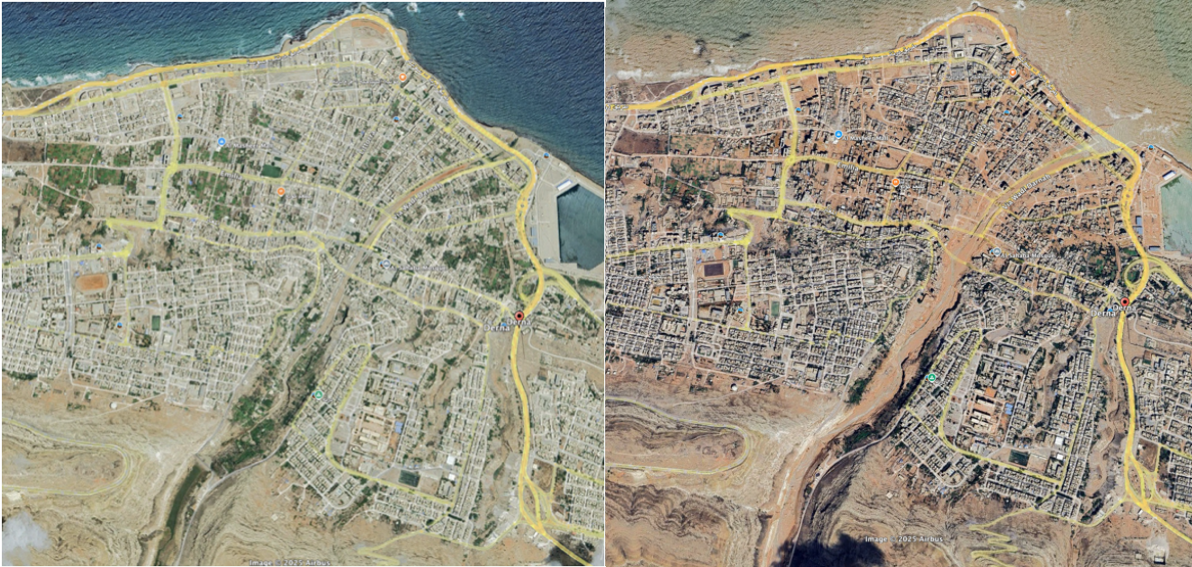
Figure 1. Views before and after the devastation due to the floods in Derna, Libya, on September 18, 2023 (Google earth).

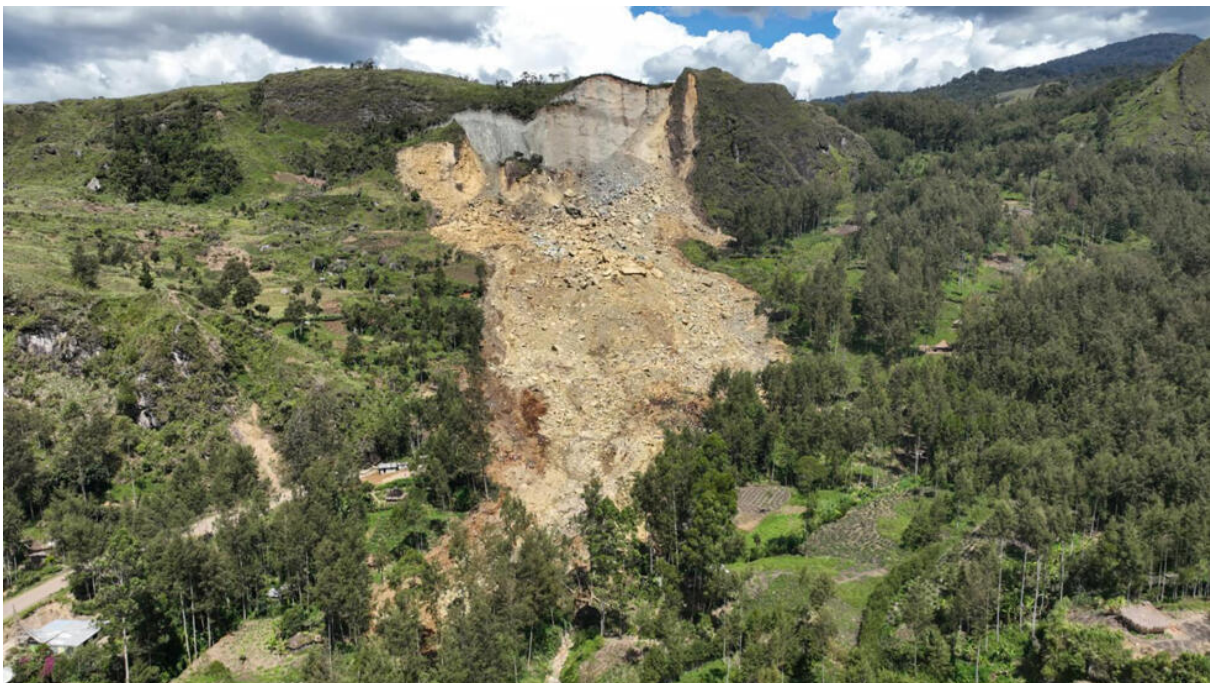
The landslide inundated multiple dwellings, resulting in several hundred fatalities. It is believed to be a rock topple mechanism where toe buckling occurred on very steep bedding (Figure 3), affecting dwellings located near the Highland Highway. Authorities estimate that hundreds of people were living directly below and in the run-out area. The landslide also appears to have triggered multiple rotational and translational landslides, some of which were several hundred metres away from the initial debris run-out area.

Figure 3. The Mutilaka landslide in Papua New Guinea (24/5/2024). The landslide is 650 m long. (Photo Dr. Jan Kupec).

The team proposed a realignment of the roading corridor to avoid an area considered highly susceptible to further landslides, including rainfall triggered slope instability.

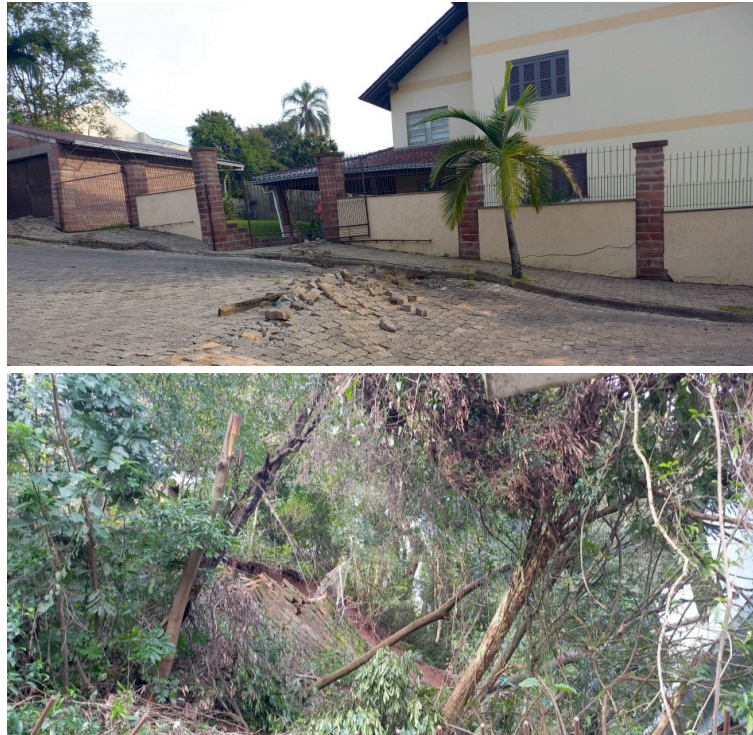
In Santa Cruz do Sul, observations showed that the main cause of the problems lied in pre-existing instabilities that were worsened by rainfall. The entire region has been subject to ground movements for years, and this intense event not only intensified the problem (see Figure 6) but also, in a way, exposed the underlying causes.

Figure 6. Cracks in streets and instability suggesting large scale ground failure.

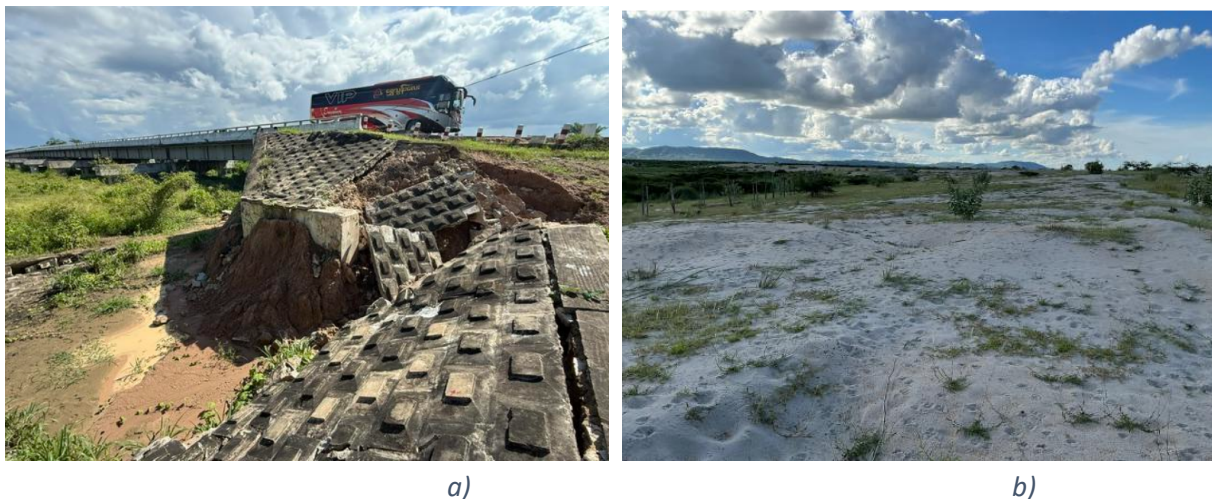
The earthquake severely impacted Myanmar’s transportation network, especially the Yangon–Mandalay Highway. Extensive liquefaction-induced settlement led to uneven road surfaces and distorted alignment. The photo in Figure 8a shows bridge abutment damaged due to lateral spreading of soils, resulting in severe structural failure. Liquefaction damage with sand boils were also observed in an under-construction site of shopping mall in Mandalay (Figure 8b) and widespread in a village close to Naypyidaw, the capital of Myanmar. In this area, low converted N value based on dynamic cone penetration tests and a shallow groundwater table approximately 1.2 meters below the ground surface confirmed high susceptibility to liquefaction.

Figure 8. a) Abutment damage along the Yangon – Mandalay highway; b) sand boils at shopping mall site, Mandalay.

- Strengthening foundations and embankments against liquefaction,
- Retrofitting vulnerable soft-storey structures,
- Expanding seismic monitoring networks,
- Developing regional hazard assessments that incorporate long-period seismic impacts.

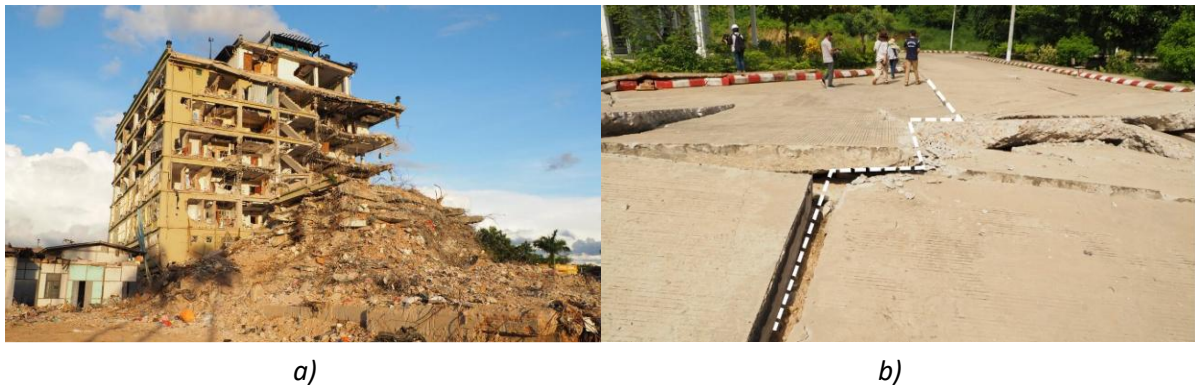
In various buildings in which ground floors consisted of columns with very few shear walls (Figure 9a), it was observed that lower stories completely crushed, whereas upper floors resisted better. This highlighted a fundamental design deficiency that must be urgently addressed in future seismic design codes and retrofitting programs, particularly for reinforced concrete buildings in high-risk areas.

In some places, the fault could directly be observed at surface, like in Naypyidaw where the observed ground motion intensity was high. Figure 9b shows a significant right-lateral displacement accompanied by shear deformation of the ground surface in the Children's Specialized Hospital. Buildings situated directly atop the fault rupture that sustained severe damage, whereas a room located about ten meters away from the rupture suffered much less damage. This confirmed that, in this area, the primary cause of fault-induced damage was surface deformation rather than ground shaking.

Figure 9. a) Sky Villa condominium in Mandalay (207 fatalities); b) Children's Specialized Hospital in Naypyidaw.

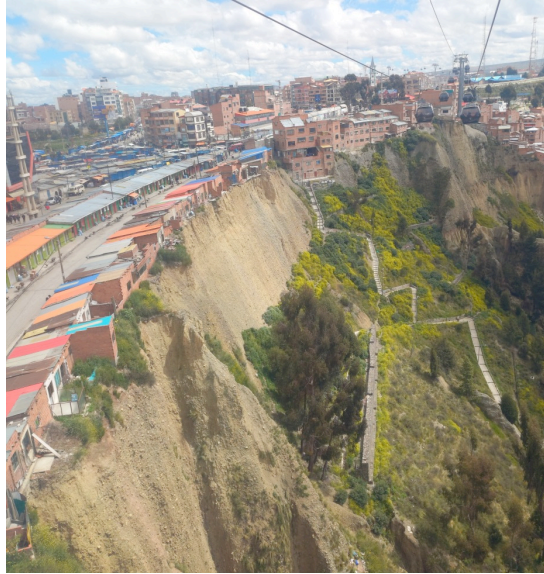
Figure 10. Slope in partially saturated soil in the city of La Paz.

- Slopes in partially saturated soils that can remain stable with almost vertical gradients as long as the suction pressure remains sufficiently high (Figure 10).
- Colluvial deposits that, due to precipitation conditions, increase their interstitial pressure and induce large-scale movements.

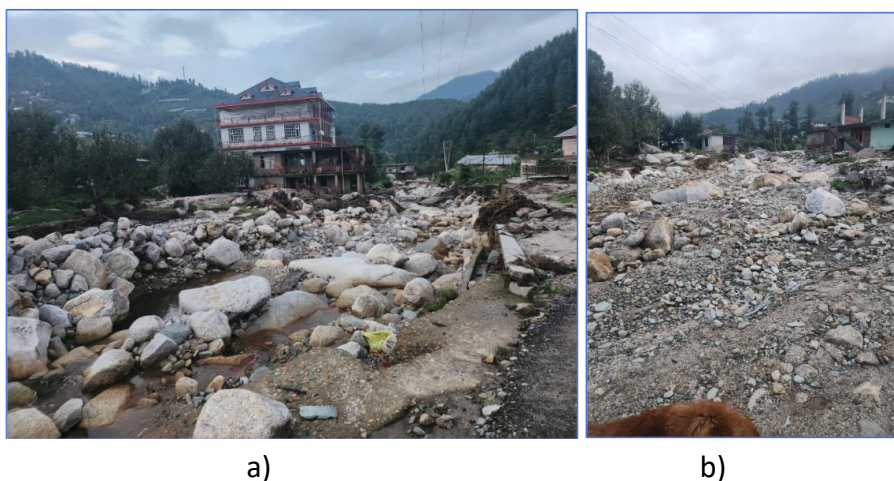
The area of Janjehli (Figure 14) demonstrated a typical cascading scenario, where coarse particles, including large boulders, were transported and deposited across dry and semi-active gulleys as well as into the riverbed. The interaction of dry flow over existing channels suggests intermittent flow activation. Exposed bedrock and the collapse of multiple houses were observed in the deposition zone.

Figure 14. Landslide in Janjehli a) exposed bed rock with big boulders and rocs b) multiple houses collapsed with left out deposition of debris over bed

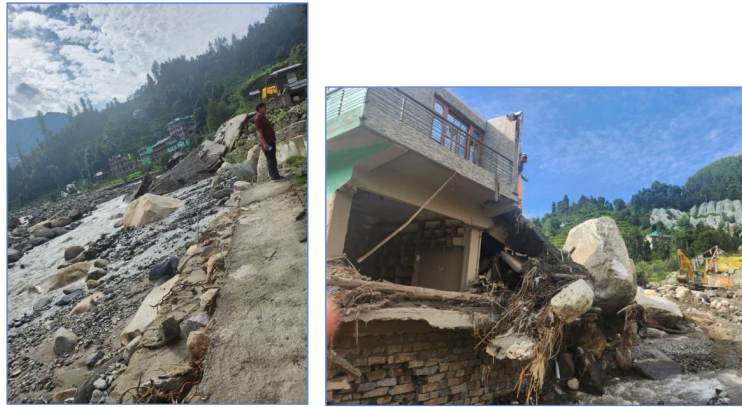
In Pandav Shila (Figure15), the failure included riverbank erosion and a strong flow-structure interaction. The mass movement here dammed the local river and destroyed nearby homes, primarily due to the impact of boulders within the debris striking built structures. This is

another instance of cascading failure, where an initial slide evolved into a debris flow that altered the river course and intensified destruction.

Figure 15. Landslide in Pandav Shila a) Eroded banks b) Flow-Structure interaction caused house collapse

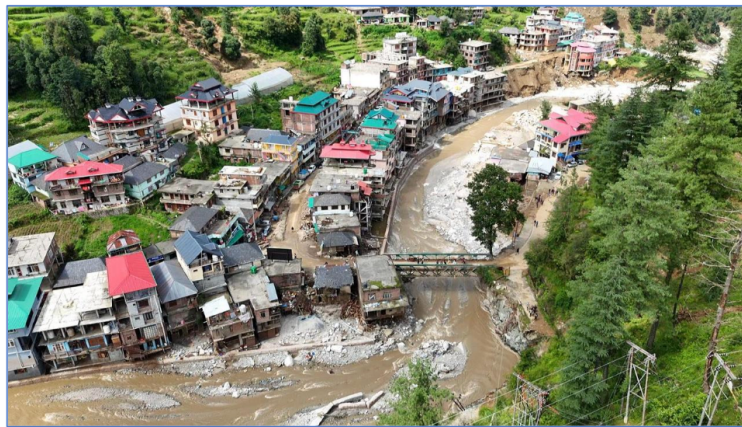
The Thunag valley (Figure 16) represented the most complex and severely affected site, characterized by multiple overlapping processes like landslides, debris flows, bank erosion, and river damming which is occurring in close sequence and spatial proximity. This is a textbook case of a cascading geomorphic event, where each process fuelled the next, resulting in extensive landscape transformation and infrastructure damage. Figures 11 and 12 capture the progressive failure sequence, with river blockage, redirected flow paths, and significant debris deposition along both natural and built environments.

Figure 16. Landslide near Thunag Valley caused river damming and bank erosion
