# ISSMGE Bulletin

Volume 5, Issue 2  
April 2011

### Geotechnical Damage due to the 2011 Christchurch, New Zealand

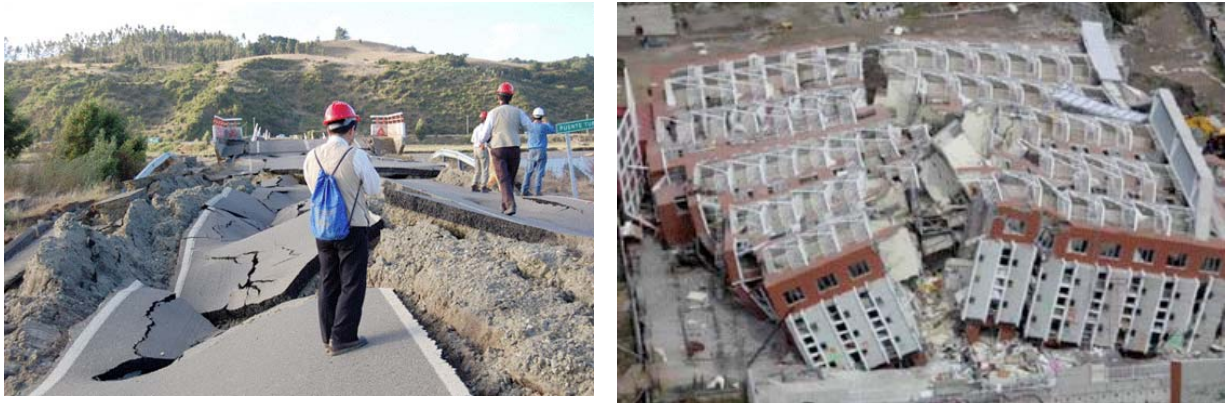
Figure 13 Views of damages during the post-conference technical visit

A post-conference technical visit was a guided trip to the areas of Concepción and Arauco in the south region of Chile, where major geotechnical damages were observed after the earthquake of February, 27, 2010.

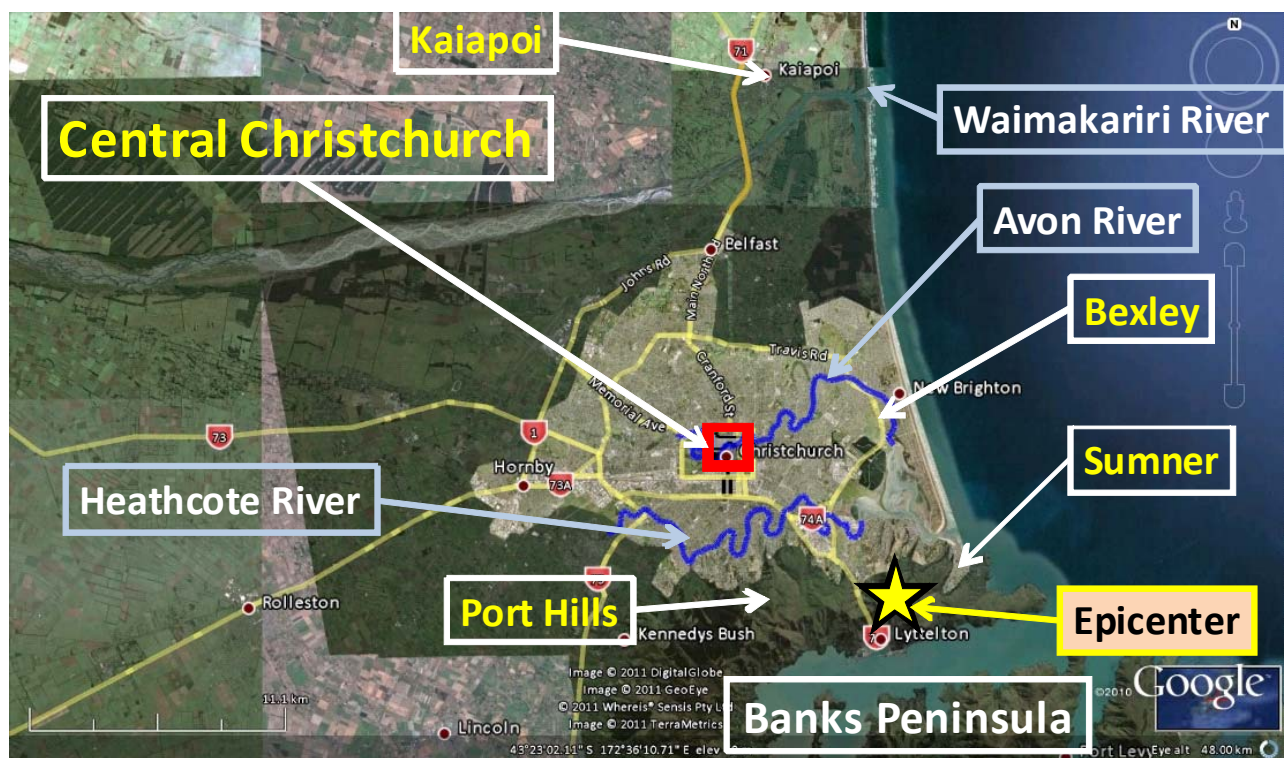
Figure 1. Geographical information in Christchurch region.

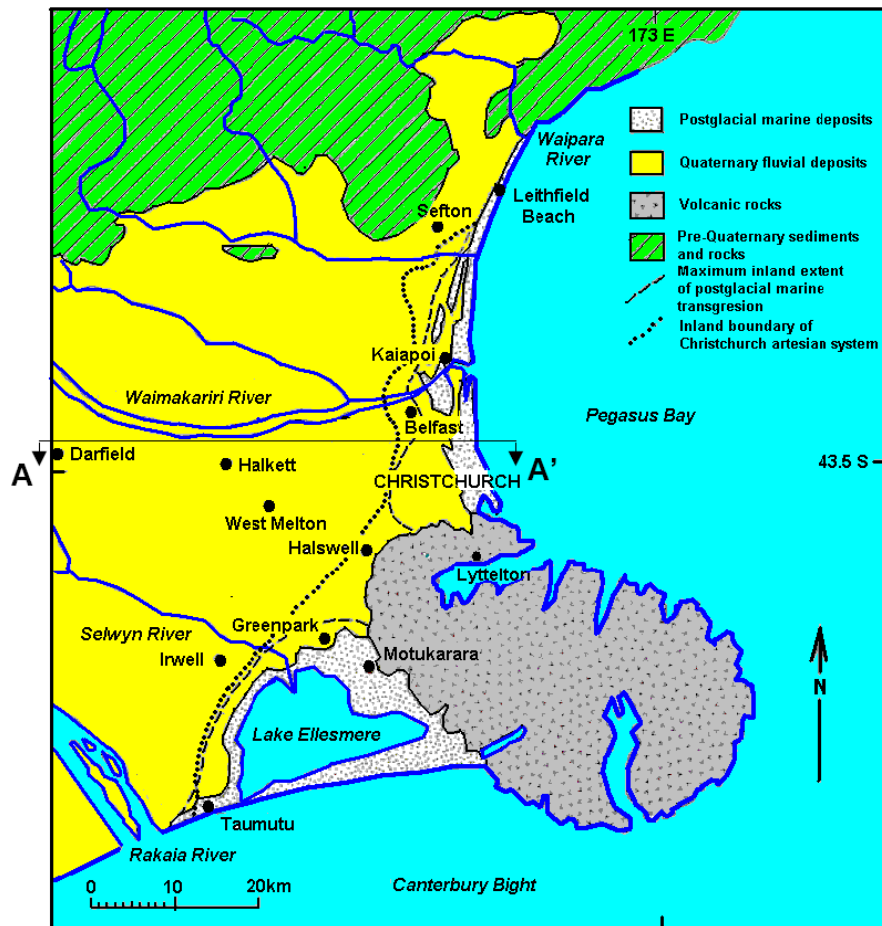
Figure 2. Simplified geology of Christchurch region. (Modified from Brown and Weeber, 1992).

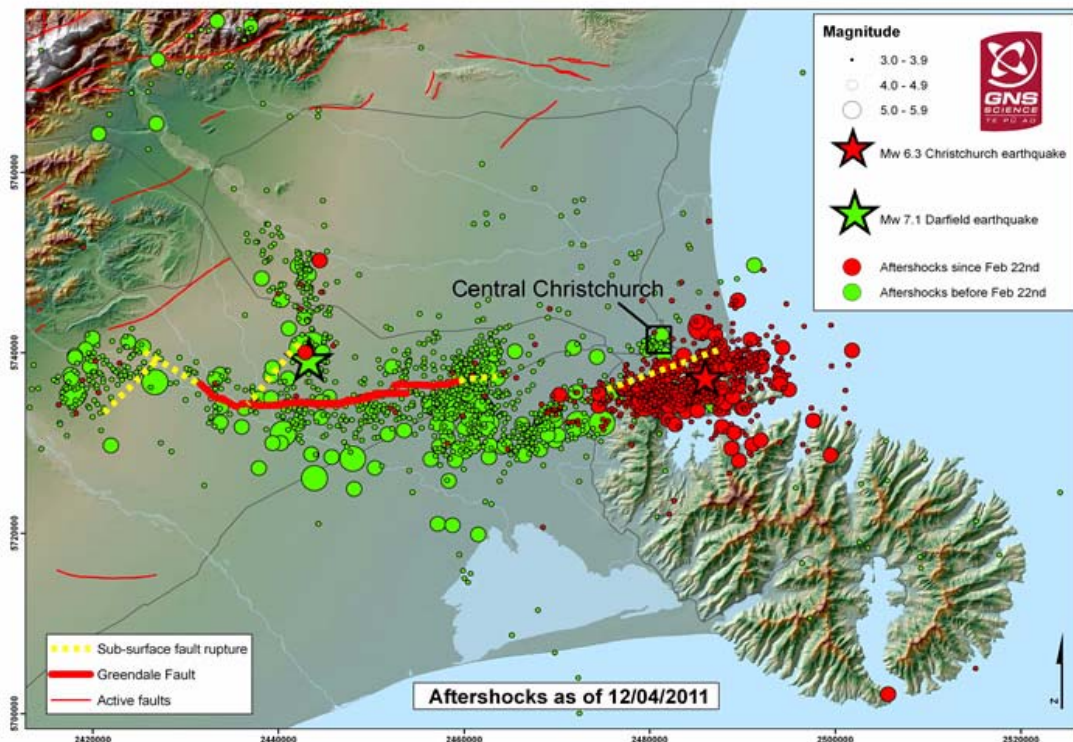
Figure 4. Location of main shock, aftershocks above magnitude 3, and fault ruptures in Canterbury. (Graphic by GNS Science, <http://www.gns.cri.nz/>) (as of 12 April 2011).

Figure 4 shows the locations of the main shock, aftershocks with magnitude above 3, and fault ruptures in Canterbury. It is clearly understood that a large number of aftershocks occurred in the south-west part of the fault that includes the epicenter of the February 2011 earthquake.

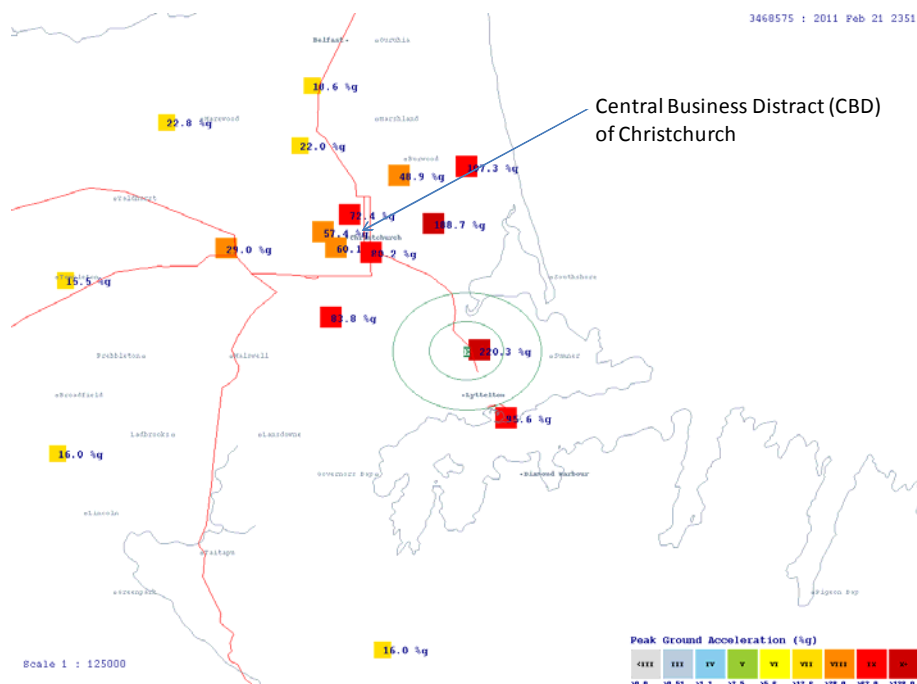
Figure 5. Distribution of maximum acceleration recorded during the earthquake. (Graphic by GNS Science, <http://www.gns.cri.nz/>).

During the 2011 Christchurch earthquake, a series of strong motion accelerographs were triggered and motions recorded at several stations. The distribution of maximum accelerations is shown in Figure 5. The values indicated in the figure correspond to the maximum of the three components recorded. It can be seen that the maximum recorded acceleration was in the order of 2.2 g near the earthquake epicenter, a number of rock falls were caused by significant shaking in this area. The accelerometers around the CBD showed maximum acceleration ranging from 0.57 g to 0.80 g in this earthquake, more than three times of those recorded during the September 2010 event. Due to much stronger shaking, many multi-story buildings suffered severe structural damage in the CBD.

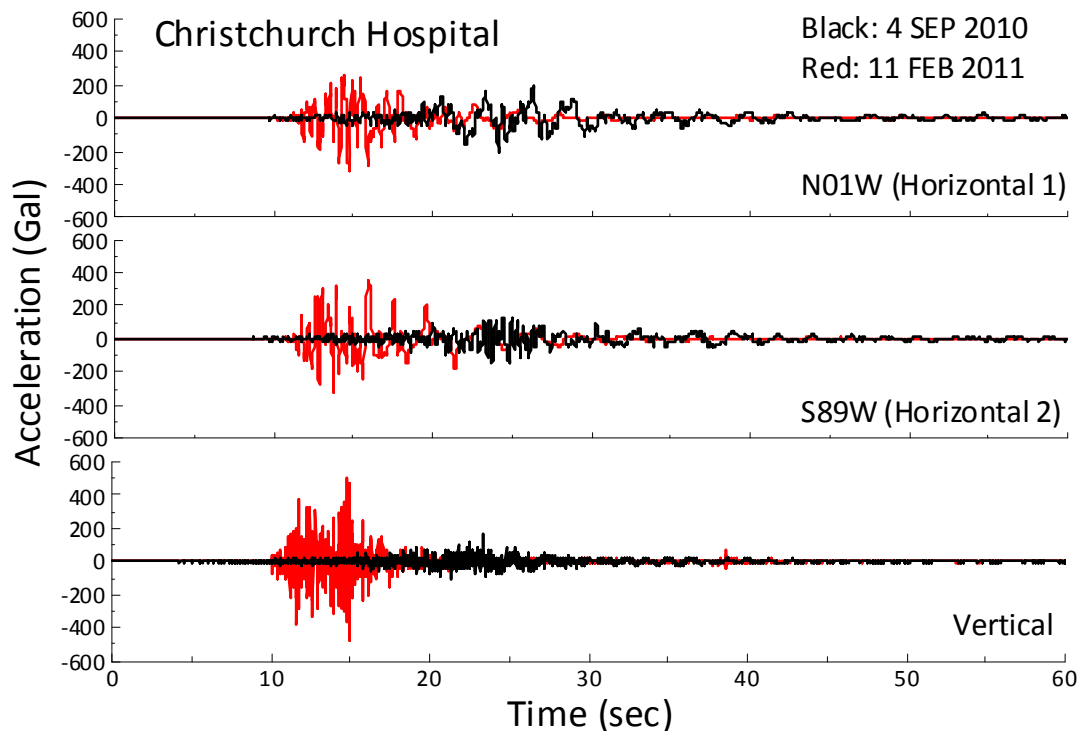
Figure 6. Acceleration records of the 2010 Darfield Earthquake and 2011 Christchurch earthquake at the Christchurch Hospital.

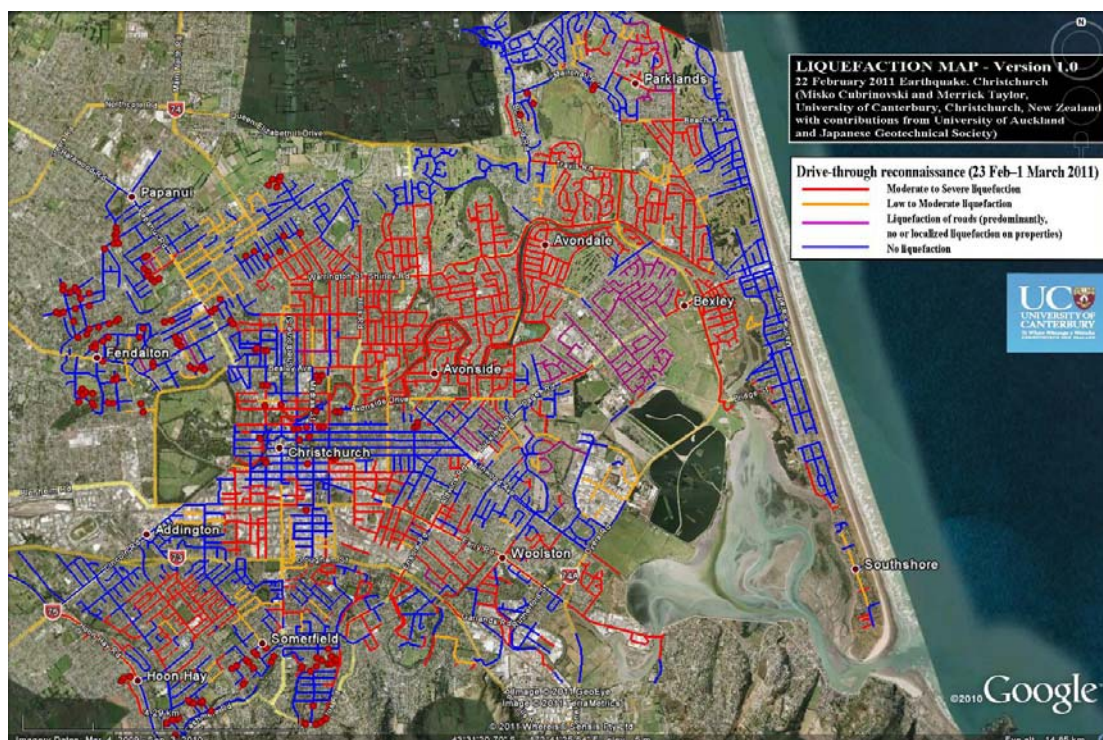
Figure 8. Areas of liquefaction in Christchurch caused by the 2011 Christchurch Earthquake. (Cubrinovski and Taylor, 2011, <http://www.nzsee.org.nz/>)

The earthquake caused widespread liquefaction in the eastern suburbs of Christchurch city as well as in Central Business District (CBD). The liquefaction-affected area in Christchurch during this earthquake was much wider than the one in September 2010. While major liquefied sites in the September 2010 earthquake were distributed along the Avon River (northeast of CBD), liquefaction was observed in the 2011 earthquake across a wide areas in suburbs north to south of Christchurch city. Figures 7 and 8 show the areas of observed liquefaction in urban area of Christchurch after the 2010 Darfield earthquake and 2011 Christchurch earthquake, respectively. These two maps were based on surface manifestation of liquefaction visible in aerial photographs and initial observations from ground surveying. The survey to understand areas of liquefaction caused by each quake was conducted immediately after the earthquake occurrence by a reconnaissance team of the University of Canterbury.

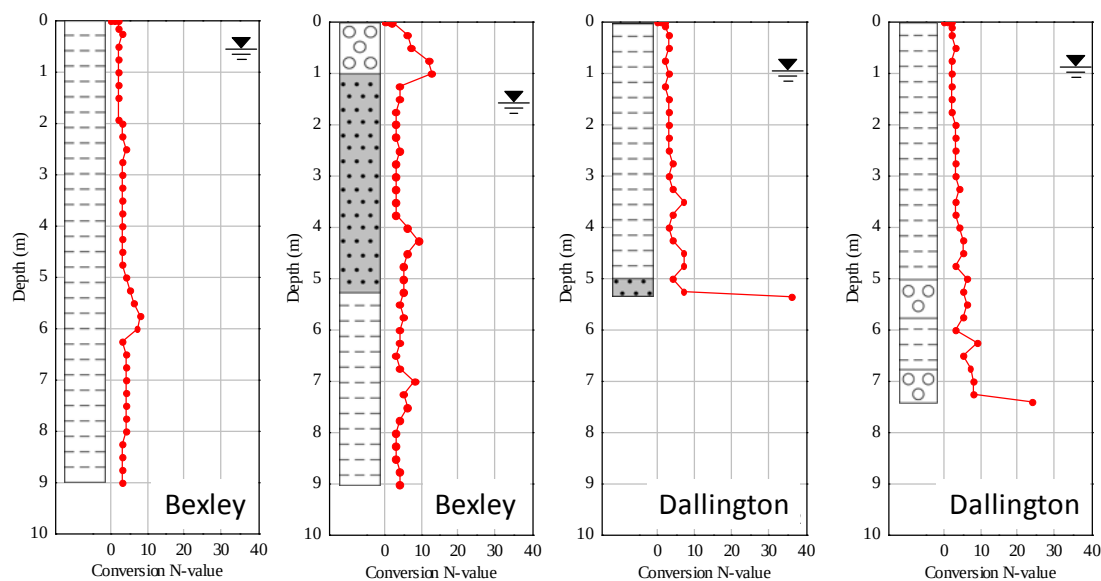
Figure 9. Converted N-Value profile in Bexley and Dallington. Ground survey was conducted by University of Canterbury and JGS Reconnaissance teams in September 2010 (JGS, 2010).

Typical results of SWS tests in Christchurch are shown in Figure 9. It can be understood from the figures that there are strata of very loose ( $N < 5$ ) silt/sand, at about 5 m or deeper below the ground water table.

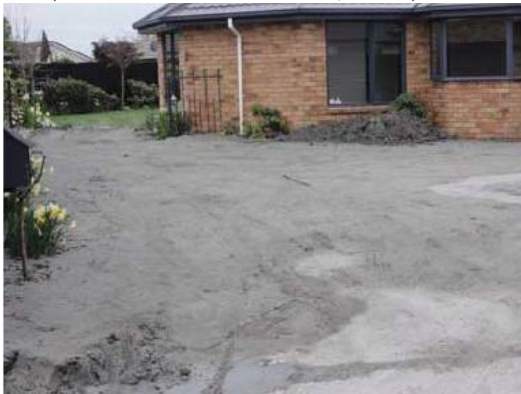
(a) After the 2010 Darfield Earthquake  
(Cubrinovski and Orense, 2010)

(b) after the 2011 Christchurch Earthquake

Figure 15. Damage to residential houses due to repeated liquefaction in Seabreeze Close, Bexley.

In Bexley, a large number of residential houses/properties suffered severe damage from liquefaction in September 2010 earthquake. After the 2011 earthquake, it was again one of the worst hit areas in terms of liquefaction-induced damage. Figures 15 (a) and (b) show damaged residences after the 2010 and 2011 earthquakes, at Seabreeze Close in Bexley. Massive amount of sands were ejected and deposited around the houses. Differential ground settlement was caused by severe sand boils, resulting in tilting in many houses.

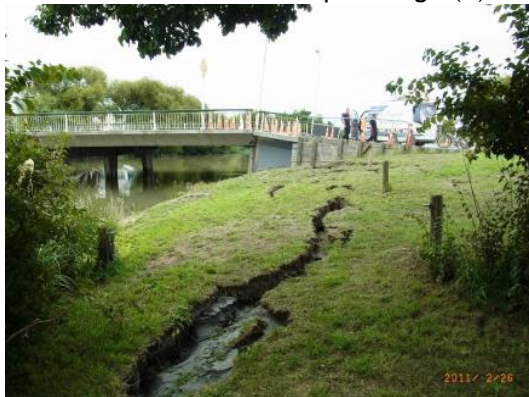
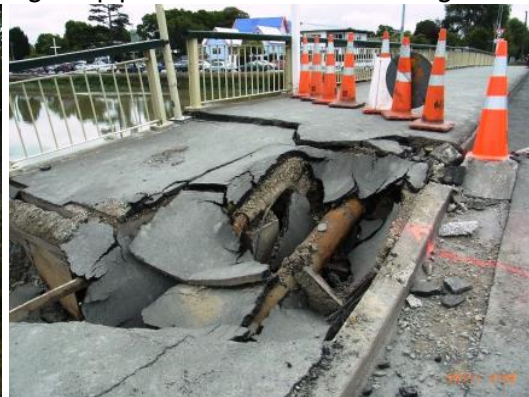
(a) Tilt in abutment due to lateral spreading

(b) Damage to pipeline installed in the bridge

Figure 16. Damage to bridge crossing the Avon River (Avondale Road).

Damages in levees along Avon River were observed everywhere, spanning from inside the CBD to the river mouth. Many bridges crossing the Avon river suffered tilting in their abutments, as a result of lateral spreading and loss of bearing capacity due to liquefaction (Figure 16a). Damage to pipelines was also observed at the connections between bridge and backfill. In most cases, the settlement of the bridge abutment itself is smaller than that of the adjacent soil because the bridge is supported by pile foundations (Figure 16b).

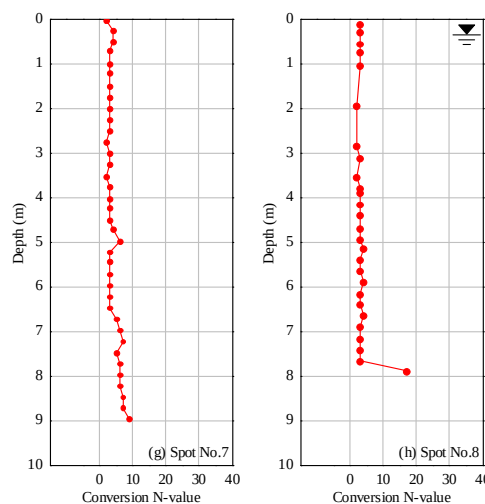
Figure 25. Converted SPT N-value profile in North Kaiapoi. Ground survey was conducted by University of Canterbury and JGS Reconnaissance team on September 2010 (JGS, 2010).

After the 2010 Darfield earthquake, SWS tests were conducted at a residential property shown in Figure 23 (Cubrinovski et al., 2010 and JGS, 2010). The profiles of converted N-value from SWS tests are shown in Figure 25. The upper portion of the ground consists of very loose sand, with depth more than 7 m and the ground water table was very shallow. Figure 26 shows the grain size distribution curves of sand ejecta collected in Kaiapoi. The solid curve with red color in the figure indicates the grain size distribution of soil collected after this earthquake, while the other dashed curves correspond to soils taken after the 2010 Darfield earthquake. The sands ejected in both earthquakes have generally similar grain size distribution. Moreover, they have similar grain size distributions as the sand ejecta in Christchurch, which are shown in Figure 10.

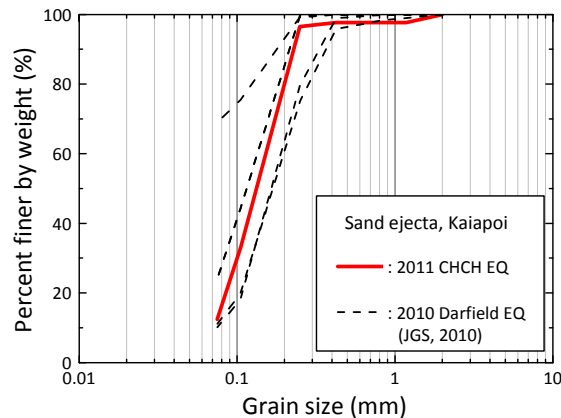
Figure 26. Grain size distribution curves of sand ejecta collected at Kaiapoi.

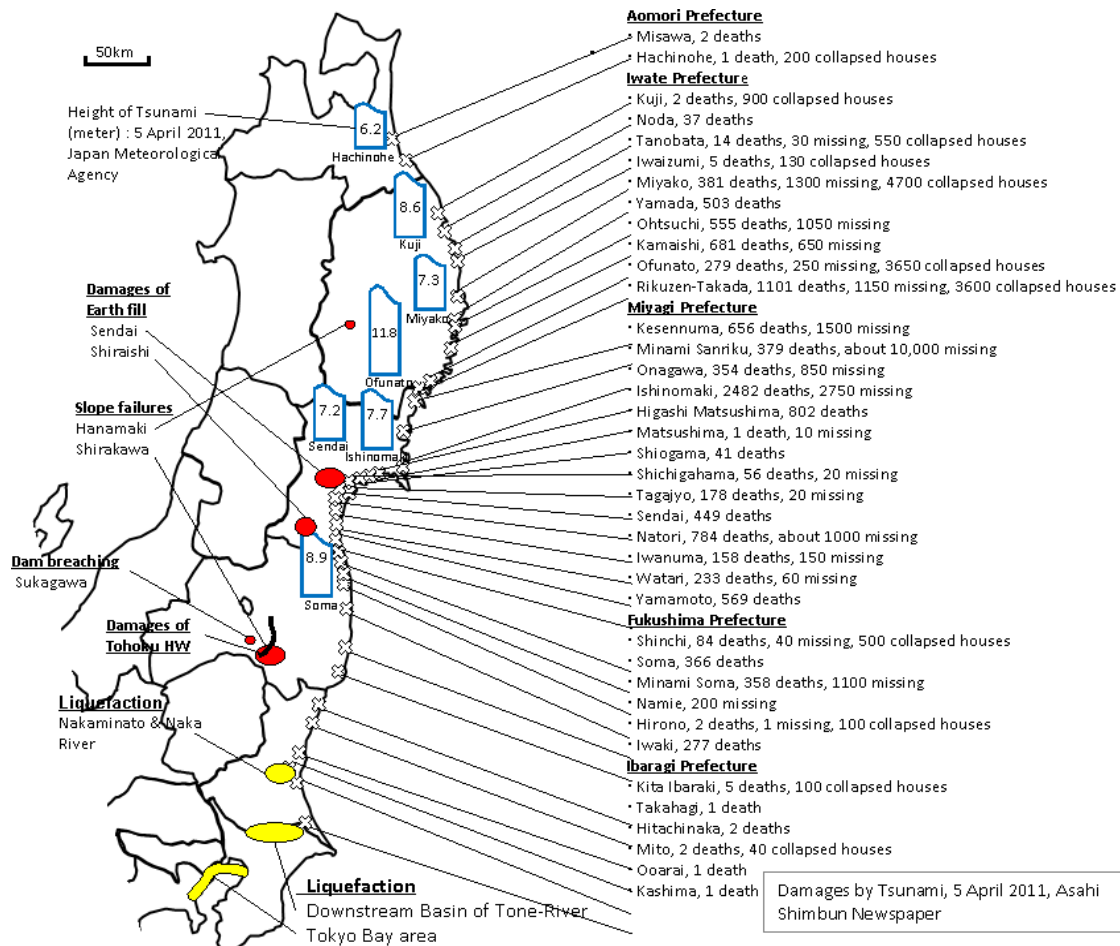
Fig. 6 Distribution of seismic damage

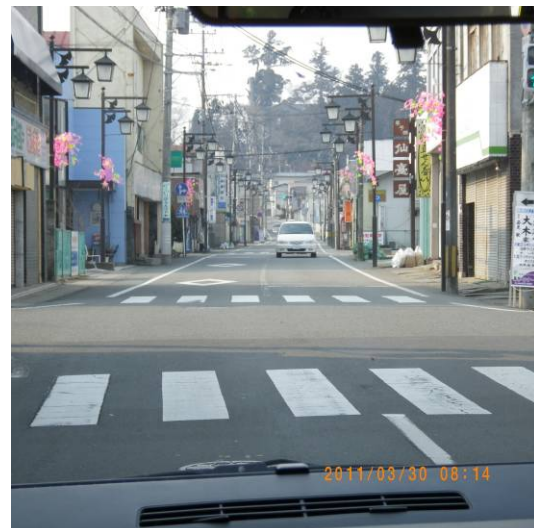
(a) Intact buildings in central Sendai City (b) Houses and shops without damage in Tsukidate Township

Fig. 7 Good performance of buildings and houses in the affected region

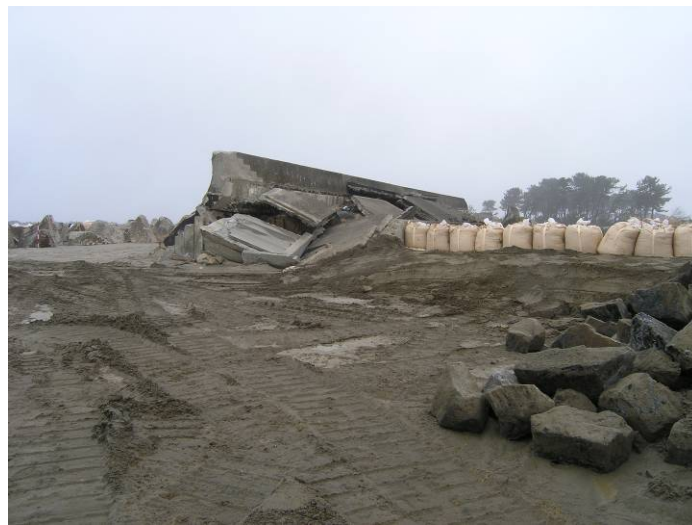
Fig. 13 Destroyed sea wall near Abukuma River mouth

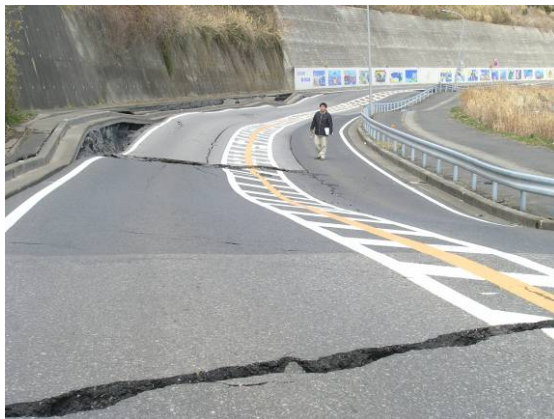
Fig. 21 Distortion of road embankment in Nakaminato of Ibaraki Pref.

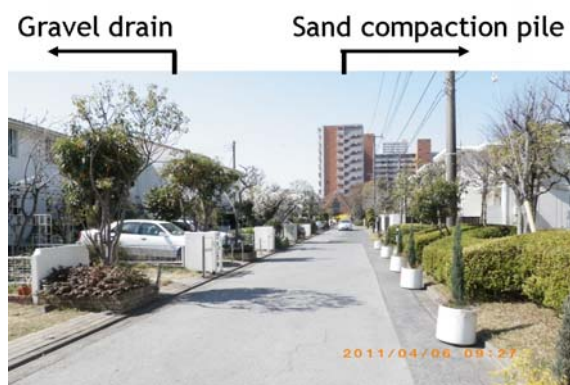
Fig. 30 Successful soil improvement in Irifune-Kita area of Urayasu residential area

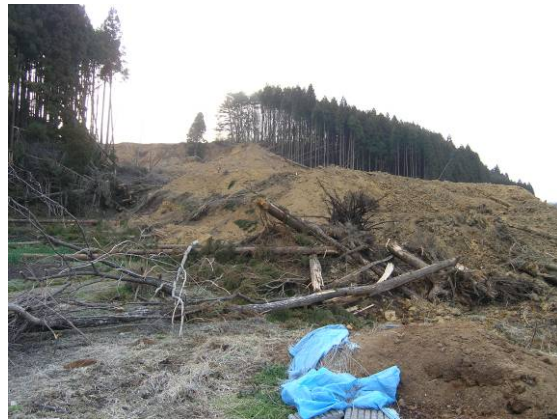
Fig. 32 Failure of natural slope at Hanokodaira of Shirakawa City

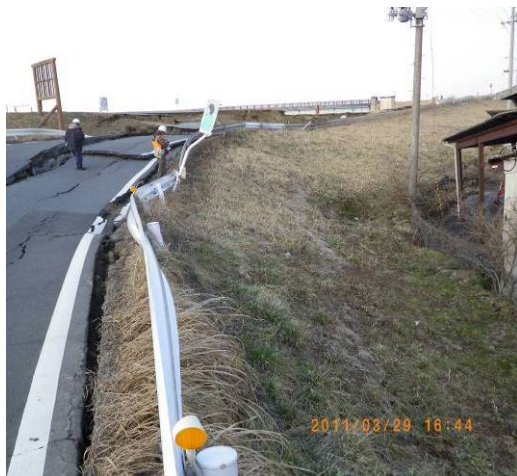
Fig. 33 Distortion of Shida Bridge approach Naruse River, north of Sendai

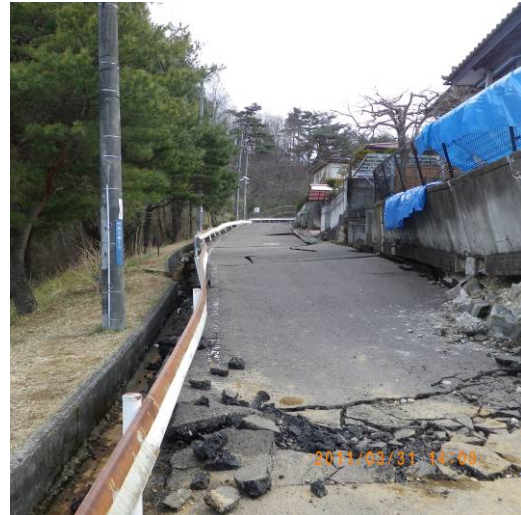
Fig. 39 Damage that was limited to filled part of residential development in hilly area (Oritate 4 of Sendai)
