5<sup>TH</sup>  
INTERNATIONAL  
SYMPOSIUM ON  
FRONTIERS IN  
OFFSHORE  
GEOTECHNICS

# THE 7<sup>TH</sup> ISSMGE McCLELLAND LECTURE: LEARNING FROM OFFSHORE FIELD PERFORMANCE

*P. Jeanjean, K. Hampson, L. Majzlik,  
J. Bronikowski, A. Zakeri, and A.W. Hill*

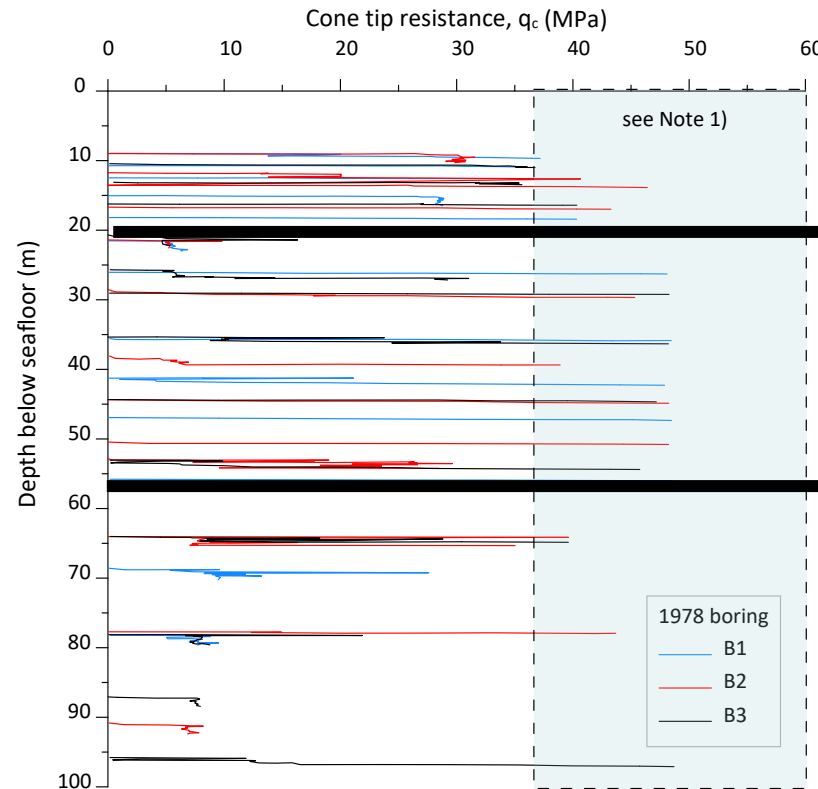
# VALHALL 1978 CPTs AND GROUND MODEL

FOUNDATION ZONE AFFECTED BY 2 GLACIATIONS

Note: 1) All  $q_c$  values greater than 37 MPa were measured at CPT refusal.  
They do not represent actual in-situ values.

Formation	Description
Forth	Dense to very dense fine to medium sand. Gravel can occur
Fisher	Hard to very hard silty clays interbedded with dense to very dense sands
Ling Bank	Predominantly very hard silty clays with occasional very dense sand layers

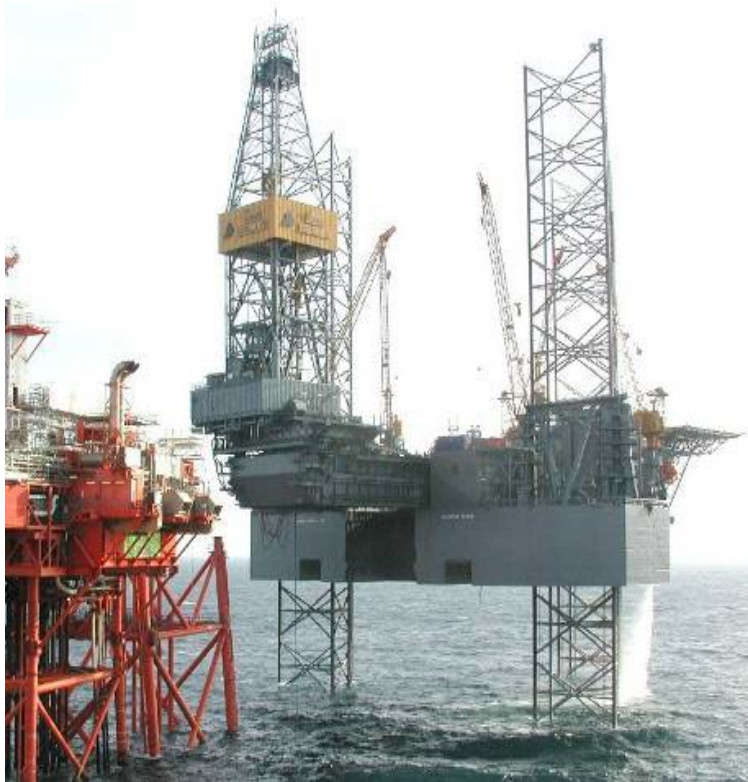
# INVESTIGATION WITH JACK-UP RIG

NO UNUSUAL SOIL CONDITIONS (E.G. CEMENTED LAYERS, BOULDERS) ENCOUNTERED BUT CORED THROUGH THE BUCKLED PILE!

0.3m  
Section of pile from borehole drilled  
in the center of refused pile P7

◆ Borings performed from jack-up

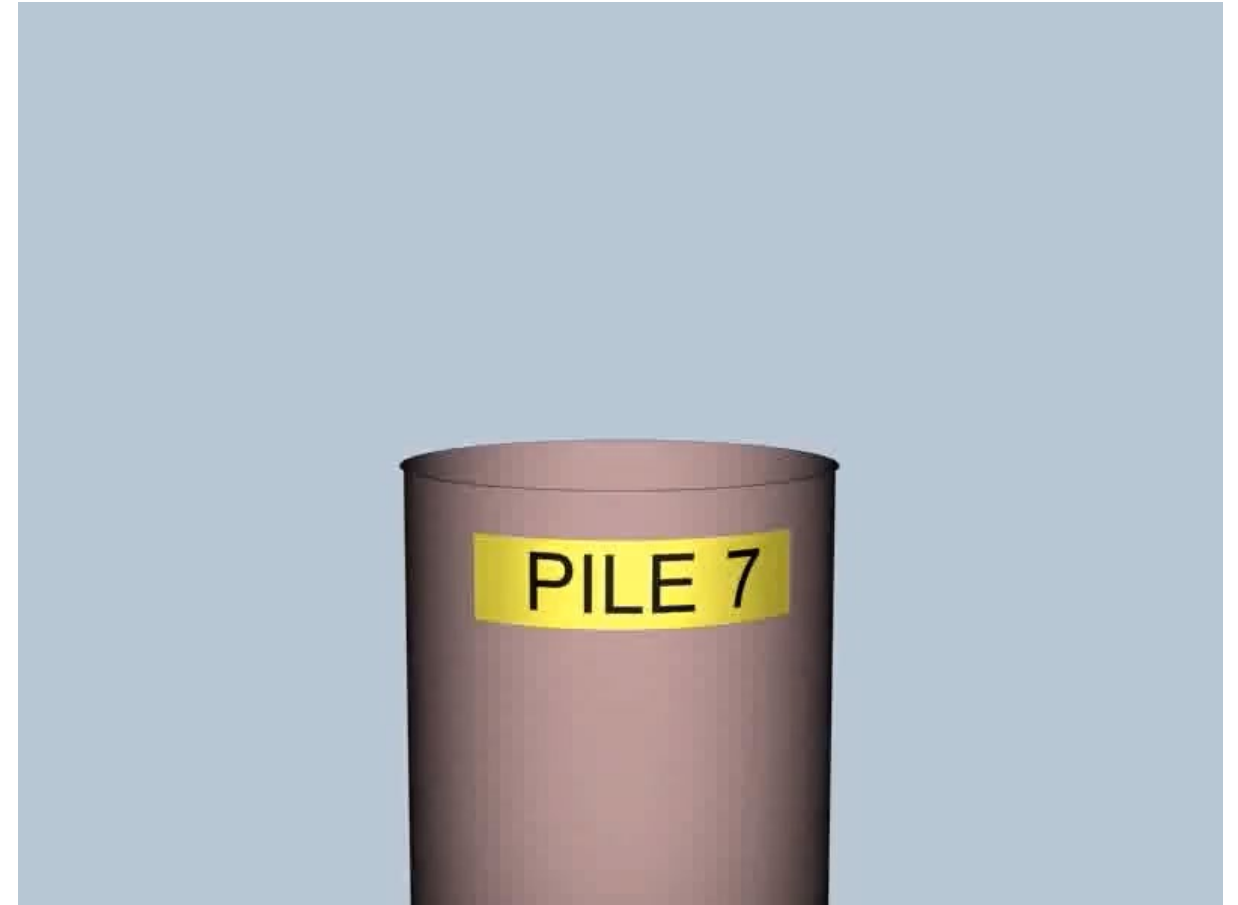
Pile P7: highly deformed section in bottom 4D

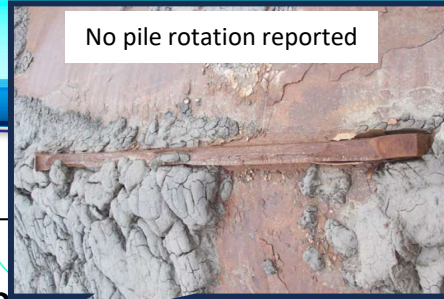
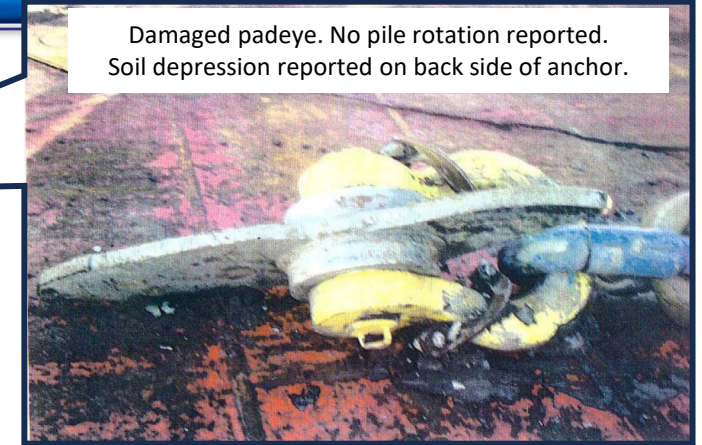
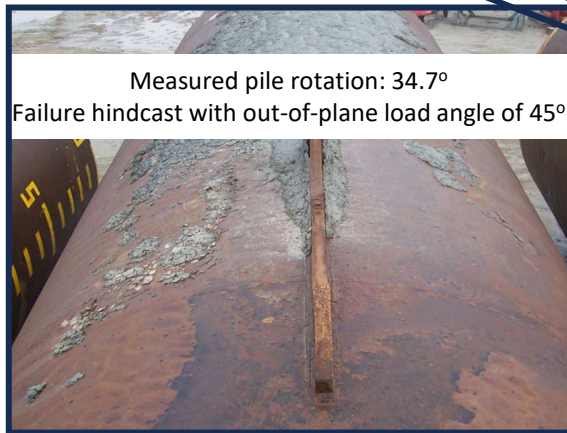
# SUCTION PILES FAILED STRUCTURALLY, NOT GEOTECHNICALLY

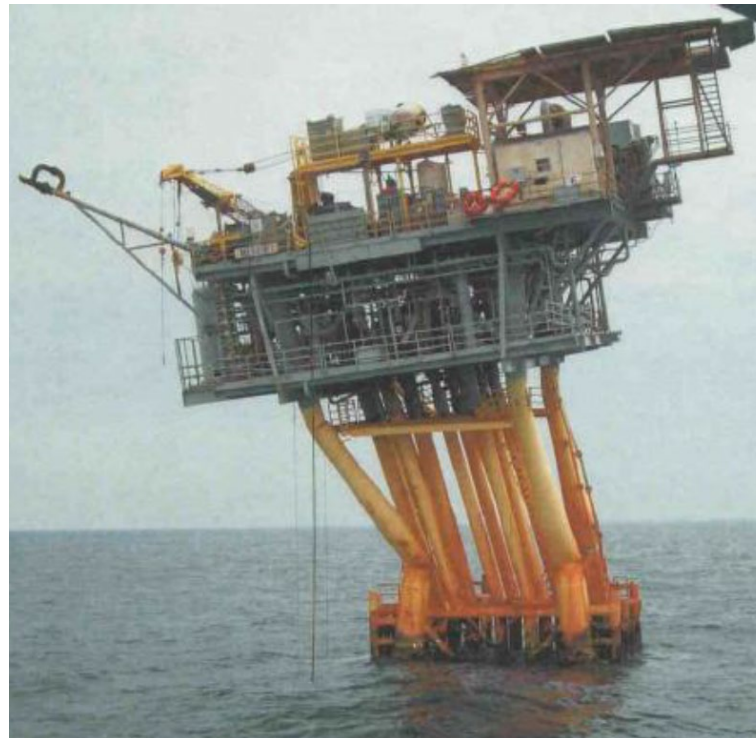
Platform damaged beyond repair  
in Eugene Island area

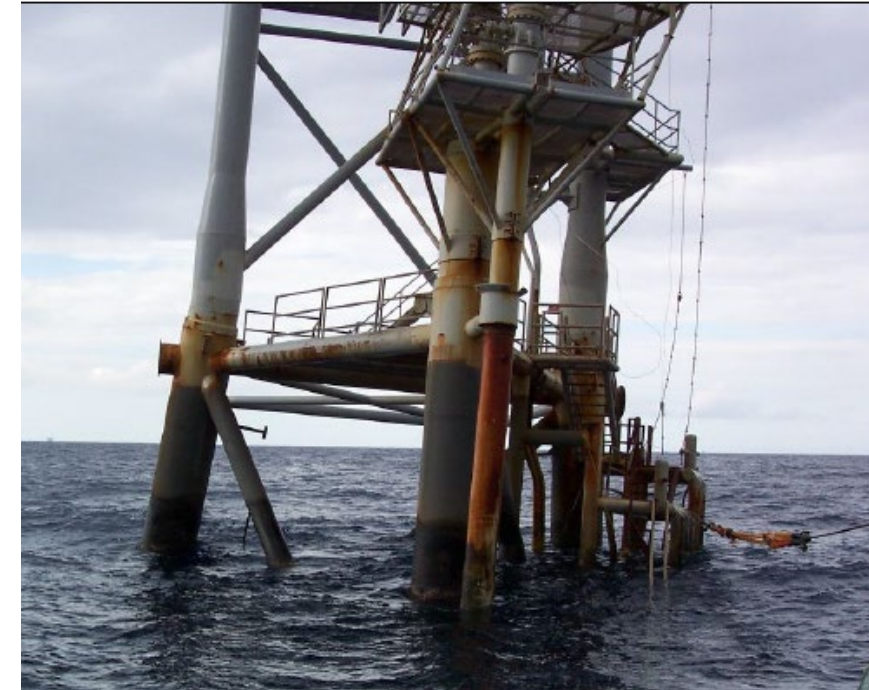
Platform leaning beyond repair  
in East Cameron area

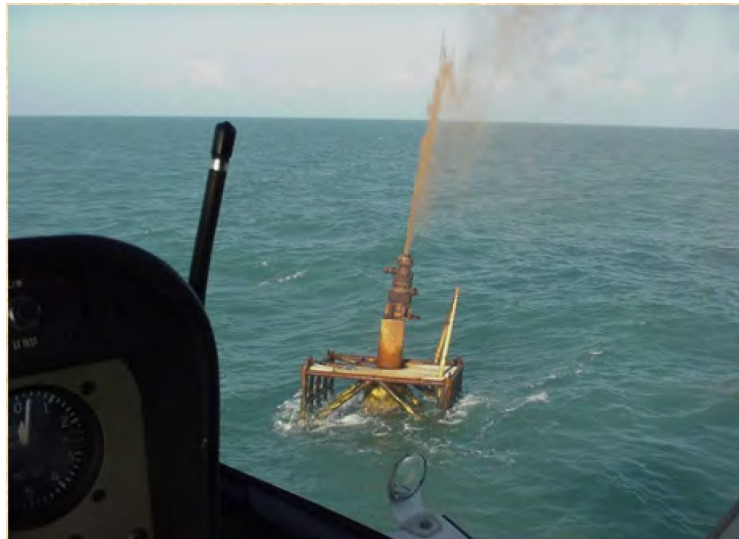
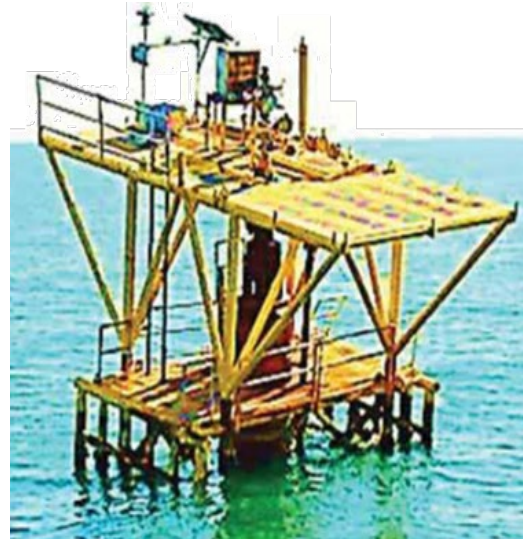
- ▶ Water depth: 16.2m
- ▶ Pile: 1.2m diameter, 29m penetration in soft clay
- ▶ Caisson damaged during Hurricane Andrew in August 1992, found leaning 15 degrees at waterline

Illustrative caisson damage after hurricane  
(these caissons are not the one for this case record)

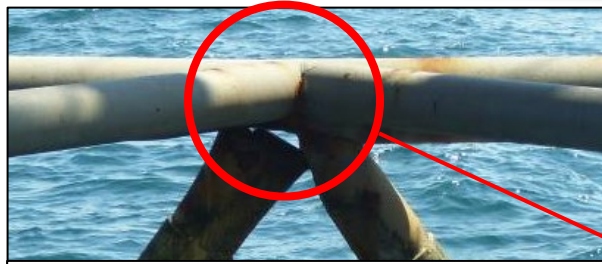
Joint failure and separated members

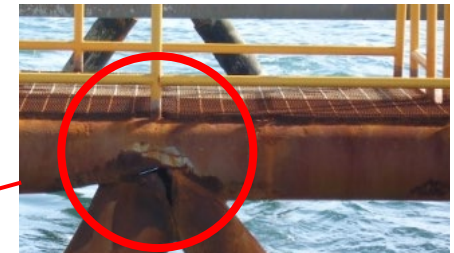
Joint failure and separated members

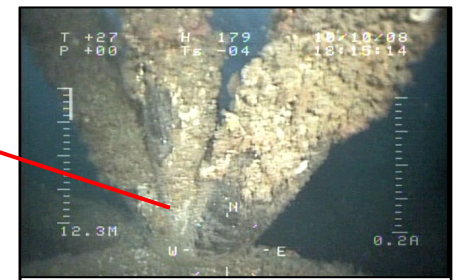
Cracked and damaged joint

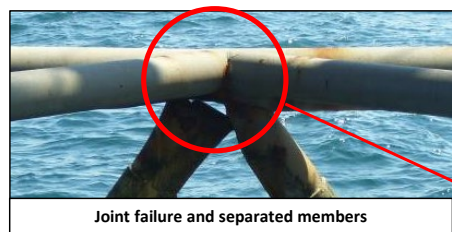
# SS PLATFORM PREDICTED VS OBSERVED DAMAGE

USING ISO 19901-4:2025 CYCLIC P-Y CURVES WITH DSS SHEAR STRENGTH

ISO 19901-4:2025 framework for lateral pile-soil interaction in clays not proved wrong!
