## Embankment stability works with quick solutions to improve resilience in roadway infrastructures

**F. Collazos Arias**

**M.L. Alonso Plá**

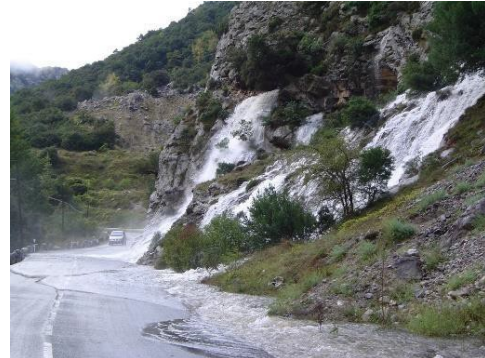
Figure 1. Situation of PK 158,140 MI produced by heavy rains on rocky slope (upstream) without acting.

The problem to be solved of management of runoff water, is that of the currents of water that appear after a heavy downpour or in the event of avalanche or thaw fall on the road in the form of a waterfall from the escarpments that border the road, which stop or at least hinder the circulation of the vehicles (Figure 1).

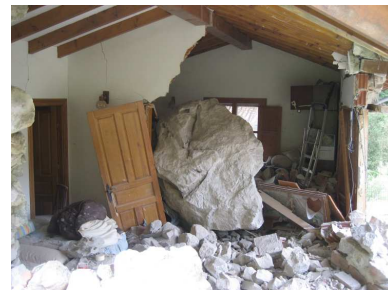
Figure 2 Situation in the road N-621 produced after intense rains with stone falling.

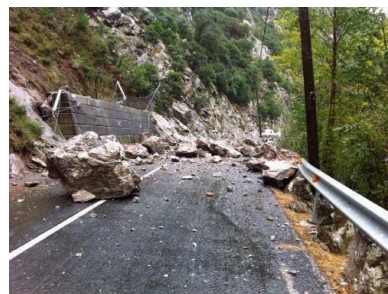
Figure 3. Safety compromised due to stone falling in the road N-621 after intense rains.

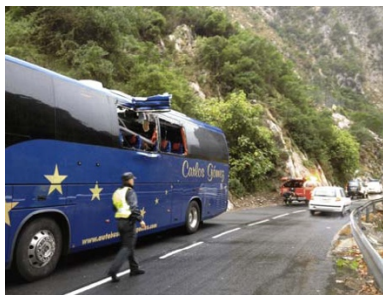
Figure 4. Safety problems due to stone falling in the road N-621 after intense rains.

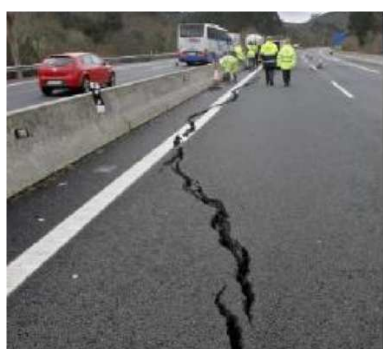
Figure 5 Cracking of the road way with descent of 100 cm in the A-8, Liendo.

Regarding the Type 2 problem, there was a large slide of the right road (Figure 5), in this case embankment of the highway A-8 in PK 167, in Liendo, on February 8, 2013, with strong horizontal and vertical displacement of the right lane, of the order of 30 and 100 cm respectively. This led to cut traffic in the roadway and to the urgent set up of metal lanes in the central reservation to prevent the slippage from affecting the opposite lane, which is along where the two traffic directions circulated.

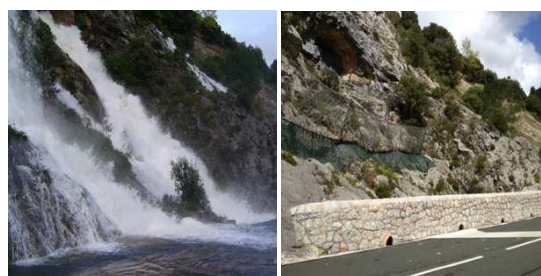
Figure 8 Situation of PK 158,140 MI produced by heavy rains and situation of PK 158,140 MI with the finished stonework (national road side)

It is associated with a rocky ballast that descends to the edge of the road, with a variable height between 50m and 75m and 17o. The speed and energy of the water force sprouting from two karst cavities and channeled to the Deva River has been decreased, through 5 consecutive levels, 1 of M2 and 4 of M1-2. The receiving bowl has been improved by rock bite and a masonry wall has been executed, with putlog holes being performed and mimetized with the natural environment, which allow for the integration of landscape (Figure 8).

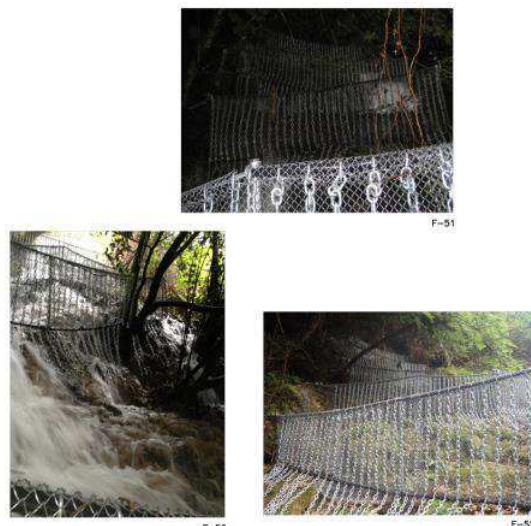
Figure 9. Situation of the PK 169,050 MI produced by rains. Protection channels 2, 3 y 4.

The speed and energy of the water force that descends from four channels that converge in two and are channeled to the Deva River has been decreased. All this by arrangement of the different modules is shown in Figure 9.

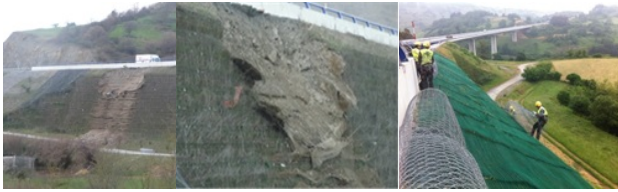
Figure 14. Safety problems due to stone falling in the road N-621 after intense rains.

Seat and overturning of walls, with problems, usually sliding at its base (excessive thrust) or the mass of land on which they rested; or increased compressibility of the wetting foundation. On the A-67 near the town of Pujayo, a landslide occurred on the 17 m high green wall with an inclination of 70°, which supports the dual carriageway at the access fill to the Pujayo viaduct. A superficial "spoon" type landslide over an approximate length of 15 m and a height of about 6 m. Also observed in other areas of the green wall was the beginning of a process of overturning/breakage of the top step of the wall (Figure 14). The solution consisted of securing the head of the slope of a green wall with a reinforcement system consisting of a volumetric three-dimensional geogrid, triple reinforcement mesh and 16 mm diameter steel cable, forming 8x3 m triangulations, all anchored to the ground by means of self-drilling bolts and cable nets. As this is a green wall with a pedraplén type fill, it was necessary to use self-drilling bolts with a greater amount of mortar in the anchoring bulb to ensure the strength required by the system (Figure 14).

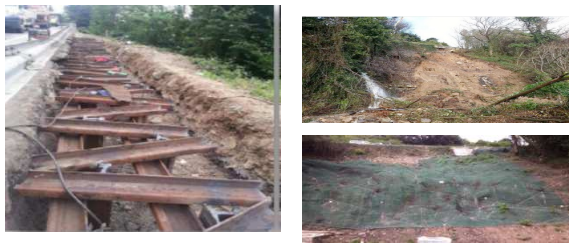
Figure 15. Lane swelling, laying of geogrid, bolted cable network and reconstruction of water trough on the N-629 road caused by heavy rains.

Another landslide occurred at KP 118+300, on 20 January 2013 (Figure 15), on the support wall of the N-623, a local road in Corvera de Toranzo, which did not suffer any damage due to the lanes being driven in at the time and which has been left exposed to the air. The solution consisted of clearing the slope, placing geogrid and bolted cable network. Channelling of the spring. Enlargement of the rail pile to reinforce the existing one with a welded and concreted head.

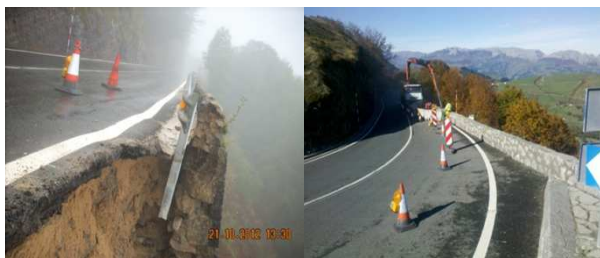
Figure 16. Subsidence of the N-629 road platform caused by heavy rains and provisional signposting

On the N-629 road (Figure 10), at PK 50+100, at Puerto de Los Tornos. Another landslide occurred in 2012, it is a very old road, more than 100 years old and with a meagre road surface. Among the solutions adopted was the installation of a metal structure composed of UPN-160 and HEB-160 type beams, braced and bolted to the ground using 30 mm TITAN 30/16 self-drilling bolts, similar to the one done in 2016, on the N-623a road (Figure 16), where a double-sided riprap was also installed.
