*The paper was published in the proceedings of the 20<sup>th</sup> International Conference on Soil Mechanics and Geotechnical Engineering and was edited by Mizanur Rahman and Mark Jaksa. The conference was held from May 1<sup>st</sup> to May 5<sup>th</sup> 2022 in Sydney, Australia.*

## Evaluation of geological-geotechnical hazard associated with the triggering of landslides in the urban area of Além Paraíba – Minas Gerais, Brazil

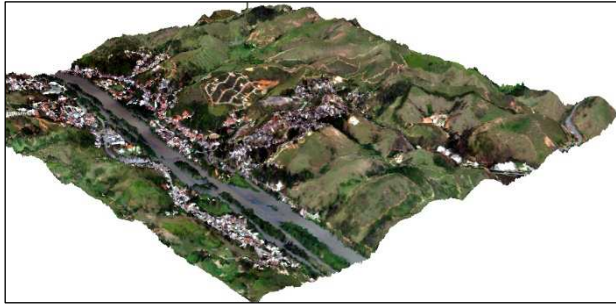
Figure 2. Examples of the 3D Models created from the products obtained from FLIGHT 1.

The image processing and the modeling were done at the Department of Civil Engineering of Universidade Federal de Viçosa, using the Agisoft PhotoScan computer program, used to generate point clouds, a 3D Models and orthomosaics (Figure 2) and Digital Elevation Model (DEM) (Figure 3). All the products derived from the aerial survey with the UAV were organized based on an orthomosaic. With the geospatial data processed, it was possible to generate a Ground Sampling Distance (GSD) of 9.75 cm/pixel of spatial resolution for the imaged area, which enabled the digital cartographic base to be updated for the purposes of the study. ArcGis® 10.3.1 was used to create thematic maps.
