## Bushfire affected slope instability on steep forested terrain at Jenolan Caves Road, New South Wales Australia

**Nicholas Bridgement**

*Transport for New South Wales, Australia*

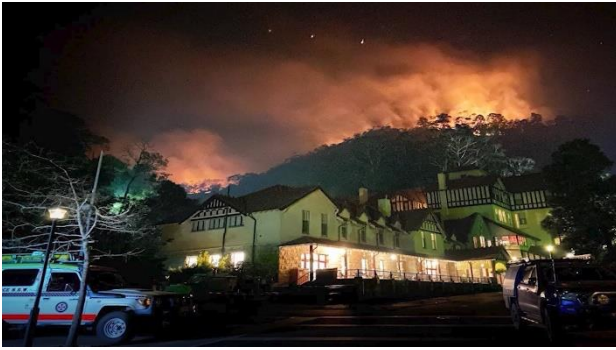
Figure 3. Green Wattle Creek bushfire above the historical Caves House (photograph supplied by NSW Fire and Rescue Oberon)

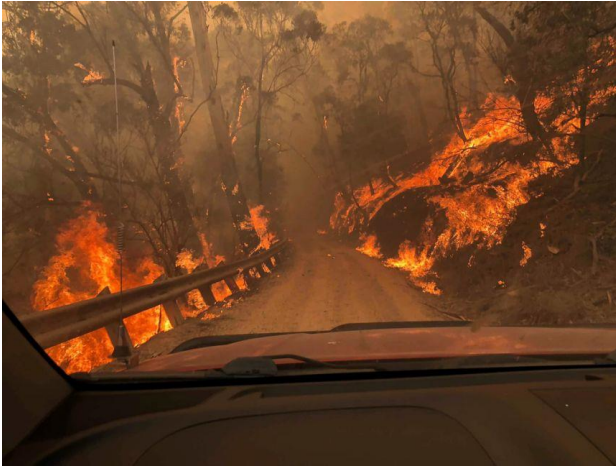
Figure 4. Green Wattle Creek bushfire Two Mile Hill (photograph supplied by NSW Fire and Rescue Oberon)

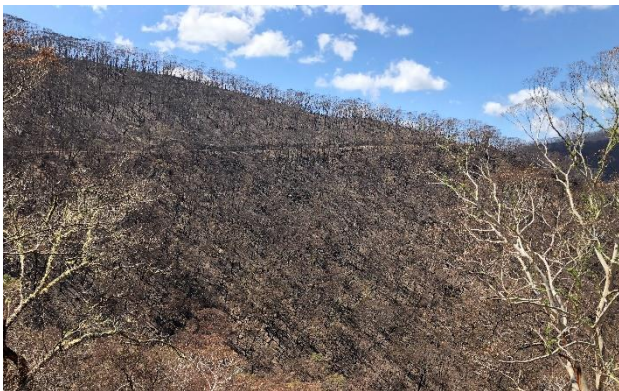
As the majority of surface vegetation was removed by the Green Wattle Creek bushfire, valley slopes and gullies above Five Mile Hill became very exposed and prone to erosion, increasing rockfall and landslide activity. The weekend of the 8-9 February 2020 marked the beginning of the end of the

Figure 6. Burnt and exposed slopes above and below Five Mile Hill

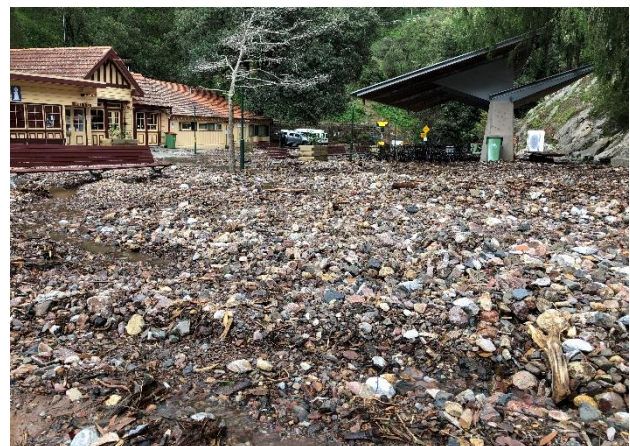
This large rain event resulted in significant disruption to Jenolan Caves which had only just reopened to visitors following the bushfires. The immediate area around Caves House was inundated with flood water and transported debris from the valleys above Jenolan Caves depositing a layer of gravel, cobbles and tree debris which was measured up to 500mm in thickness as shown in Figure 8. Two Mile Hill had reopened to traffic prior to the storm, but Five Mile Hill remained closed for the final stages of the bush fire clean-up and would remain closed until mid-June 2020. The combined effects of steep exposed slopes with a large storm event was the beginning of unprecedented slope instability, particularly for Five Mile Hill.

Figure 8. Flood debris in the caves precinct and main tourist area following the February 2020 east coast low pressure storm event

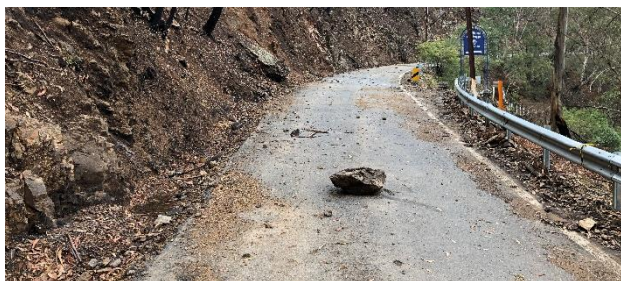
This rockfall was mobilised from the upper slope above the cutting and had dimensions of 800mm x 650mm x 300mm. Despite the shape, the boulder was easily mobilised from the 45° natural slope surface above the cutting. There are numerous other examples recorded across the study period, often with no discernable triggering mechanism other than steep sloping ground with minimal vegetation.

Figure 10. Rockfall from the upper natural slopes above Five Mile Hill

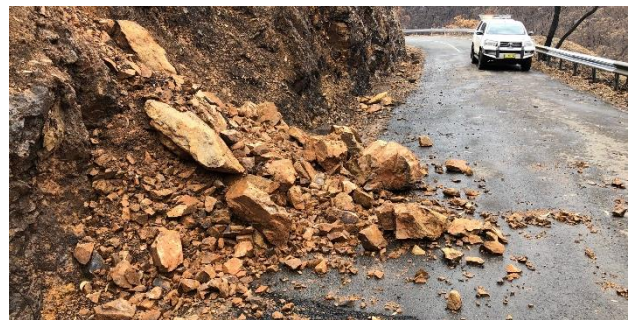
The burnt tree stump and root mechanism also resulted in an increase in wedge type failures during and after rain events with a total of 40 recorded over the study period. The majority of these failures were within the interbedded siltstone and sandstone unit. These wedges were controlled by the intersection of defects within the rock and due to the highly fractured nature, breaking up into mainly gravel to cobble size fragments, often with larger boulders. These wedge failures were often deposited in a cone shaped pile of debris at the toe of the cutting usually spilling out into the road. Typically the volume of these failures was less than 5m<sup>3</sup> an example of which is presented in Figure 11.

Figure 11. An approximately 4m<sup>3</sup> wedge failure resulting in broken interbedded siltstone and sandstone fragments comprising gravel, cobbles and boulders up to 800mm across.
