Consolidation project of an urban landslide: Case study on Tetarom Park Cluj-Napoca

Nicoleta-Maria Ilieș, Vasile-Stelian Farcaș, Denisa-Maria Pașca, Vasile-Florin Chiorean & Andor-Csongor Nagy

KEYWORDS: urban landslide, pile retaining wall, geotechnical investigation, long term monitoring

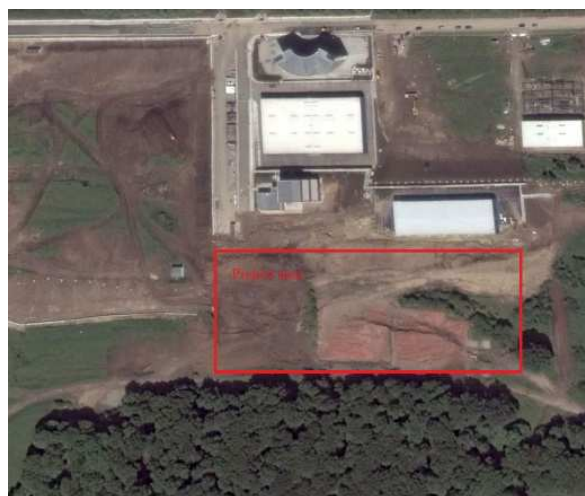
was known for instability phenomena, the first landslides on the slope can be tracked back to the Pleistocene era. Vertical systematization required to build the industrial park, poor groundwater management and unpropped man made interventions triggered a new landslide, affecting both the investigated perimeter and neighboring areas, as in Figure 1.

Figure 1. Project area on north side of Hoia Hill.

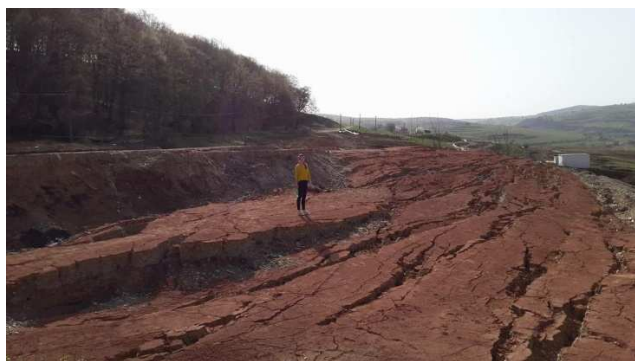
The landslide had a length of about 130 meters, with a width of 155m, as shown in Figure 2. The slope deformation was of detrusive nature, of great depth, with the sliding plain at the contact between the reshuffled material above and the base rock (marls, sandstones).

Figure 2. Landslide occurred in March 2016.

The sloped terrain develops a major landslide, as seen in Figure 2, with deep sliding plain / strip, as presented in Figure 4. This phenomenon results as a concurring factors like geology, geotechnical stratigraphy, history of the sloped terrain, mechanical behavior of soils, a major climatical event (high discharge of precipitation in a short time period), and a malicious human intervention (excavation at the base of slope).
