## Soil failures during construction on the slopes in Kyiv

**Kaliukh Iurii**, Tytarenko Volodymyr, Ischenko Yurii & Slyusarenko Yurii  
*The State Research Institute of Building Constructions, Ukraine*

## 2 CASE STUDY 1. GROUND FAILURE IN THE COURSE OF THE MULTI-STOREY GARAGE CONSTRUCTION ON THE LANDSLIDE HAZARD SLOPE OF THE STARONAVODNYTSKA RAVINE

### 3 CASE STUDY 2. PIT WALLS GROUND FAILURE IN THE COURSE OF THE CONSTRUCTION ON THE STRUTYNSKOHO STREET IN THE RESTRAINED URBAN DEVELOPMENT CONDITIONS

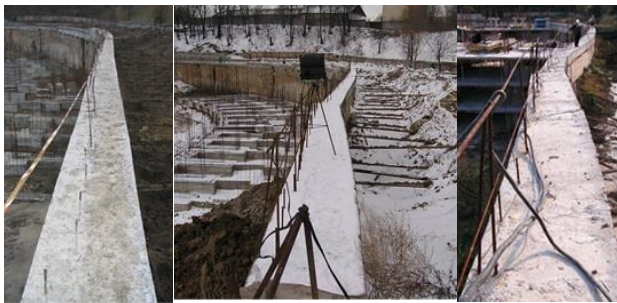
A). State as of 28.11.2003 B). State as of 17.02.2004 B). State as of 13.10.2004

Figure 2. Ground failure: the deformations (bending under the shearing pressure action) of the garage ground beam piles

The left and right wings of the upper tier retaining wall received the significant horizontal displacements (1000-1200 mm and more), which caused the reinforced concrete ground beam destruction by vertical cracks with the widths of up to 50 mm due to retaining walls continuous horizontal displacements along the Y... Y" axes in the 1... 12 axes and the emergency situation initiation. The deformations ("bending" under the shearing pressure action) of the garage complex enclosure piles ground beam along the Y axis in the 31 ... 39 axes are shown in Figure 2. (A-B). The further soil deformations could lead to a larger ground failure and deformations of building structures located above the buildings of a multi-storey urban development. To save and correct the situation, as well as to perform the project documentation comprehensive analysis and audit, existing structures visual inspection and mathematical modeling of the stress-strain state of the garage complex slopes and building structures, the concept and principles of landslide protection structures construction in restrained urban development were used. It was decided to improve the general concept of the multi-storey garage structural solution. According to the revised design version, the load-bearing structures of the multi-storey garage retaining walls had to be located in a cascade on the slope; be interconnected by underground elements and held by the load-bearing elements of the buildings frames, forming a single rigid spatial system. Based on this concept, the appropriate mathematical models of the complex buildings were developed and calculated, taking into account both traditional loads and

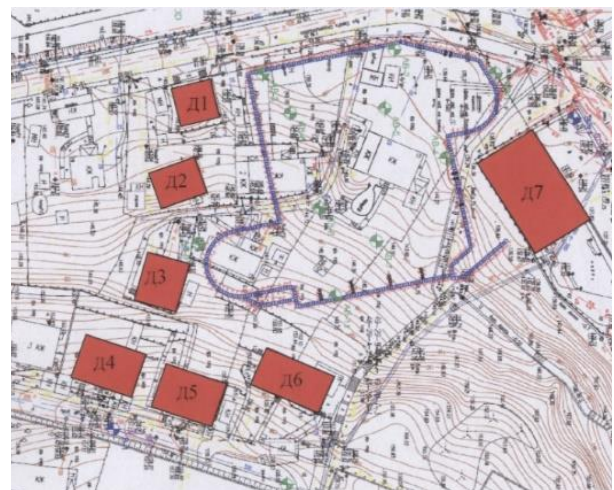
D1 is a one-storey brick non-residential building (shop). The minimum distance from the building to the pit enclosure outer perimeter is approximately 9.5 m;

Figure 3. – The layout of the construction site and surrounding development buildings and structures

D2 is a two-storey brick residential building. The distance from the building to the pit enclosure outer perimeter is approximately 13.0 m (design section H) and 18.0 m (design section I);

D3 is a two-storey brick residential building. The distance from the building to the pit enclosure outer perimeter is 5.5 m;

D4 is a one-storey brick residential building. The distance from the building to the pit enclosure outer perimeter is 30.0 m; D5 is a two-storey brick residential building. The distance from the building to the pit enclosure outer perimeter is 23.0 m; D6 is a residential brick building. The distance from the building to the pit enclosure outer perimeter is approximately 12.0 m; D7 is a two-storey non-residential building (gas station building). The distance from the building to the pit enclosure outer perimeter is 9.0 m.

Until 05.02.2011, the new cracks occurrence or existing ones opening were not noticed, but the cracks development was fast progressing after that date. The anchors arrangement for shoring the pit walls (Figure 3) caused the buildings subsidence around the pit and their destruction beginning (Figure 4). To ensure the
